Re: 49 CFR Part 573; Recall of Mercedes-Benz M-Class (163) Disengaging Cruise Control

Manufacturer's Campaign Identification Number 2011090001

11V-208

Disengaging the Cruise Control

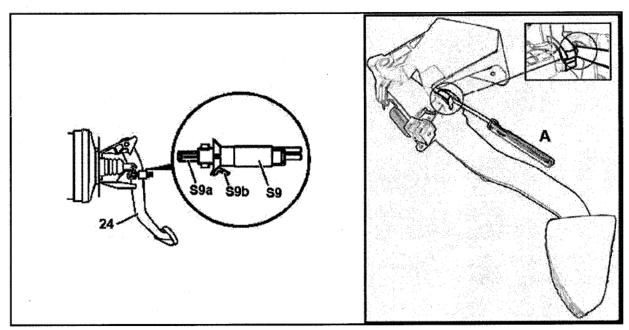
Figrue 1

-):
- Pull out white actuating pin (S9a, Figure 1) at brake light switch (S9) up to end stop.
- Press brake pedal (24, Figure 1) forwards.
- · Install brake light switch.
- Slide feeler gauge (A, Figure 1) (1.2 mm) between retaining plate of brake pedal and tappet (S9a) (actuating pin) of brake light switch.
- Slowly release brake pedal; the actuating path adjusts itself automatically.
- Remove feeler gauge.

Installation instructions for installation of the brake light switch have changed. Please be sure to read instructions (below) <u>completely</u> prior to installation of new switch. The use of a feeler gauge is now required to properly set adjustment between the retaining plate of the brake pedal and the tappet (actuating pin) of brake light switch. Please refer also to the installation video attached below.
