Subject: Safety Recall B0E – **Remedy Parts Available**
Certain 2007-2008 Model Year RAV4 Vehicles
Certain 2008 Model Year Highlander/Highlander HV Vehicles
Curtain Shield Airbag (CSA) Sensor

TECHNICAL INSTRUCTIONS
FOR
SAFETY RECALL B0E
CURTAIN SHIELD AIRBAG (CSA) SENSOR
CERTAIN 2007 – 2008 MODEL YEAR RAV4

TECHNICAL INSTRUCTIONS
FOR
SAFETY RECALL B0E
CURTAIN SHIELD AIRBAG (CSA) SENSOR
CERTAIN 2008 MODEL YEAR HIGHLANDER / HV

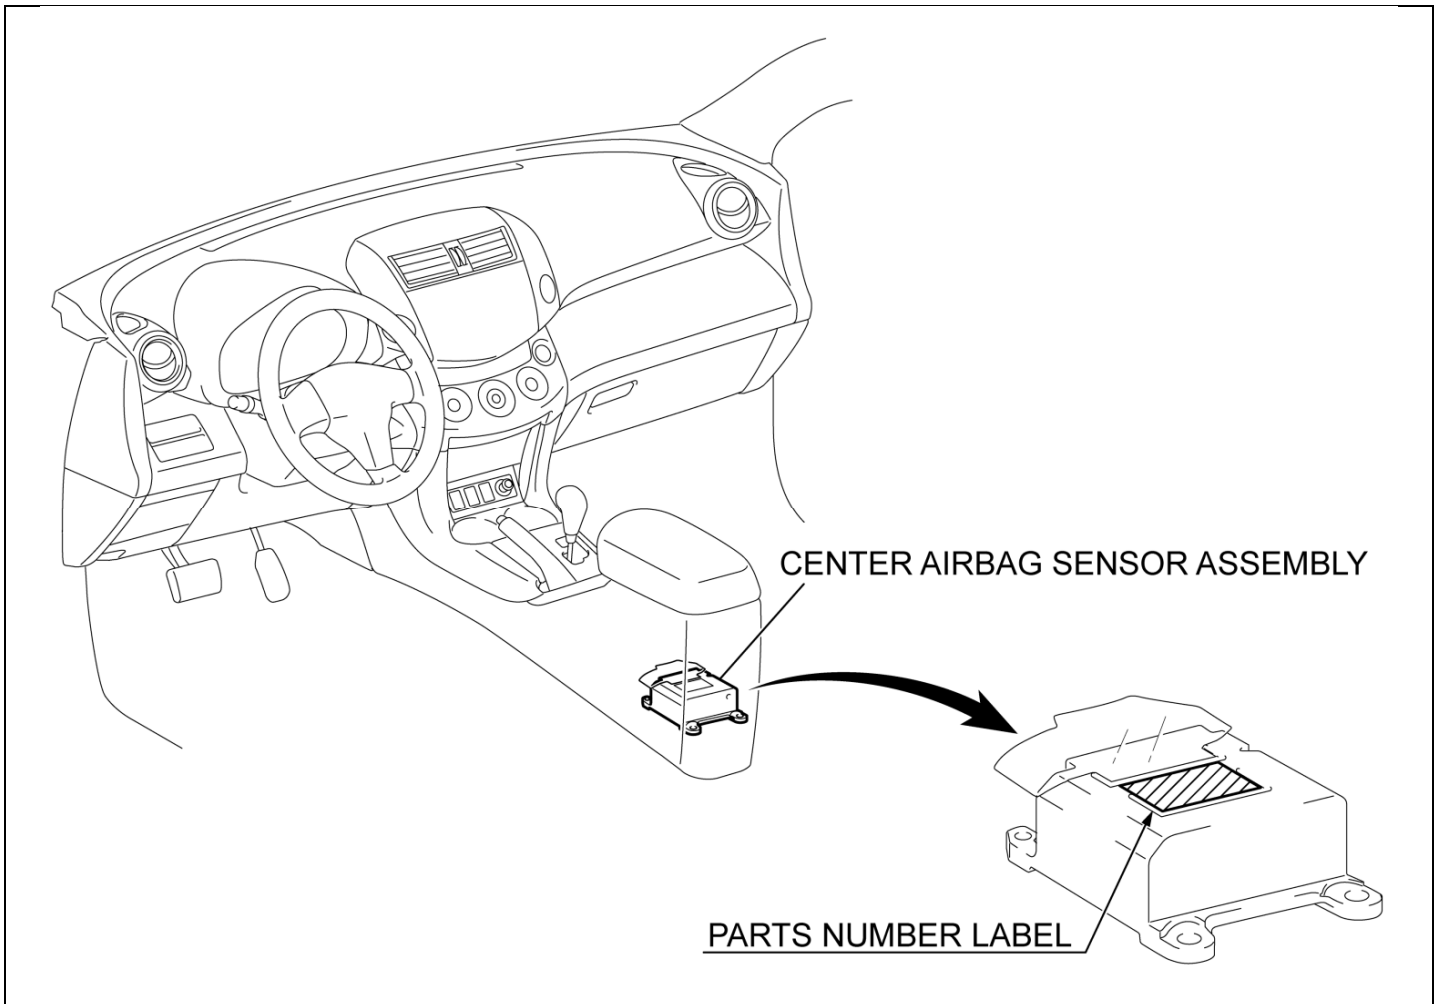
IV. BACKGROUND

In the curtain shield airbag (CSA) system of the subject vehicle, there are two sensors in the airbag sensor assembly which are designed to detect vehicle roll angle. If one of these sensors malfunctions, the airbag warning light (Malfunction indicator Light: MIL) will illuminate and the roll detection system will be suspended; however, the airbag (CSA) remains available in the event of a side crash. If both sensors fail nearly simultaneously after initial airbag system check, the CSA and the seat belt pretensioner could be inadvertently activated. Inadvertent activation of the CSA and/or the seat belt pretensioner can cause injury to a vehicle occupant.

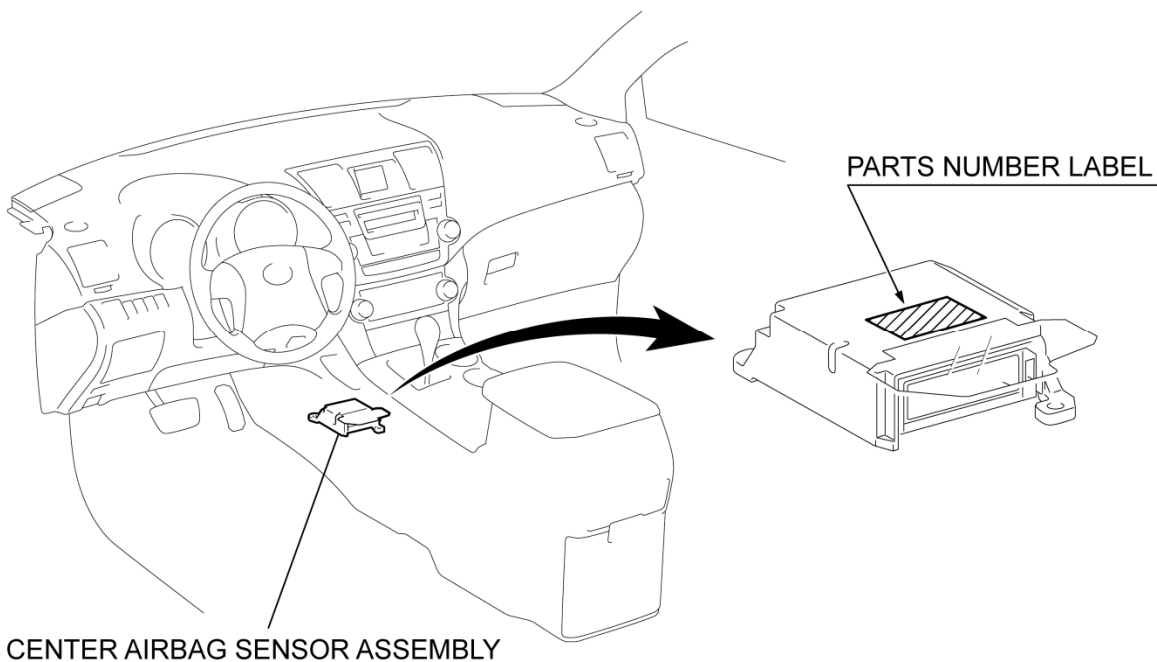
IV. BACKGROUND

In the curtain shield airbag (CSA) system of the subject vehicle, there are two sensors in the airbag sensor assembly which are designed to detect vehicle roll angle. If one of these sensors malfunctions, the airbag warning light (Malfunction indicator Light: MIL) will illuminate and the roll detection system will be suspended; however, the airbag (CSA) remains available in the event of a side crash. If both sensors fail nearly simultaneously after initial airbag system check, the CSA and the seat belt pretensioner could be inadvertently activated. Inadvertent activation of the CSA and/or the seat belt pretensioner can cause injury to a vehicle occupant.
