DAIMLER

**Re: Defect Information Report – Supplemental Report No. 1
11V-249, FL-605
Gunite Automatic Slack Adjusters**

Subject: Gunite Automatic Slack Adjusters

June 2011
FL605A-Z
NHTSA #11V-249
Transport Canada #11-163

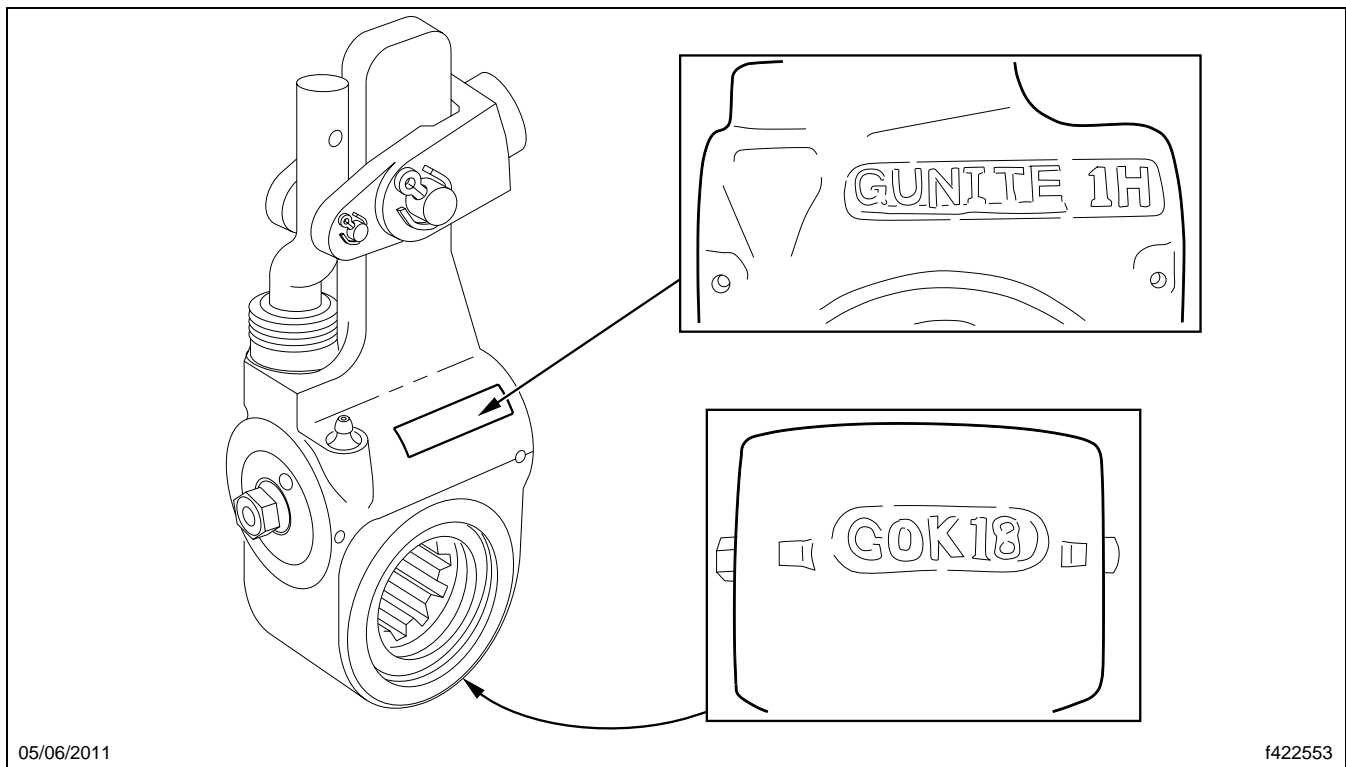
Fig. 1, Slack Adjuster Lot Number and Mold Line Nomenclature Identification

On the side of the slack adjuster housing there is the name "GUNITE" and either an "H" or a "1H", this is the mold line nomenclature.

On the bottom of the slack adjuster is the lot number information. (Ignore the first character and look at the last four characters.)

Suspect Slack Adjuster Lot Number and Mold Line Identification							
Lot Number	Mold Line	Lot Number	Mold Line	Lot Number	Mold Line	Lot Number	Mold Line
0I06	1H	0I20	1H	0K04	1H	0L18	1H
0I07		0I26		0K10		0L22	
0I14		0J06		0K12		0L24	
0I15		0J07		0K18		1A15	
0I17		0L28		0K22		1A21	
0I18		0L30		0K24		1A22	
0I19		0K02		0L12		0K26	H

4. If the combination of slack adjuster mold line and lot number exactly match any of the combinations in **Table 4** below, replace the affected slack adjuster(s) as instructed in "Gunite Slack Adjuster Removal and Installation" below.
