To: All Toyota Dealer Principals, Service Managers, Parts Managers
Subject: Safety Recall B0F
Certain 2011 Model Year Tundra Vehicles
Inspection and Possible Replacement of Rear Propeller Shaft

TECHNICAL INSTRUCTIONS
FOR
SAFETY RECALL B0F
REAR PROPELLER SHAFT INSPECTION
CERTAIN 2011 MODEL YEAR TUNDRA

UPDATED DECEMBER 7, 2011

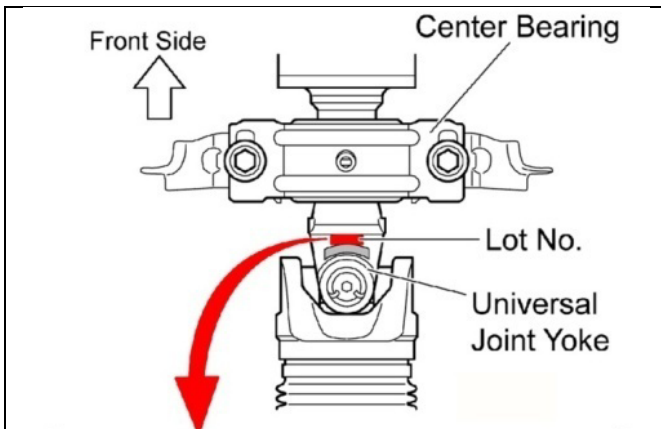
1. INSPECT THE LOT NUMBER ON THE UNIVERSAL JOINT YOKE

- a) Does the lot number **start** with **10HV**? **There may or may not be a number following the V in the 10HV lot number, this number has no bearing on this inspection.**

NOTE: The propeller shaft may need to be rotated to inspect the lot number.

If the first 4 digits of the 5 digit lot number cannot be determined, the propeller shaft **SHOULD** be replaced.

The vehicle **IS** affected. The propeller shaft must be replaced.

- b) Refer to TIS for instructions on propeller shaft replacement.
