# TOYOTA

Subject: Safety Recall B0F  
Certain 2011 Model Year Tundra Vehicles  
Inspection and Possible Replacement of Rear Propeller Shaft

**TECHNICAL INSTRUCTIONS**  
**FOR**  
**SAFETY RECALL B0F**  
**REAR PROPELLER SHAFT INSPECTION**  
**CERTAIN 2011 MODEL YEAR TUNDRA**

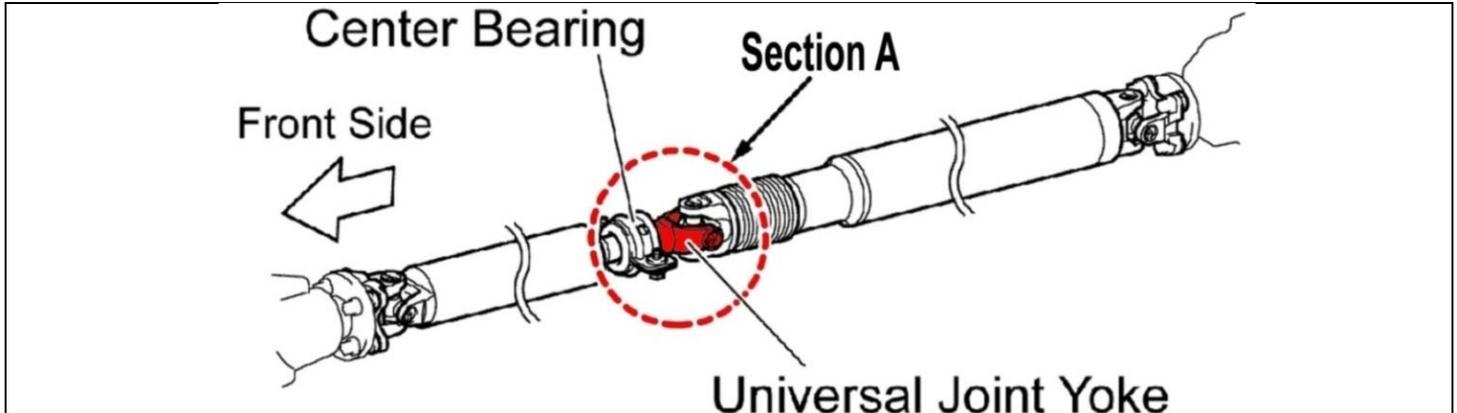
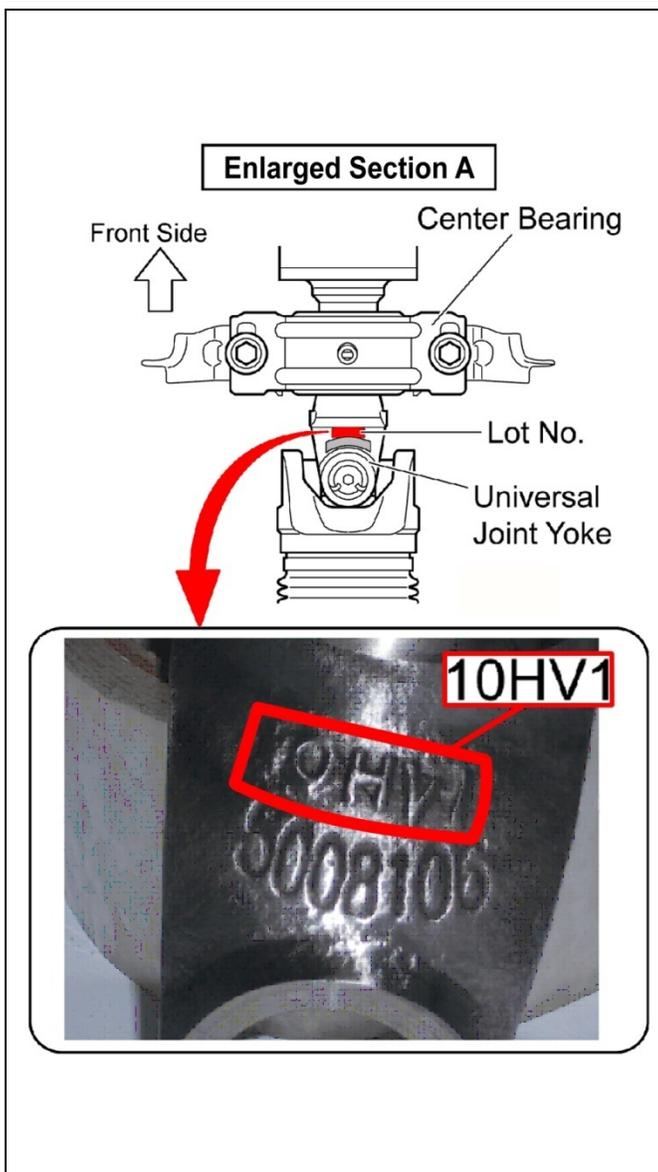
### A. LOCATE AND INSPECT THE LOT NUMBER ON THE REAR PROPELLER SHAFT

#### 1. INSPECT THE LOT NUMBER ON THE UNIVERSAL JOINT YOKE

a) Is the lot number 10HV1?

The vehicle **IS NOT** affected. The campaign is complete.

The vehicle **IS** affected. The propeller shaft must be replaced.

**NOTE: The propeller shaft may need to be rotated to inspect the lot number.**

If the 5 digit lot number cannot be determined, the propeller shaft **SHOULD** be replaced.

- 1) Take a picture of the lot number.
- 2) Order the propeller shaft assembly.
- 3) Call the Quality Compliance Hotline and provide:
  - Dealer code
  - Dealer contact and phone number
  - Order reference number
  - Part number ordered
  - Order date
  - VIN
- 4) Quality Compliance will release parts upon confirmation of inspection.

b) Refer to TIS for instructions on propeller shaft replacement.
