Subject: Safety Recall B0F  
Certain 2011 Model Year Tundra Vehicles  
Inspection and Possible Replacement of Rear Propeller Shaft

**TECHNICAL INSTRUCTIONS**  
**FOR**  
**SAFETY RECALL B0F**  
**REAR PROPELLER SHAFT INSPECTION**  
**CERTAIN 2011 MODEL YEAR TUNDRA**

Lonnie Peterson / TMS Toyota Customer Services  
Product Quality and Service Support, Quality Compliance  
April 26, 2011  
Approved By: Bob Waltz

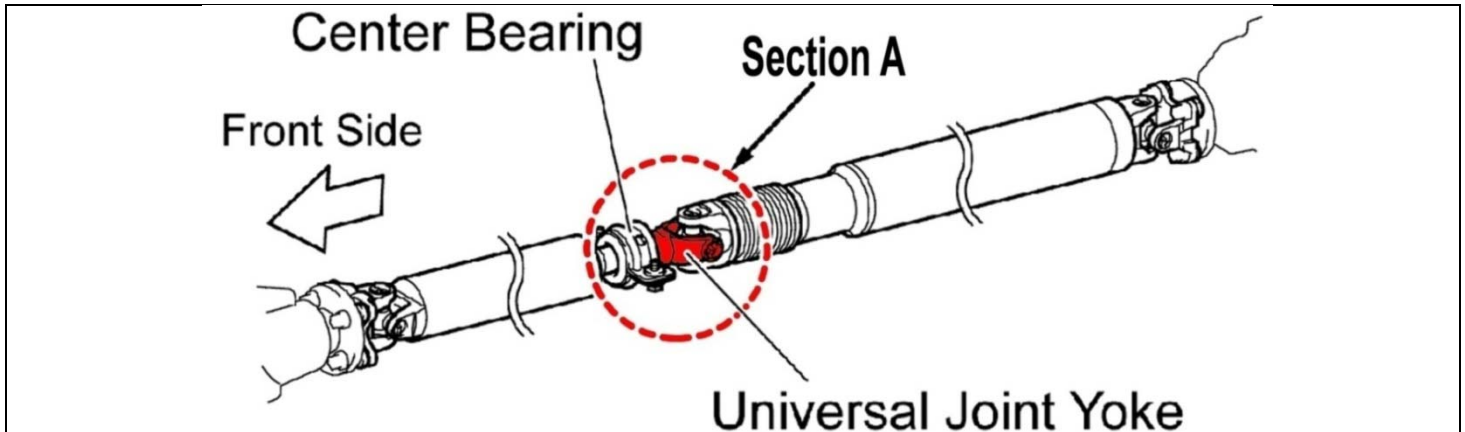
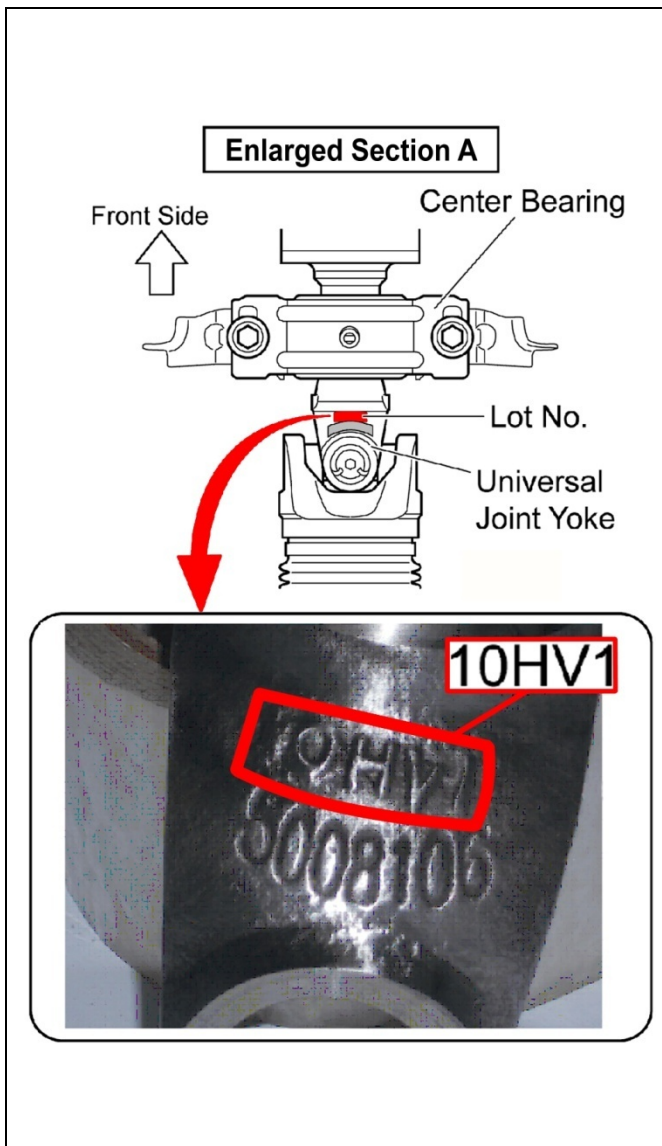
### A. LOCATE AND INSPECT THE LOT NUMBER ON THE REAR PROPELLER SHAFT

#### 1. INSPECT THE LOT NUMBER ON THE UNIVERSAL JOINT YOKE

- a) Is the lot number 10HV1?

**NOTE: The propeller shaft may need to be rotated to inspect the lot number.**

**NOTE: If the lot number cannot be distinguished, the propeller shaft should be replaced.**

The vehicle **IS NOT** affected. The campaign is complete.

The vehicle **IS** affected. The propeller shaft must be replaced.

- b) Refer to TIS for instructions on propeller shaft replacement.

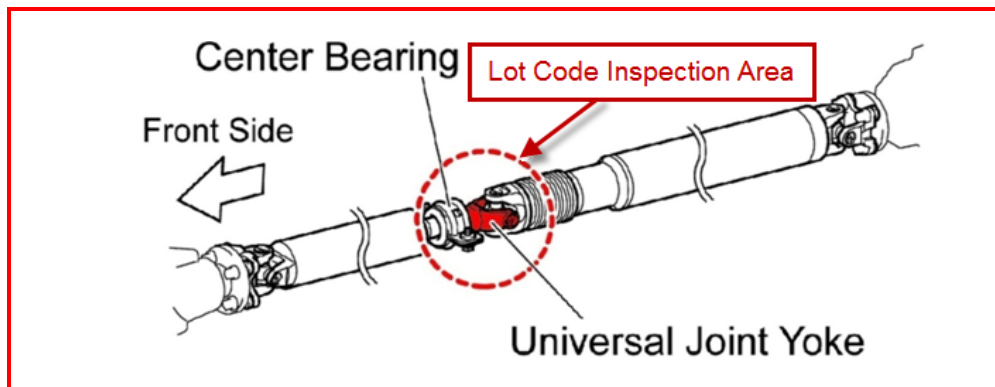
On certain 2011 Model Year Tundra vehicles equipped with a 3-Joint type propeller shaft, the rear propeller shaft slip yoke may have been improperly cast. The improperly cast yokes are from a specific production lot. In vehicles with a slip yoke from that lot, there is the possibility that the slip yoke may break and the rear propeller shaft may separate at the joint. If this occurs the propeller shaft could contact the road surface, which could increase the risk of a crash.

- Any authorized Toyota dealer will inspect the rear propeller shaft to determine if it might contain an improperly manufactured slip yoke. Based upon the inspection results, in a limited number of cases, the dealer may need to replace the rear propeller shaft. The inspection and, if necessary, replacement will be performed at **NO CHARGE** to the vehicle owner.
