# Recall Bulletin

## PRODUCT SAFETY RECALL

**SUBJECT:** Intermediate Steering Shaft Separation

**MODELS:** 2011 Chevrolet Cruze

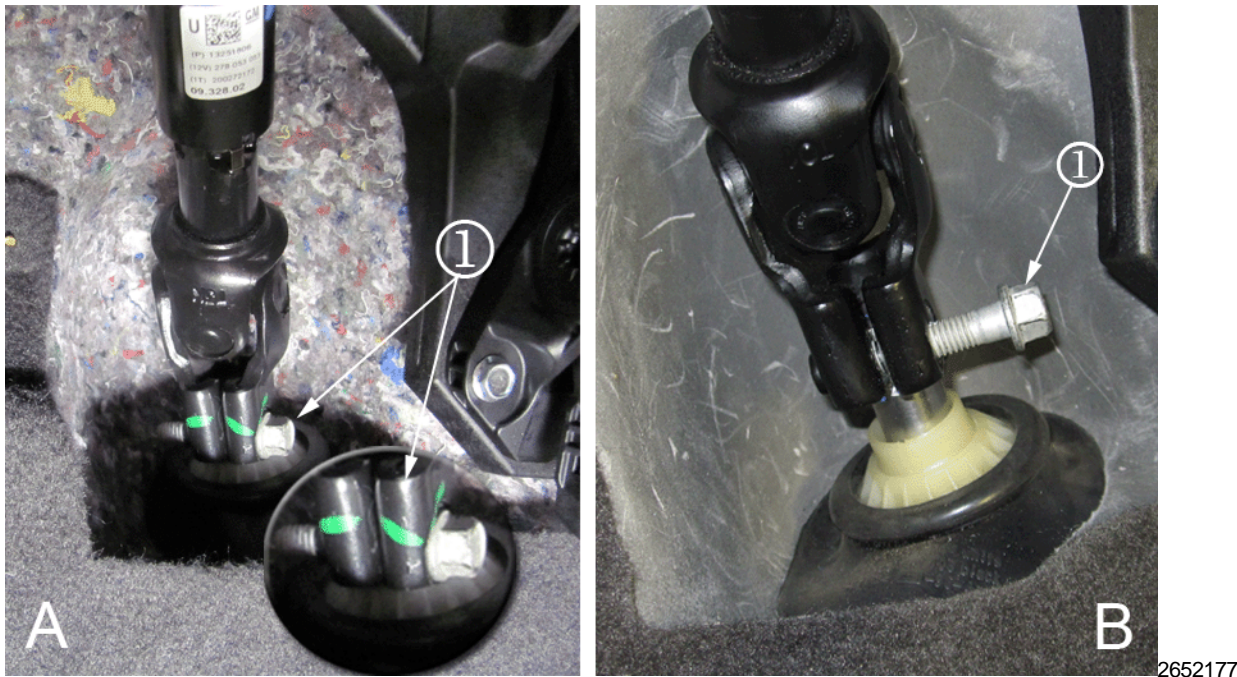
**(A) Lower Intermediate Steering Shaft Bolt Fully Seated**

**(B) Lower Intermediate Steering Shaft Bolt NOT Seated**

**(1) Lower Intermediate Steering Shaft Bolt.**

1. Inspect the intermediate steering shaft for a fully seated lower intermediate steering shaft bolt. Refer to the illustration. Portion “A” of the illustration shows a fully seated bolt. Portion “B” of the illustration shows a bolt that is not fully seated.
  - If the lower intermediate steering shaft bolt is fully seated and tightened to minimum of 25 N•m (18 lb-ft), proceed to Step 3.
  - If the lower intermediate steering shaft bolt is NOT fully seated, replacement of the intermediate steering shaft, intermediate shaft bolts and steering gear is required. Refer to the “B” portion of the illustration. Proceed to Step 2.

2. Replace the steering gear and intermediate steering shaft. Refer to *Steering Gear Replacement* and *Intermediate Steering Shaft Replacement* in SI. Proceed to Step 3 after completing repairs.
3. Turn the ignition to the ON/RUN position with the engine off.
