# Customer Service Notice

Units Affected: All AT40M/P units built from serial numbers 0607CZ0000 (June, 2007) through 1009CZ0118 (October, 2009)

## Link Replacement

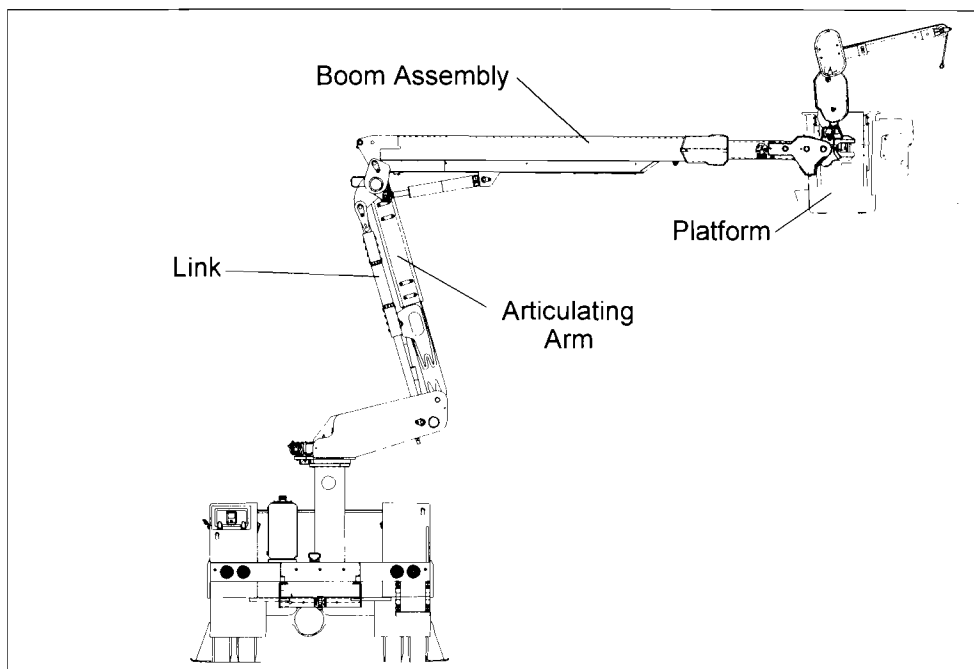
Figure 1 — Link Location

The link on the AT40M/P units is part of the articulating arm assembly (refer to Figure 1). The link is also part of the chassis insulating system on the aerial device. Altec has found rust inside the steel weldment may run over the inner surface of the insulating link and over time compromise the dielectric integrity of the link. The source of the rust within links was found to be metal particles generated during manufacturing. This condition only effects the quality of the insulating link of the chassis insulating system. The chassis insulating system is not required by industry standards, but was provided by Altec as standard equipment on these units. The insulating properties of the main boom are not effected.

**Failure to maintain the dielectric characteristics of the provided chassis insulating system can allow the chassis to become energized in the event of accidental contact between the upper boom assembly and an unguarded energized conductor. Death or serious injury will result should a person standing on the ground come in contact with or close proximity to an energized chassis.**

Altec requires that the links on the above listed units be replaced to ensure continued dielectric integrity. The links must be replaced within 60 days of receipt of this CSN. If the chassis insulating system has been dielectrically tested within the last year, the unit may continue to be operated as normal while awaiting link replacement. If the unit has not had the chassis insulating system tested in the last year, such a test should be conducted or crews must treat the link sections as non-insulating. The manufacturing process has been changed and replacement link has been redesigned to address the initial condition.

Call 1-877-GO-ALTEC to order the Link Replacement Kit, part number 970299534, or to schedule the work to be done by an Altec service technician. This repair is covered under the Altec Warranty System. Installation of the Link Replacement Kit can be done by the customer. The parts for this repair are covered under the Altec Warranty System. Additionally, Altec will reimburse up to \$240 for the labor to perform this repair. A warranty claim must be submitted for reimbursement for the cost of the parts and labor. Customers are responsible for the travel costs of an Altec Mobile Service technician if the technician performs the repair at the owner's location.
