Toyota Motor Sales, U.S.A., Inc.
19001 South Western Avenue
Torrance, CA 90501
(310) 468-4000

Subject: Safety Recall B0G – **Remedy Notice**
2001 to 2003 Model Year Prius Vehicles
Replacement of Electric Power Steering (EPS) Pinion Shaft Nuts

TECHNICAL INSTRUCTIONS
FOR
SAFETY RECALL B0G
EPS PINION SHAFT NUTS REPLACEMENT
2001 – 2003 MODEL YEAR PRIUS

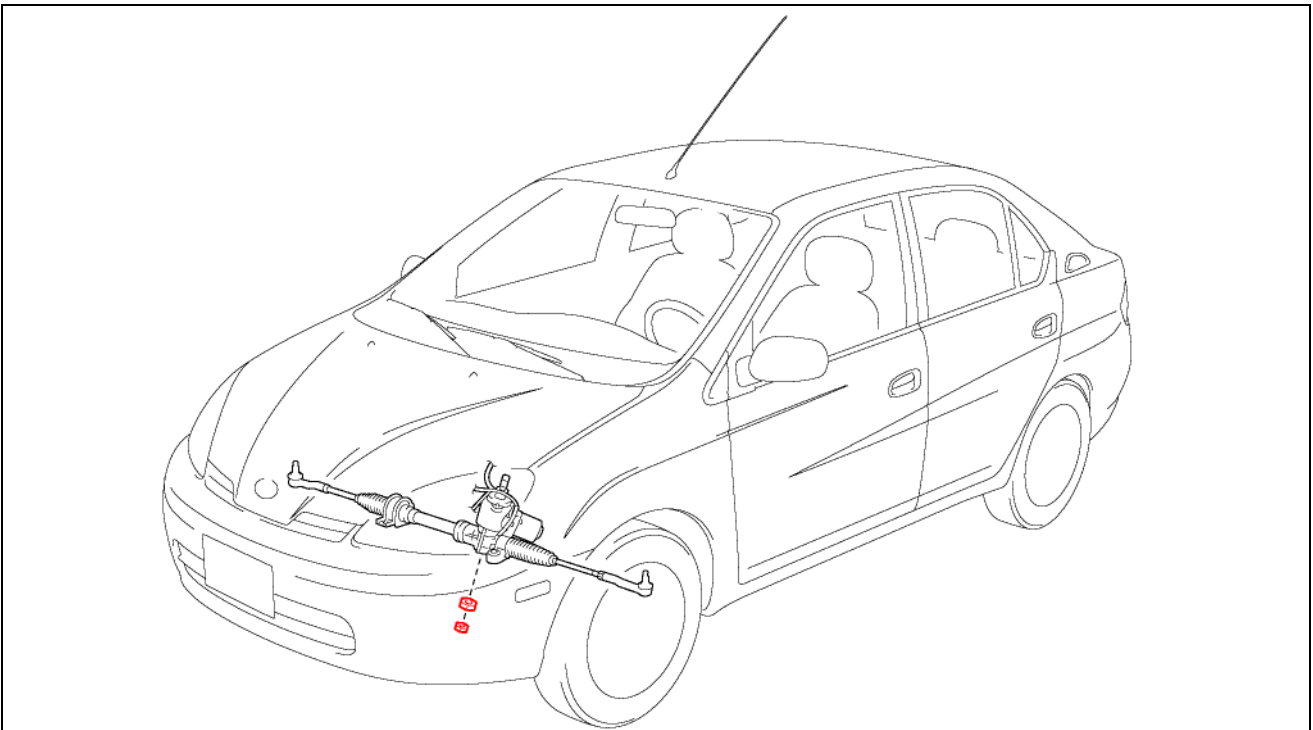
IV. BACKGROUND

In the EPS system of the 2001 through 2003 Prius, due to the inadequate fixation of nuts that secure the pinion shaft in the steering gear box assembly, if the steering wheel is repeatedly and strongly turned to the full-lock position, there is a possibility that the nuts may become loose. If the vehicle is continuously operated in this condition, the pinion shaft may become unstable which may cause power generated by the electric motor to not be fully transmitted. This could result in significant increased steering effort when making a left turn increasing the risk of a crash.

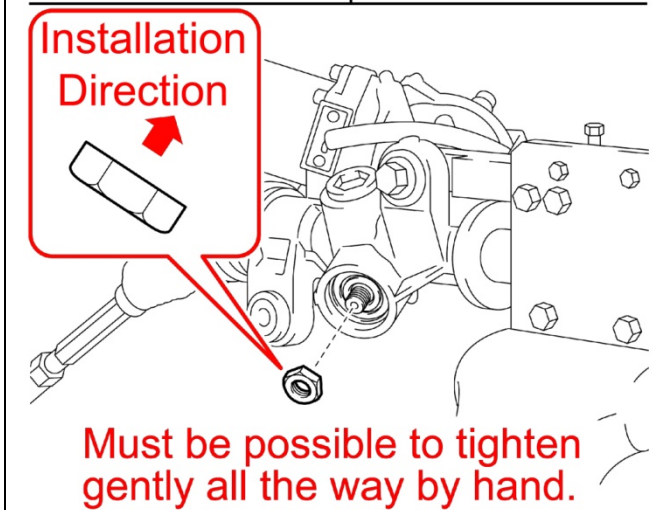
Pinion Shaft Nuts		Notes
Adjusting Nut	New	Thickness: 6.0mm Green chemical applied to nut (friction stabilizer)
	Old	Thickness: 7.5mm
Lock Nut	New	Thickness: 7.5mm Distorted thread locknut
	Old	Thickness: 7.5mm
