Kathy Wachs / Service & Parts Operations
 Lexus Customer Services
 June 29, 2011
 Approved by: Robin LeFevre

To: All Lexus Dealers
 From: Lexus Customer Services

Safety Recall BLD (Interim B2D) - *Preliminary Notice*
 Certain 2006 and 2007 Model Year RX 400h Vehicles
 Intelligent Power Module (IPM) Replacement
 *****URGENT*****

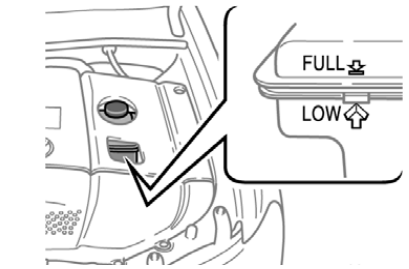
| <p>Inverter Coolant Reservoir</p> | <p>(1) Regularly confirm that the coolant level in the inverter coolant reservoir is between FULL and LOW. If the coolant level is below the LOW line, please add coolant up to the FULL line.</p> <p>Lexus dealers will inspect the coolant level, and if necessary, add coolant, at no charge at the customer's request.</p> |

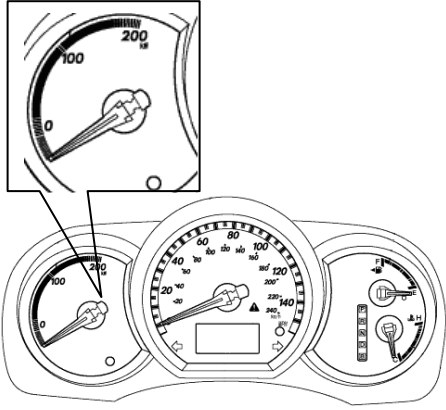
| <p>Power Meter</p> | <p>(2) Avoid placing a high load on the Hybrid System. Drivers may do so by refraining from towing with the vehicle until the remedy is completed.</p> <p>(3) Monitor your Power Meter. The Power Meter indicates the immediate output from the Hybrid System in approximate kilowatts. Keep power usage below 100kW as much as possible. Situations where the Power Meter shows output slightly over 100kW for a brief moment should not raise any concerns.</p> |

A4a: Situations where the Power Meter shows output slightly over 100kW for a brief moment should not raise any concerns. Drivers should refrain from driving conditions where power output exceeds 100kW continuously and/or substantially. Drivers may do so by refraining from towing with the vehicle until the remedy is completed.
