Lonnie Peterson / TMS Toyota Customer Services
Product Quality and Service Support, Quality Compliance
June 29, 2011
Approved By: Bob Waltz

To: All Toyota Dealers
From: Toyota Customer Services

Safety Recall B0J – (B1J) Preliminary Notice
Certain 2006 and 2007 Model Year Highlander HV Vehicles
Intelligent Power Module (IPM) Replacement
*******URGENT*******

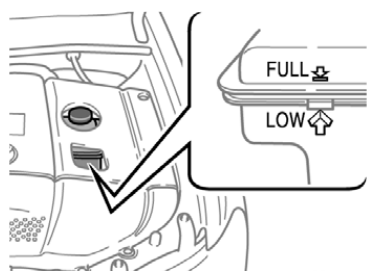
<p>Inverter Coolant Reservoir</p>	<p>(1) Regularly confirm that the coolant level in the inverter coolant reservoir is between FULL and LOW. If the coolant level is below the LOW line, please add coolant up to the FULL line.</p> <p>Toyota dealers will inspect the coolant level, and if necessary, add coolant, at no charge at the customer's request.</p>

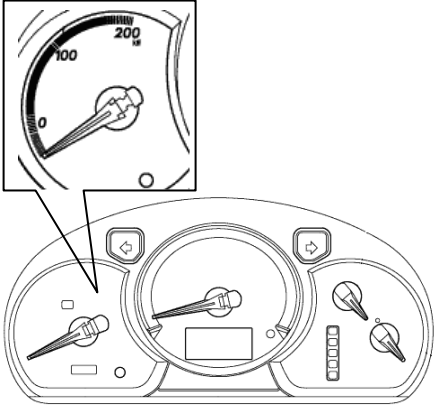
<p>Power Meter</p>	<p>(2) Avoid placing a high load on the Hybrid System. Drivers may do so by refraining from towing with the vehicle until the remedy is completed.</p> <p>(3) Monitor your Power Meter. The Power Meter indicates the immediate output from the Hybrid System in approximate kilowatts. Keep power usage below 100kW as much as possible. Situations where the Power Meter shows output slightly over 100kW for a brief moment should not raise any concerns.</p>

A4a: Situations where the Power Meter shows output slightly over 100kW for a brief moment should not raise any concerns. Drivers should refrain from driving conditions where power output exceeds 100kW continuously and/or substantially. Drivers may do so by refraining from towing with the vehicle until the remedy is completed.
