December 19, 2011

Subject: Safety Recall BLD (Interim B2D) - **Remedy Available**
Certain 2006 - 2007 Model Year RX 400h Vehicles
Intelligent Power Module (IPM) Replacement

TECHNICAL INSTRUCTIONS
FOR
SAFETY RECALL BLD
INTELLIGENT POWER MODULE TRANSISTOR REPLACEMENT
CERTAIN 2006 – 2007 MODEL YEAR RX 400h

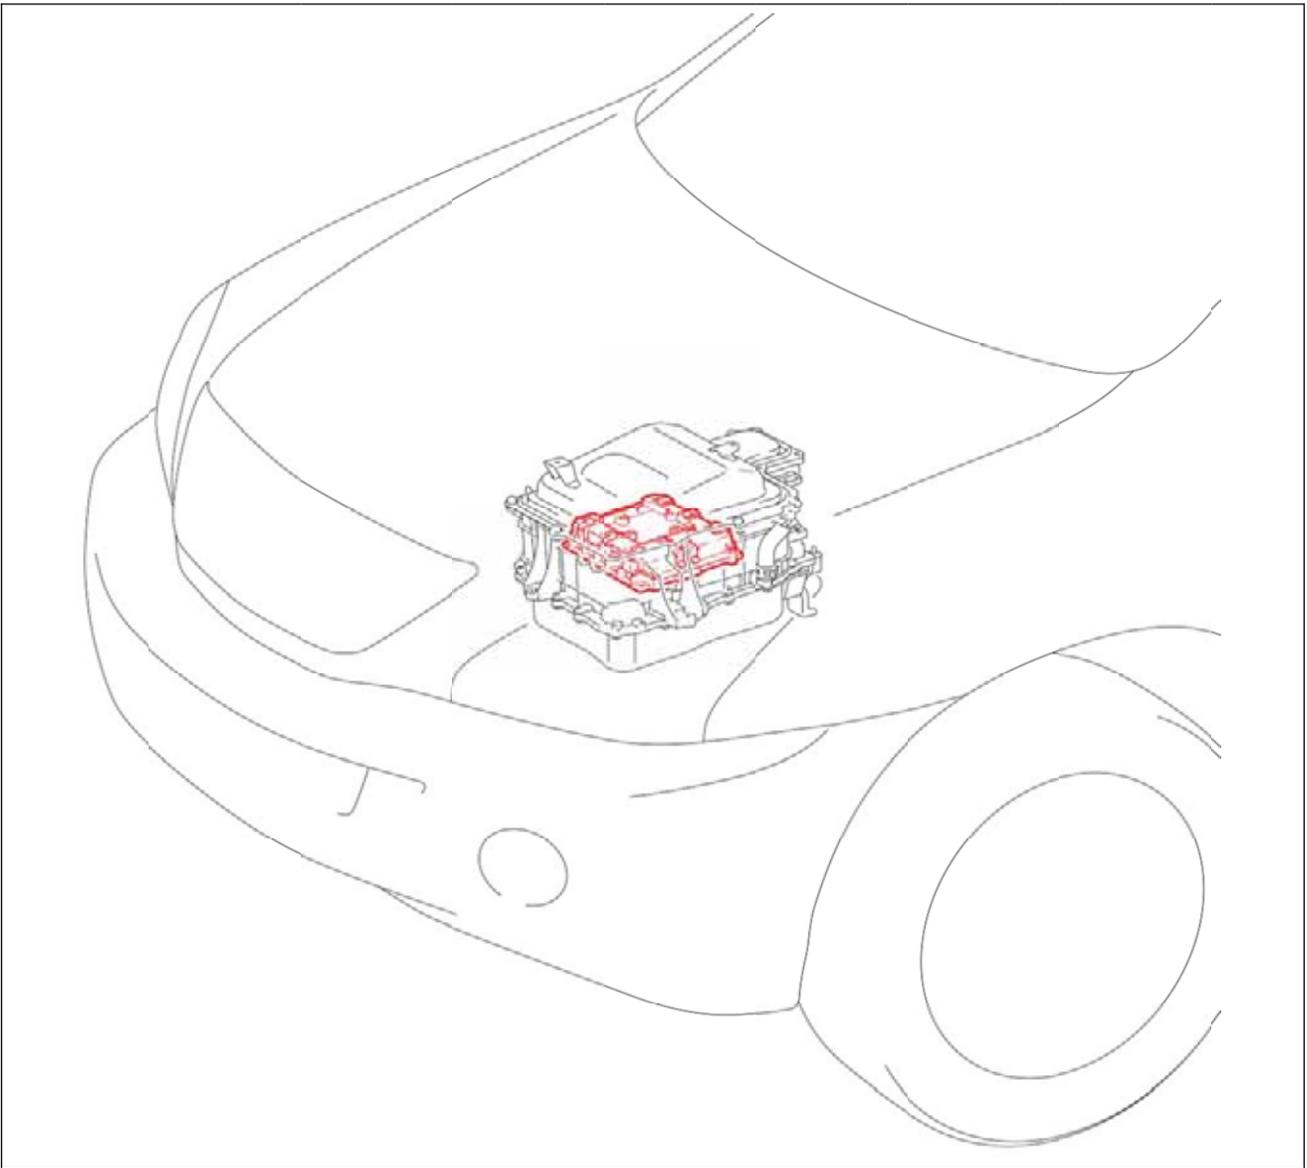
IV. BACKGROUND

The Intelligent Power Module (IPM) is located inside the Hybrid System Inverter and contains a control board with transistors. Certain transistors on the control boards of some of the subject vehicles were inadequately soldered and could be damaged from heat caused by a large current during high-load driving. If this occurs, various warning lamps will be illuminated on the instrument panel. The vehicle may enter a fail-safe/limp-home mode that limits the driving speed of the vehicle. It is possible that the hybrid system will shut down while the vehicle is being driven, causing the vehicle to stall unexpectedly, increasing the risk of a crash.

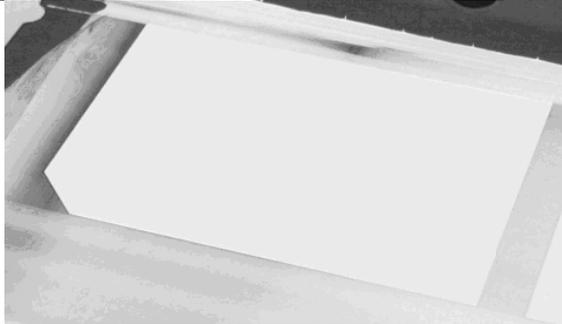
<p>CONDITION: Smooth surface and complete coverage.</p> <p>ACTION: Proceed to: SECTION X. REASSEMBLY</p>

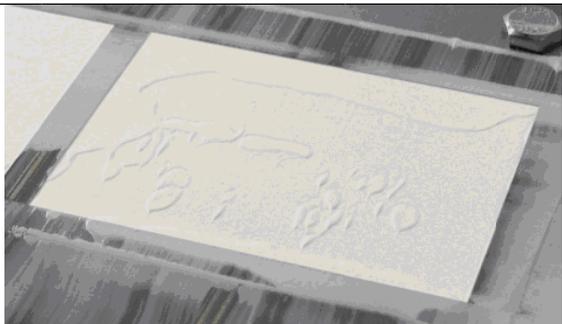
<p>CONDITION: Grease unsmooth. Metal surface of the IPM transistor NOT visible through the grease.</p> <p>ACTION: Proceed to: SECTION X. REASSEMBLY</p>

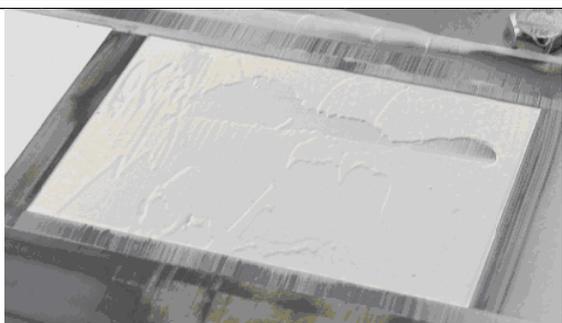
<p>CONDITION: Grease unsmooth. Metal surface of the IPM transistor visible through the grease.</p> <p>ACTION: Proceed to: STEP C #2. REAPPLY GREASE TO THE NEEDED AREAS</p>

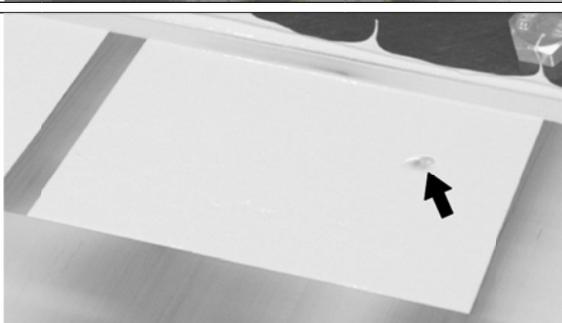
<p>CONDITION: Hole or imperfection in the grease exposing the metal surface of the IPM transistor.</p> <p>ACTION: Proceed to: STEP C #2. REAPPLY GREASE TO THE NEEDED AREAS</p>

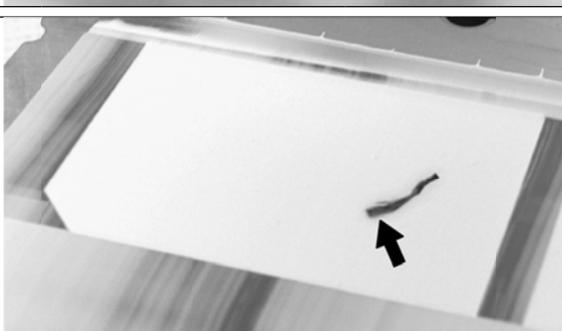
<p>CONDITION: Foreign material in the grease.</p> <p>ACTION: Proceed to: STEP C #1. REMOVE FOREIGN MATERIAL FROM THE GREASE</p>

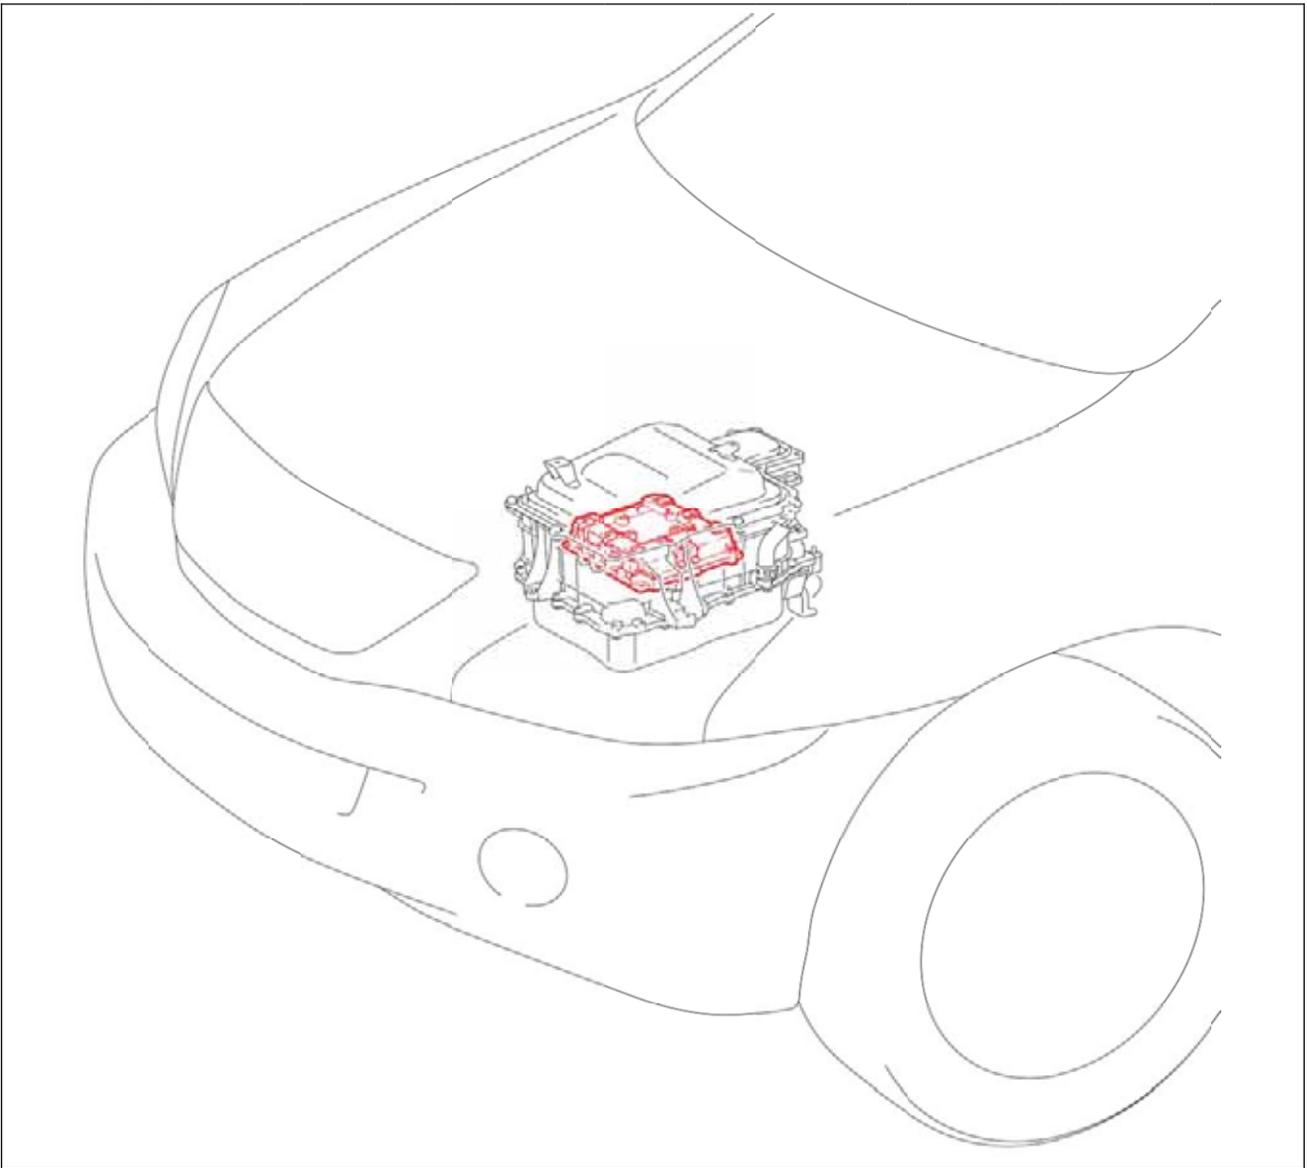
IV. BACKGROUND

The Intelligent Power Module (IPM) is located inside the Hybrid System Inverter and contains a control board with transistors. Certain transistors on the control boards of some of the subject vehicles were inadequately soldered and could be damaged from heat caused by a large current during high-load driving. If this occurs, various warning lamps will be illuminated on the instrument panel. The vehicle may enter a fail-safe/limp-home mode that limits the driving speed of the vehicle. It is possible that the hybrid system will shut down while the vehicle is being driven, causing the vehicle to stall unexpectedly, increasing the risk of a crash.

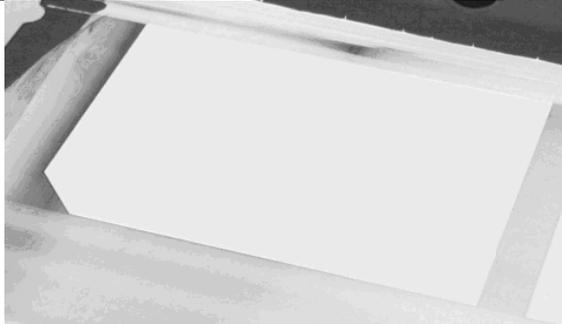
<p>CONDITION: Smooth surface and complete coverage.</p> <p>ACTION: Proceed to: SECTION X. REASSEMBLY</p>

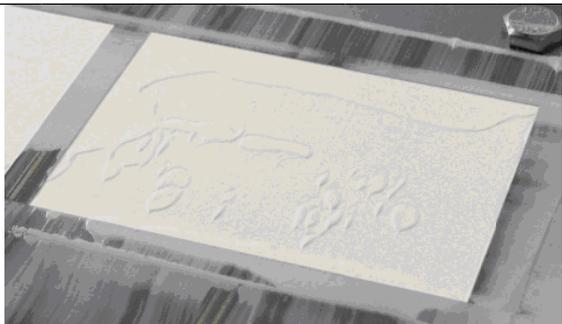
<p>CONDITION: Grease unsmooth. Metal surface of the IPM transistor NOT visible through the grease.</p> <p>ACTION: Proceed to: SECTION X. REASSEMBLY</p>

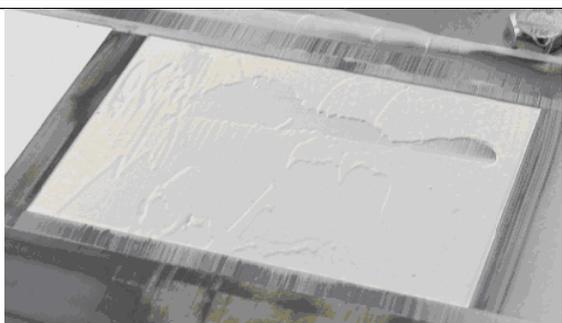
<p>CONDITION: Grease unsmooth. Metal surface of the IPM transistor visible through the grease.</p> <p>ACTION: Proceed to: STEP C #2. REAPPLY GREASE TO THE NEEDED AREAS</p>

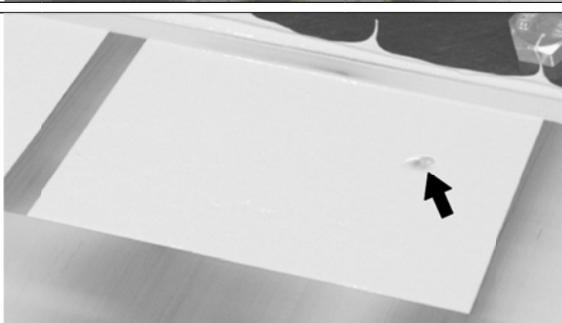
<p>CONDITION: Hole or imperfection in the grease exposing the metal surface of the IPM transistor.</p> <p>ACTION: Proceed to: STEP C #2. REAPPLY GREASE TO THE NEEDED AREAS</p>

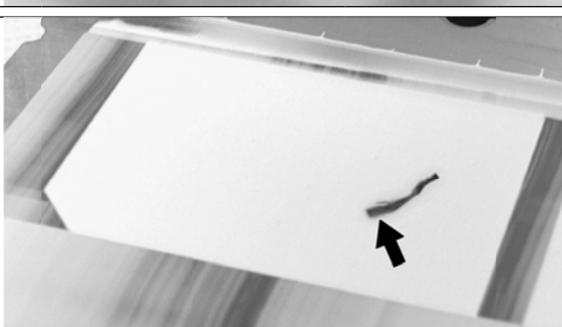
<p>CONDITION: Foreign material in the grease.</p> <p>ACTION: Proceed to: STEP C #1. REMOVE FOREIGN MATERIAL FROM THE GREASE</p>
