Altec Environmental
Products, LLC
Shelby, NC

MAB 547

MANDATORY ACTION BULLETIN

Axle Spindle Inspection and Replacement

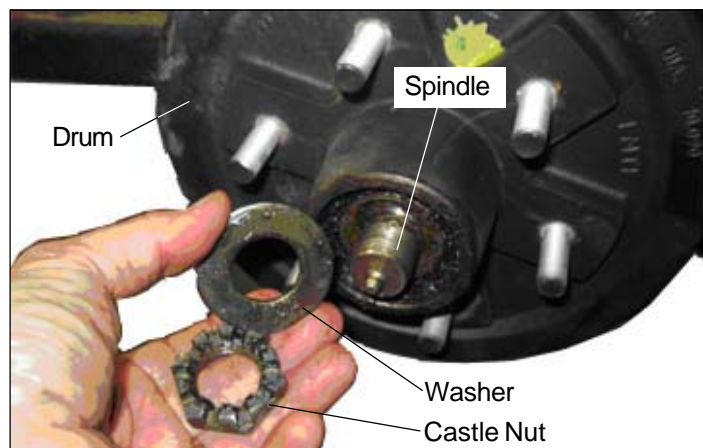
Figure 2 — Spindle Components

1. Park the chipper on a hard, flat surface and chock the wheels.
2. Position the jack under the chipper frame so raising the jack will lift one wheel off the ground. Raise the jack to remove the weight from the wheel.
3. Use a plastic or dead blow hammer to remove the grease cap at the end of the spindle.
4. Remove the cotter pin securing the castle nut and remove the castle nut and washer from the spindle (refer to Figure 2).

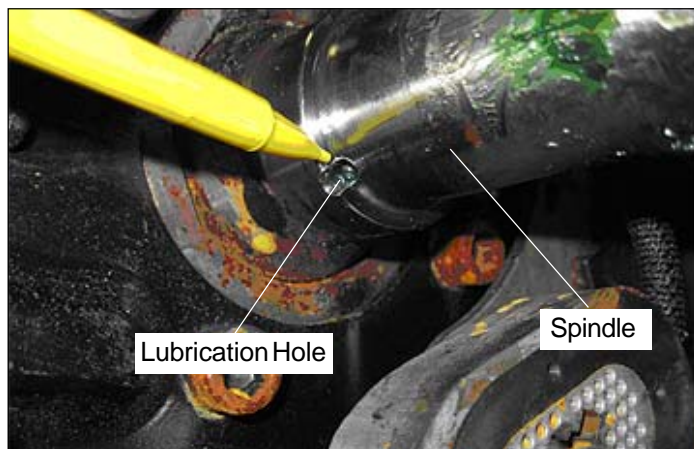
Figure 3 — Locating Lubrication Hole

7. Look for the lubrication cross drill hole on the shoulder of the spindle (refer to Figure 3).

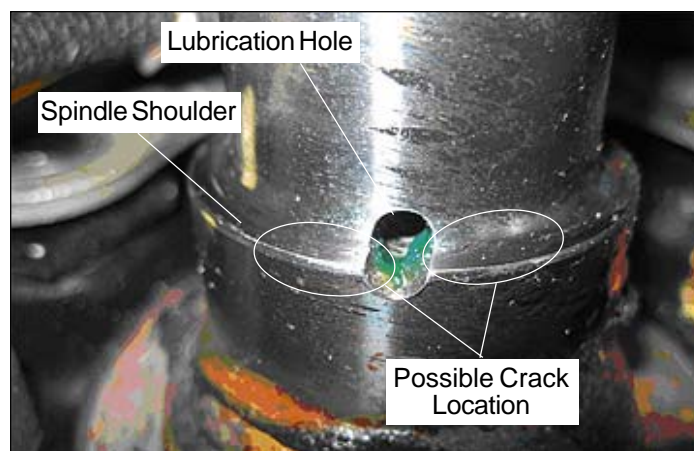
Figure 4 — Identifying Cracks

This Mandatory Action Bulletin requires immediate inspection of the chipper transport axle. Altec has received reports of spindle failures on these axles. A spindle failure can allow the transport wheel and brake hub to separate from the axle. **Death or serious injury can result from the failure of the axle spindle.**

8. Carefully look for any evidence of cracks along the base of the shoulder. Look at each side of the lubrication hole for cracks starting at the hole and radiating out along the shoulder (refer to Figure 4).

Axles on all affected chippers must be replaced within 60 days of receipt of the MAB. Chipper owners must take the following action before the chipper is towed to the next job.

9. If any cracks are found, take the chipper out of service until the axle is replaced.
