VOLKSWAGEN RENTAL CAR AGENCY COMMUNICATION

Subject: Upcoming Voluntary Safety Recall 26G8 and Voluntary Equipment Recall 26G9
2011- 2012 MY Volkswagen Jetta Sedan (6th Generation)

Vehicles with Port or Dealer Installed Volkswagen Accessory Stainless Steel Exhaust Tips (Part Number 1K0 071 910 U)

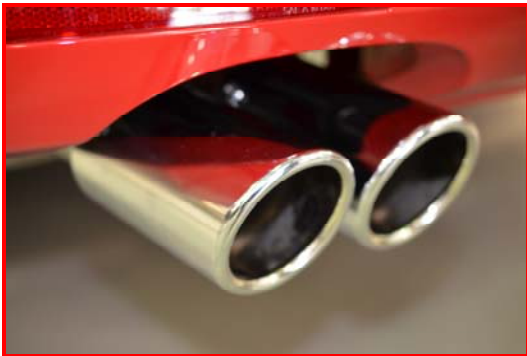
If the vehicle being inspected has exhaust pipes that look like this, it has the recalled parts. Please remove the exhaust tips from the vehicle.

- Because the affected exhaust tips can easily be removed, rental agencies are asked to immediately review their inventory and remove the affected parts from all subject vehicles. **Please note that Jetta GLI vehicles come equipped with factory-installed exhaust tips, and are NOT INCLUDED IN THIS RECALL.**
- Until sufficient stock of replacement exhaust tips becomes available, please remove the existing accessory exhaust tips from affected vehicles prior to placing/returning the vehicle into rental service.
- Please provide a list of all vehicles inspected and whether they were or were not equipped with Volkswagen accessory stainless steel exhaust tips. This list will be used to close the recall on your affected vehicles.

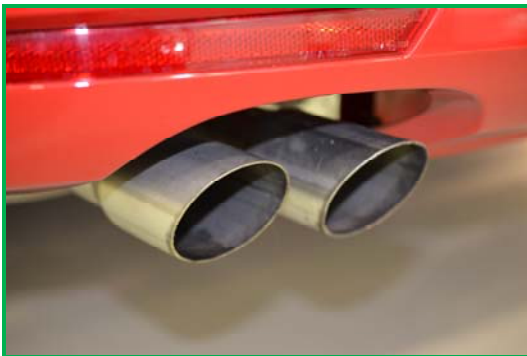
If the vehicle being inspected has exhaust pipes that look like this, the vehicle does not have the recalled parts. No work is required.
