PRODUCT CAMPAIGN BULLETIN

APPLICABILITY: 2011 Subaru Legacy & Outback **NUMBER:** WWV-33
SUBJECT: Moonroof (Sunroof) Glass **DATE:** September 2011

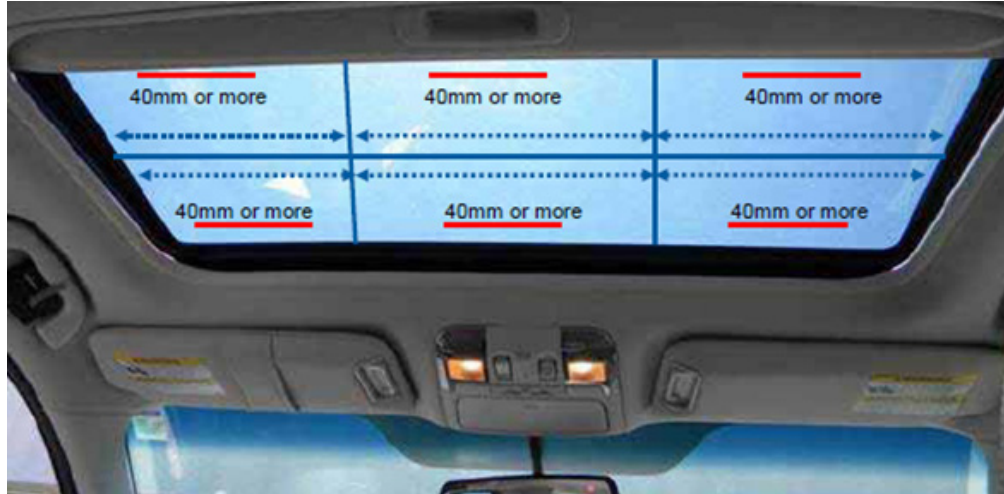
- 1) Open Sunshade
- 2) Verify if the urethane beads are present (6 Beads / 40mm or more in length).

Imagine the moonroof being divided into 6 equal sections (270mm blue arrow). Inside each of the six squares there should be a 40mm or longer bead (red line) of urethane between the moonroof glass and moonroof frame in each section.

If any of the six urethane beads measure less than 40mm in length, or no beads can be detected (missing), the Adhesive Repair Procedure will need to be performed. Refer to the **Adhesive Repair Procedure** in this bulletin.

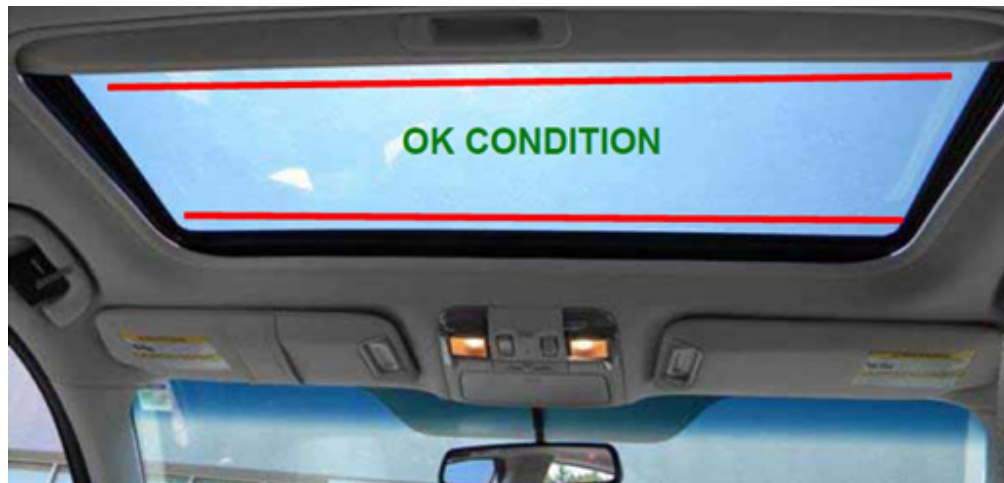
NOTE: Some vehicles may have two long urethane beads, which is also acceptable.

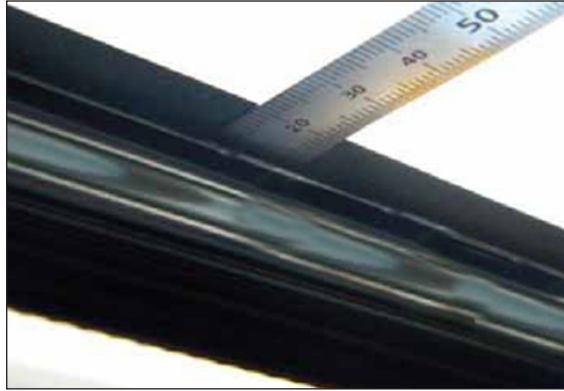
To locate the urethane beads, a metal ruler is used as a depth gauge which is inserted between the moonroof glass and moonroof frame.

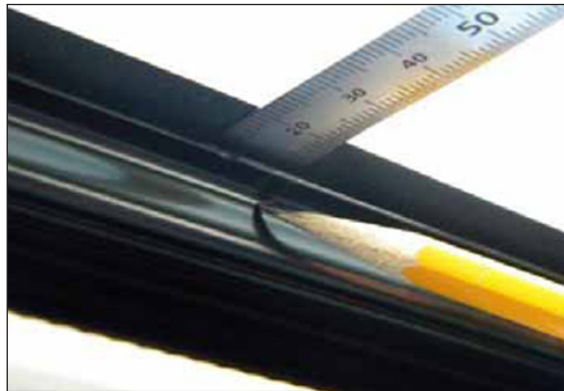
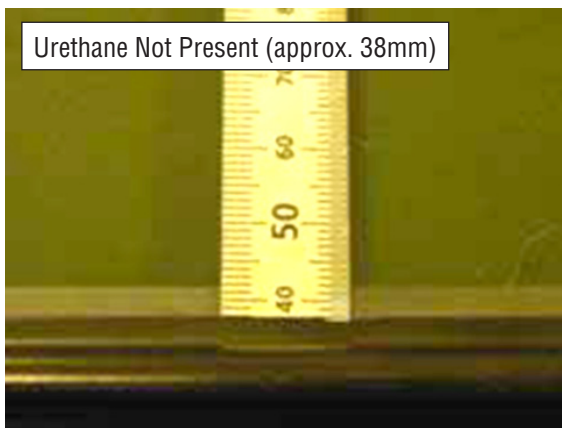
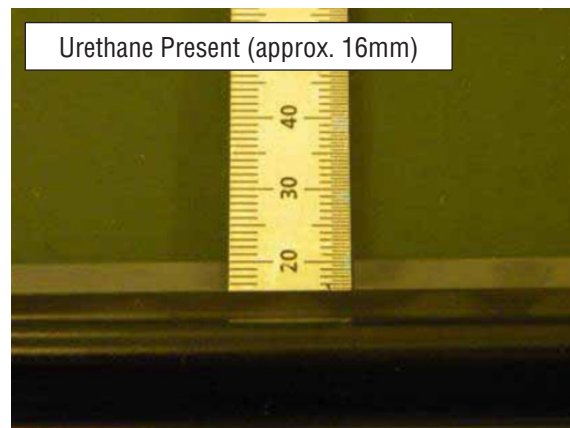
Slide the ruler between the moonroof glass and moonroof frame. Slide the ruler in a sideways motion until you locate one of the ends of the urethane bead. Using a pencil, place a small mark on the frame to mark the position.

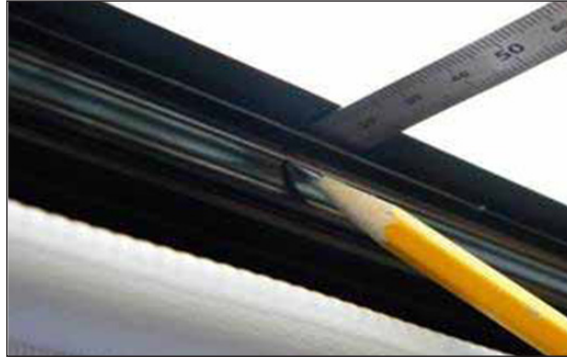
Slide the ruler along the bead until you can locate the other end of the urethane bead. Place a small mark on the frame to mark that position.

Measure the length of the urethane bead between the marks. The length of each bead must be at least 40mm. Repeat the step for the other five urethane beads.

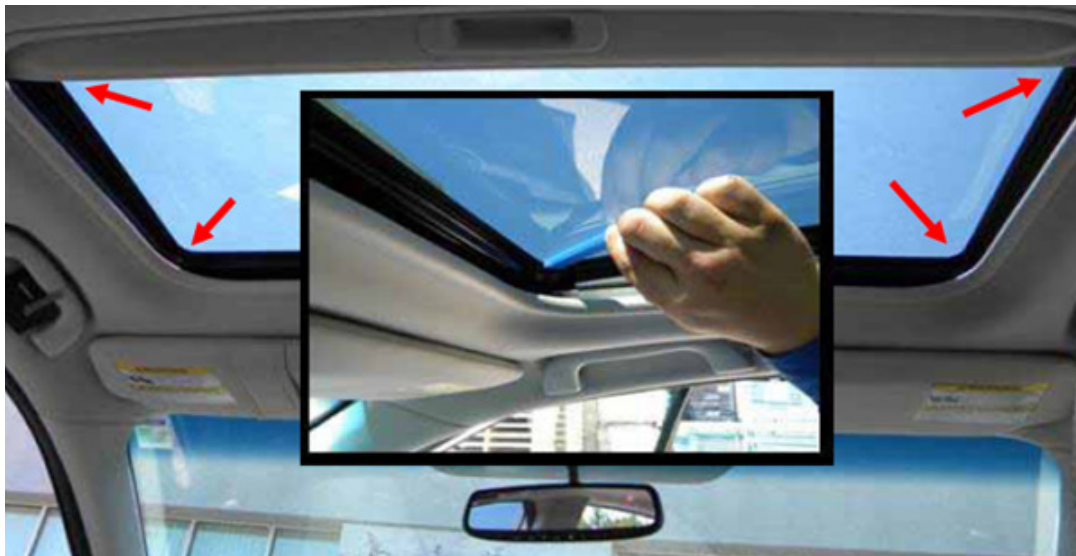
- 1) Using a plastic trim tool, check all four corners of the moonroof glass.

- Insert the plastic trim tool between the frame and glass starting at the front left corner.
- Using a reasonable amount of force, attempt to rotate the plastic trim tool up to 90 degrees from the surface of the glass. While rotating the plastic trim tool, listen, look and feel for any separation of the glass from the frame.

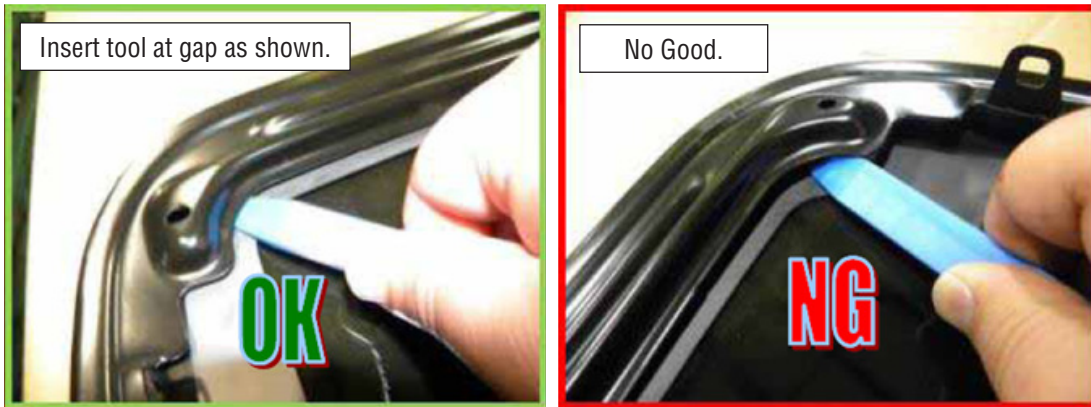
- If adhesion is inadequate the frame will move easily. If adhesion is adequate there will be little to no movement.
- Check the remaining three corners.
- If any separation occurs at any of the four corners, replace the moonroof glass/frame. Refer to the applicable Subaru Service Manual for the replacement procedure.
