SUBJECT: SAFETY RECALL OF IDLER PULLEY COVERS
Ref.: **NHTSA # 11V-016**
MCI Service Bulletin 351

Service Bulletin No. 351

MODEL D Series Coaches	TYPE Field Change Program	SECTION/GROUP 6-Cooling	DATE Feb. 8, 2011
SUBJECT MISSING WELDS ON FAN BELT IDLER PULLEY COVER			
CONDITIONS

Ref. NHTSA Recall No.: 11V-016

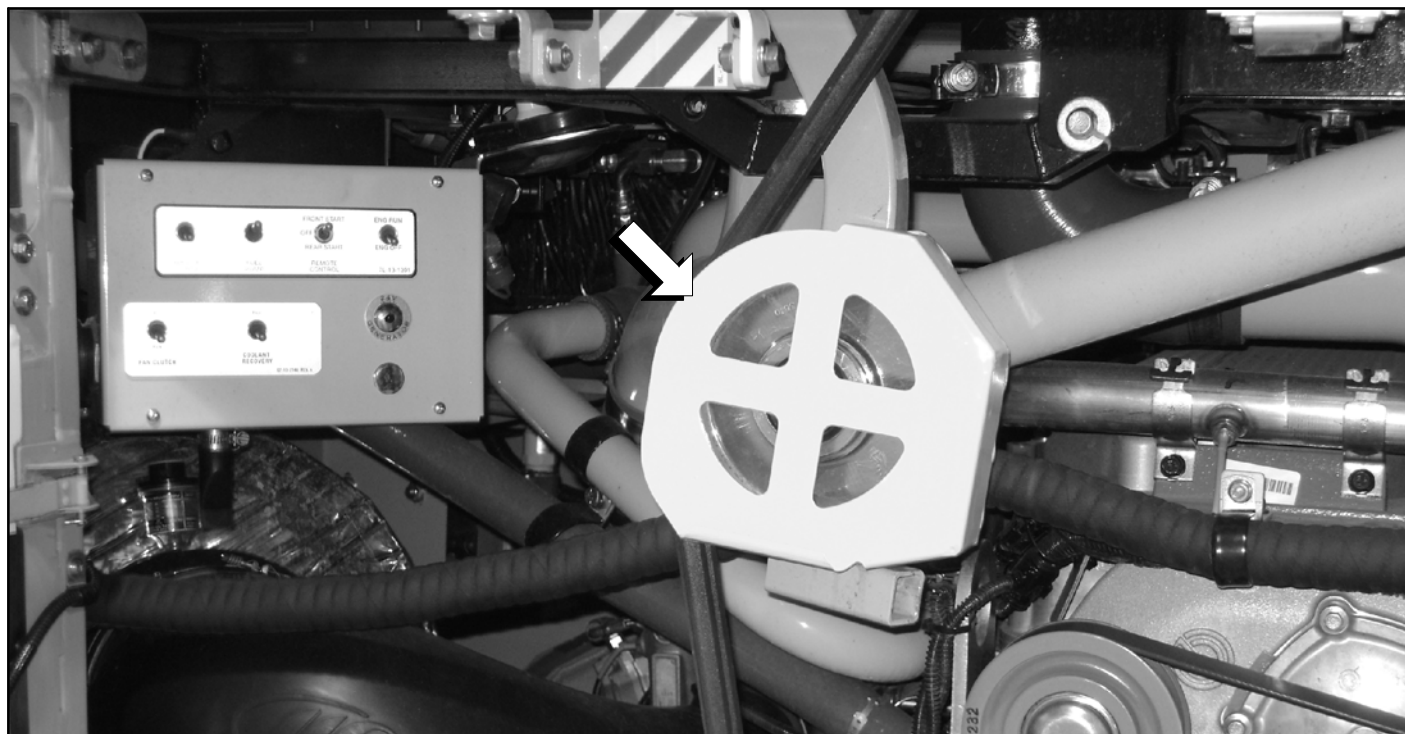
Figure 1.

3. Open the engine door. Locate the fan belt idler pulley cover (refer to Figure 1).

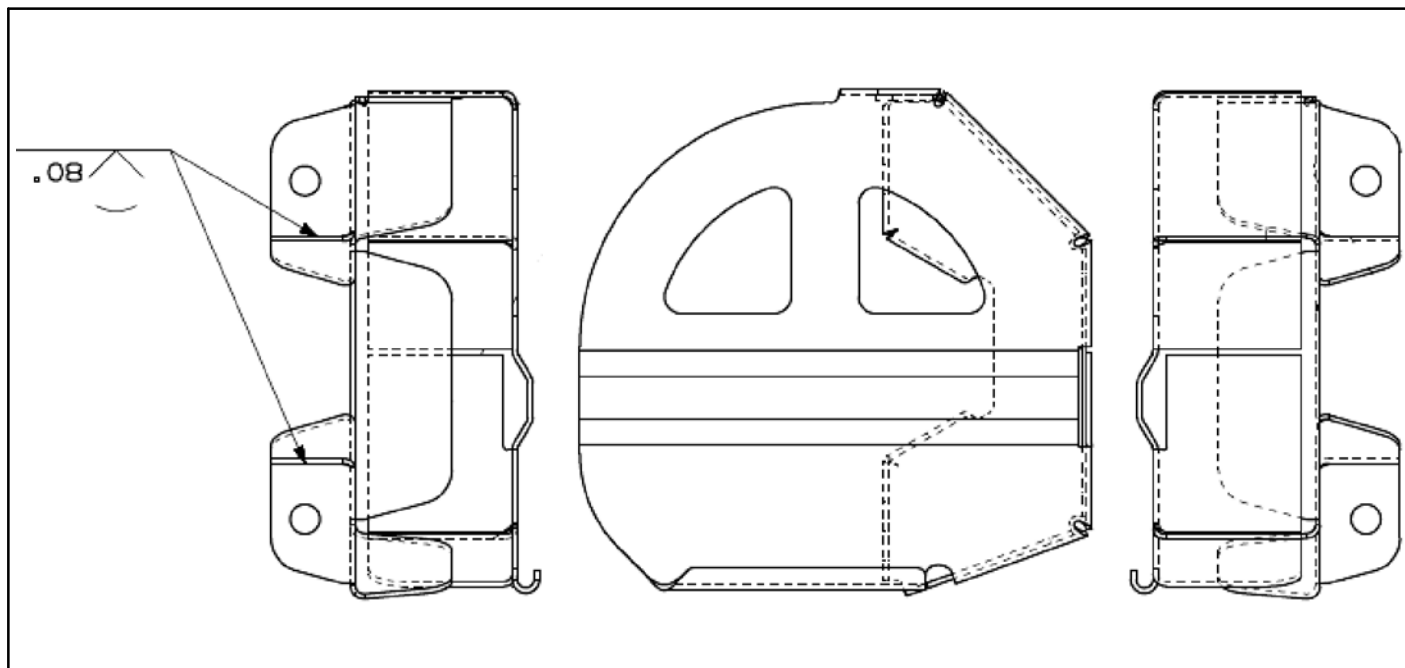
Figure 2.

MCI has determined that the fan belt idler pulley cover may lack two welds that provide stiffness and rigidity to the part. Without these welds MCI believes that the part will eventually fail as a result of fatigue near the area where the cover is assembled to the coach structure. If a failure of both attachment areas occurs, the part may become detached from the coach and potential injury to persons and/or damage to other vehicles or property could occur.

4. Visually inspect the fan belt idler pulley cover for the two (2) welds shown in Figure 2

If the two (2) welds shown in Figure 2 are on the fan belt idler pulley cover, no further action is required. Close the engine door. Fill out the attached verification form and submit to MCI's warranty department.

If the two (2) welds shown in Figure 2 are not on the fan belt idler pulley cover, proceed to Step 5.
