**Re: Defect Information Report – Supplemental Report No. 1  
11V-109, FL-589, Hendrickson Airliner Mono Leaf Suspension Springs  
Pre-Recall Notice**

**March 2011**  
**FL589**  
**Pre-Recall Notice**  
**NHTSA # 11V-109**

## **Subject: Hendrickson AirLiner Mono Leaf Suspension Springs**

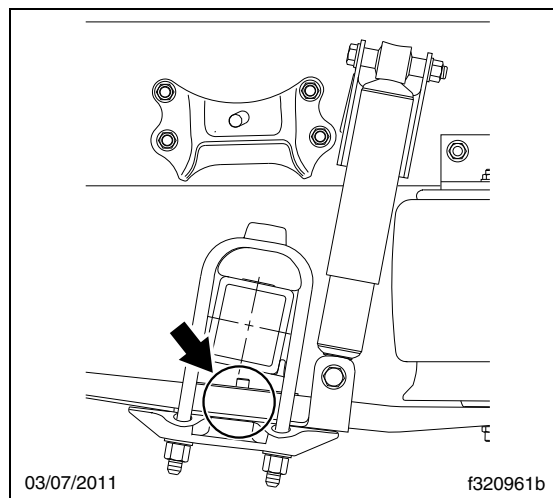
**Fig. 1, Inspection Area**

1. Park the vehicle on a level surface. Shut down the engine, set the parking brake, and chock the tires.
2. From the underside of the rear suspension, inspect the spring between the U-bolts at the clamp group. Remove any debris from the area of the spring, then using a flashlight, inspect the surface of the spring for any cracks and or separation. See **Fig. 1**.
3. If cracks are not present no further action is required. If a crack is found on any spring, contact a DTNA dealer for diagnosis and appropriate repair.

In the interim, please inspect the springs as part of your daily pre-trip inspection. See the reverse side of this notice for instructions. Should you find a crack on any of the four rear springs, contact a DTNA dealer for diagnosis and appropriate repair.
