**Certain 2004 - 2006 Model Year Highlander/Highlander HV
Floor Carpet Cover and Retention Clip
Safety Recall Notice (*Interim Notice*)**

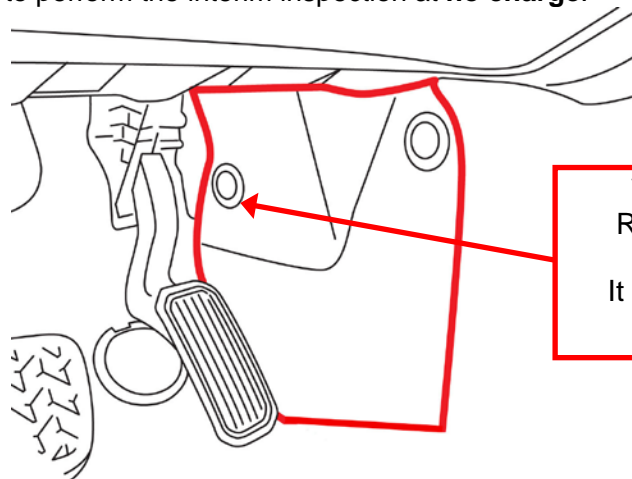
In certain 2004 through 2006 model year Highlander/Highlander HV vehicles, if the forward retention clip used to secure the driver's side Floor Carpet Cover, which is located in front of the center console, is not installed properly, the cover may lean toward the accelerator pedal and interfere with the accelerator pedal arm. If this occurs, the accelerator pedal may temporarily become stuck in a partially depressed position rather than return to the idle position. An accelerator pedal temporarily stuck in a partially depressed position may increase the risk of a crash.

Verify that the Forward Retention Clip is properly installed. It should not be missing or loose.

Once the remedy parts are available, Toyota will replace the Floor Carpet Cover with one of a different shape as well as the forward and rear retention clips. ***Toyota will send a second owner notification letter when the replacement parts are ready and preparations are complete.***
