2004 – Early 2007 Model Year RX330/350/400h Floor Carpet Cover and Retaining Clips Safety Recall Notice (*Interim Notice*)

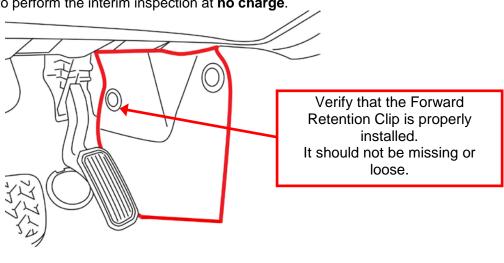
- If your vehicle exhibits the condition described above, please contact any Lexus dealer for diagnosis and appropriate repair. The inspection and if necessary repair will be performed at **no charge** to you.
- Until the remedy parts are available, you may minimize the possibility of this condition occurring by verifying that the forward Retention Clip is properly installed and the Floor Carpet Cover is not leaning. The location of the forward retention clip is depicted in the diagram. If you are not comfortable conducting the inspection, any Lexus dealer will be happy to perform the interim inspection at **no charge**.
