**SAFETY  
RECALL**

Sr11-10

DATE : MARCH 2011	SECTION : 03-FUEL
SUBJECT : REPLACEMENT OF THE FUEL TANK SUPPORT

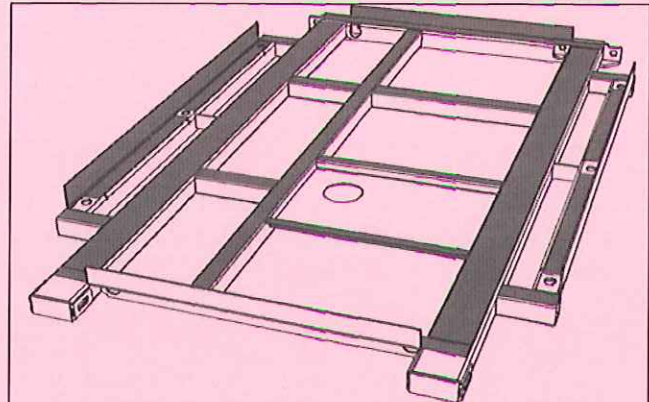
APPLICATION OF SELF-ADHESIVE NEOPRENE FOAM (dark area)

3. Apply self-adhesive neoprene foam (p/n 506758) on the new platform as shown.
4. Lift the vehicle.

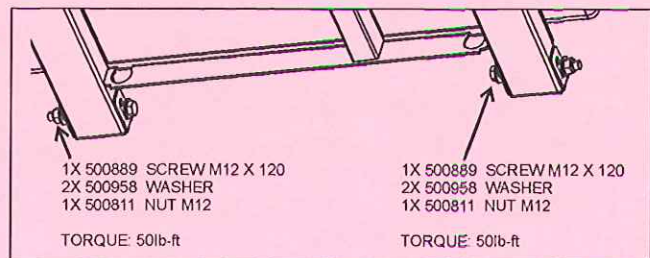
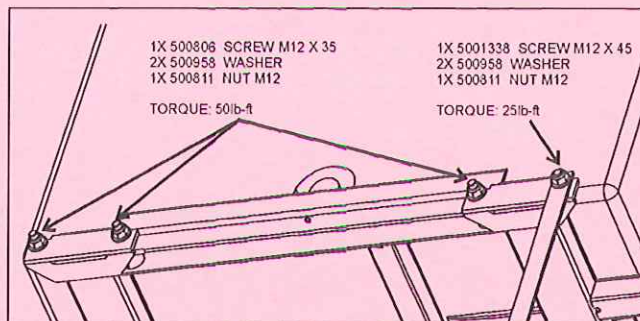
On vehicles affected by this recall, it is **absolutely necessary** to replace the fuel tank support as soon as possible. It has determined that some weakness may exist in the weld beads due to poor fusion penetration. Welding defects are not visible, thus cannot be detected by a visual inspection. No repair is allowed, so the entire support must be replaced.

7. Unscrew the bolts (6) holding the fuel tank support to the vehicle chassis.
8. Replace the existing fuel tank support with the new one. Identify the defective support so it will not be reuse.
9. Install the new support with **new** hardware (bolts, washers and nuts).
  - Tighten bolts to 50 lb-ft (5 bolts)
  - Tighten bolts to 25 lb-ft (with static wick)
