SUBJECT: SAFETY RECALL OF 2010 J MODEL COACHES WITH BRAUN WHEELCHAIR LIFTS

Ref.: **NHTSA # 11V-144**
TRANSPORT CANADA #TC 2011-091
MCI Service Bulletin 347

Service Bulletin No. 347

| SUBJECT BRAUN HYDRAULIC AND ELECTRICAL LINE INTERFERENCE | | | |

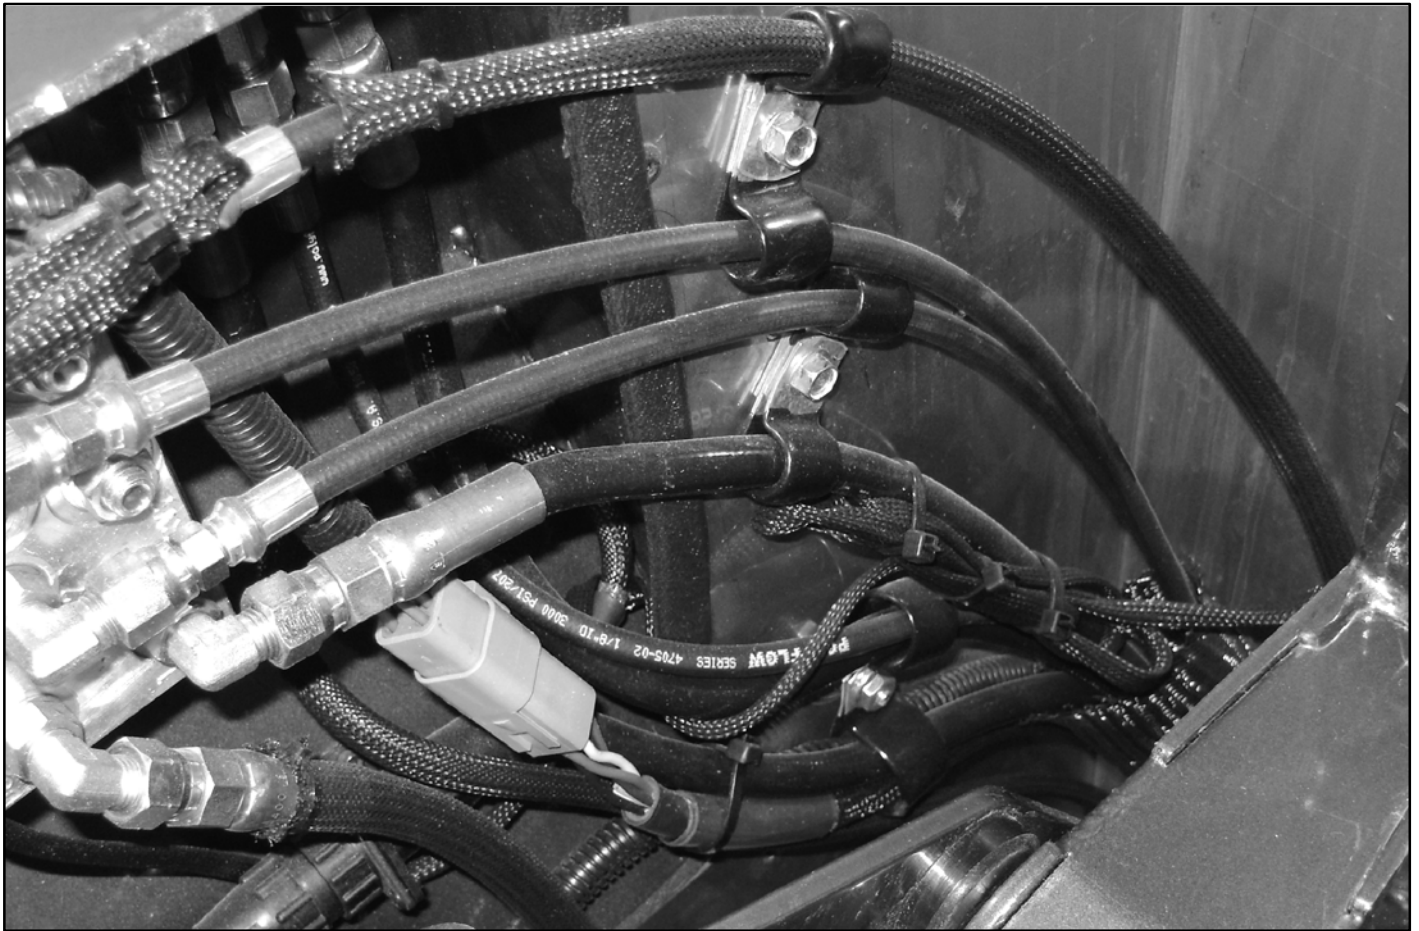
Figure 2. Reference photo of wheelchair compartment.

8. Install the clamps, p/n 19-4-32, and, p/n 19-4-48, on the hoses as shown in Figures 1 and 2. Using screws, p/n 19-4-176, and nut, p/n 19-3-2, secure the clamps to the compartment wall.

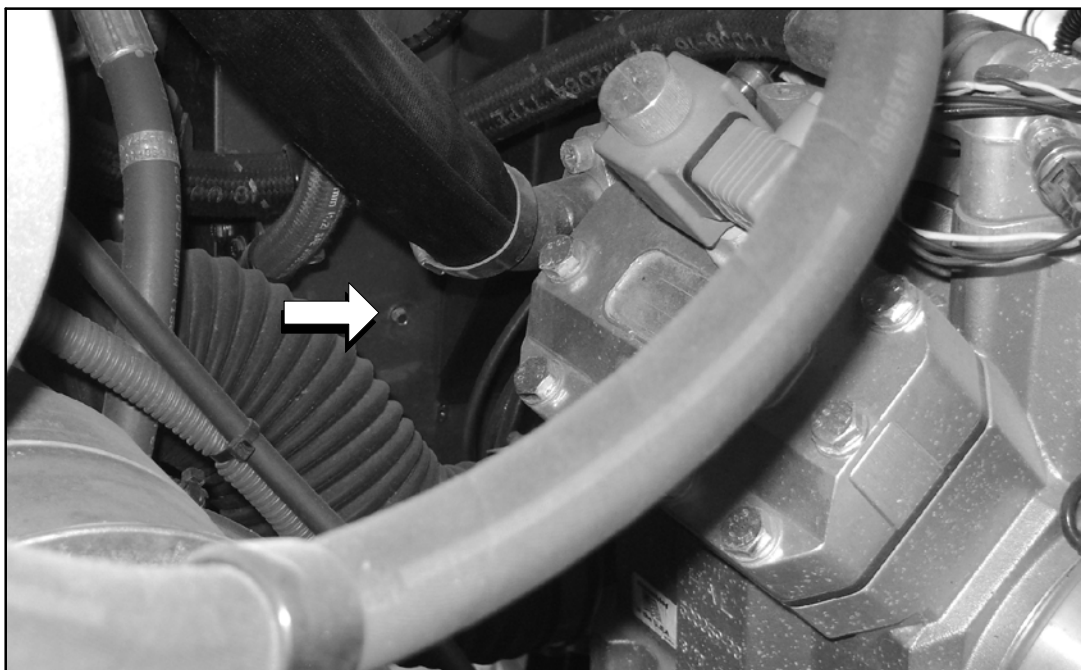
Figure 4. Reference photo of mounting hardware on rear, side service compartment side wall.

Utilize the rear, side service compartment to access the screw threads (refer to Figure 4).

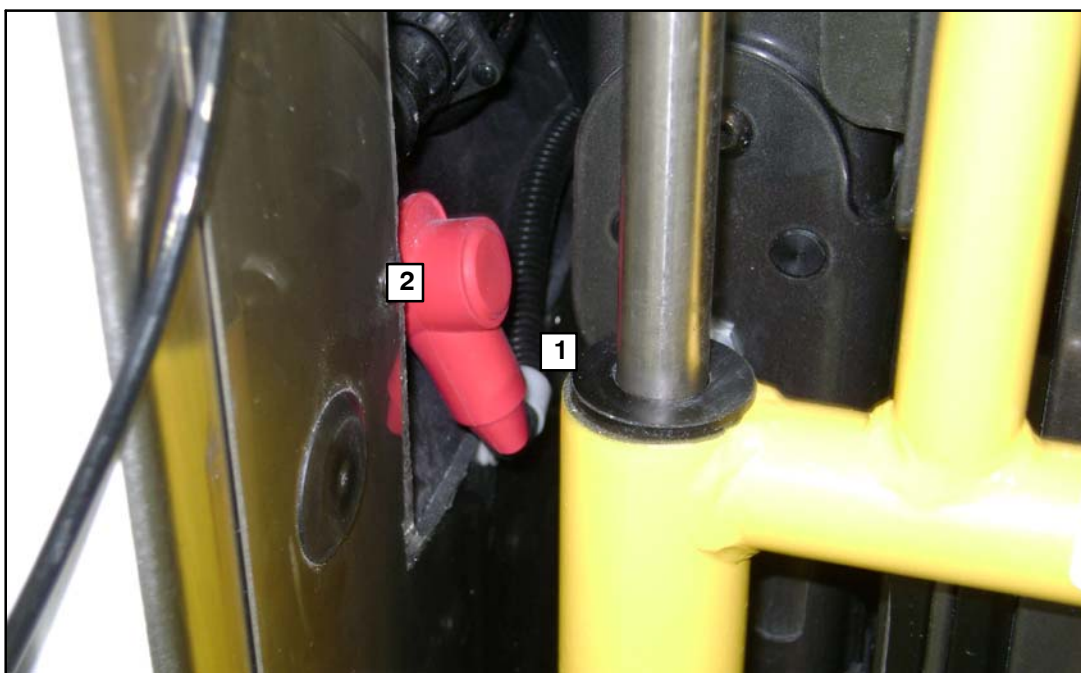
Figure 5. Reference photo of wheelchair compartment.

- 9. Using a 11/64 inch drill bit and a drill bit stop (set to the width of the compartment wall), drill a hole at the dimensions (1.51 x 3.41) shown in Figures 1 and 5. Secure the existing clamp to the compartment wall using screw, p/n 19-1-619, and washer, p/n 19-2-7.

10. In the wheelchair compartment, remove the red protective boot from the one (1) wheelchair lift electrical terminal and apply high tack sealant to the terminal (refer to Figure 5).
11. In the rear, side service compartment, remove the red protective boot from the three (3) wheelchair lift electrical terminals and apply high tack sealant to the terminals (refer to Figure 6).
12. Install the edge molding, p/n 24-51-0050, on the upper bracket edge (below the loom routing) as shown in Figure 6.

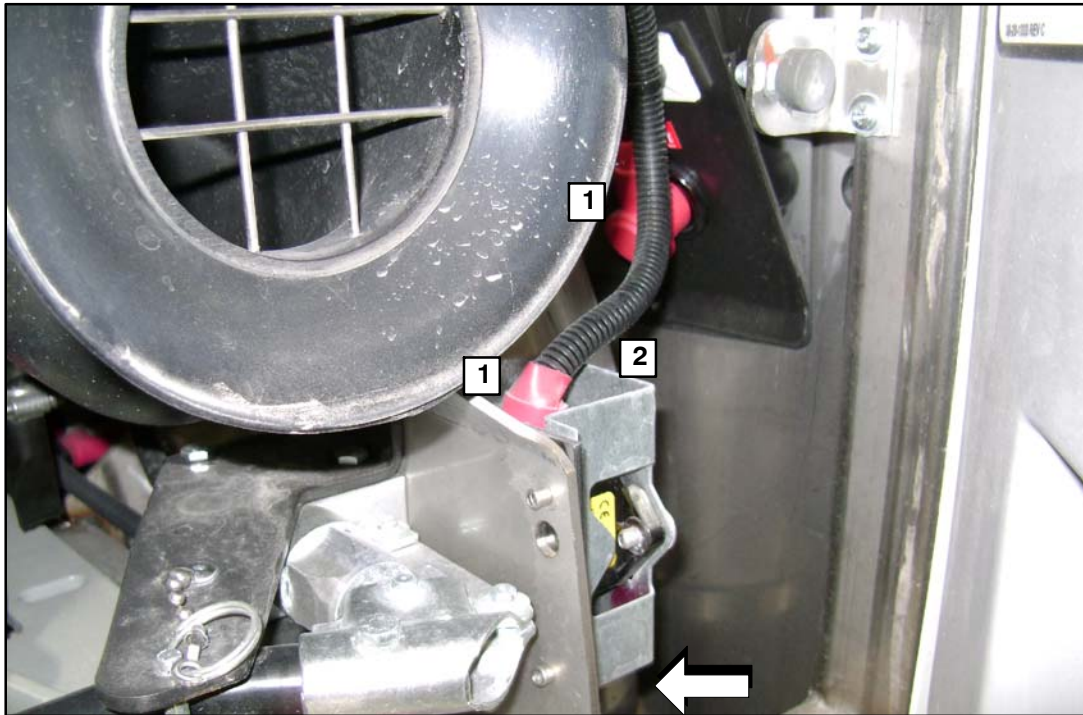
Figure 6. Reference photo of rear, side service compartment

| ITEM | FIGURE 6 DESCRIPTION |
|---|--|
| 1 | Remove the red protective boot and apply high tack sealant to the terminals |
| 2 | Install the edge molding |
