Subject: Sterling Bullet Left Tie Rod Ends

Models Affected: Specific Sterling Bullet vehicles manufactured October 15, 2007, through November 10, 2008.

Recall Campaign

April 2011
FL588A
NHTSA #11V-193
Transport Canada #11-011
REVISED NOTICE

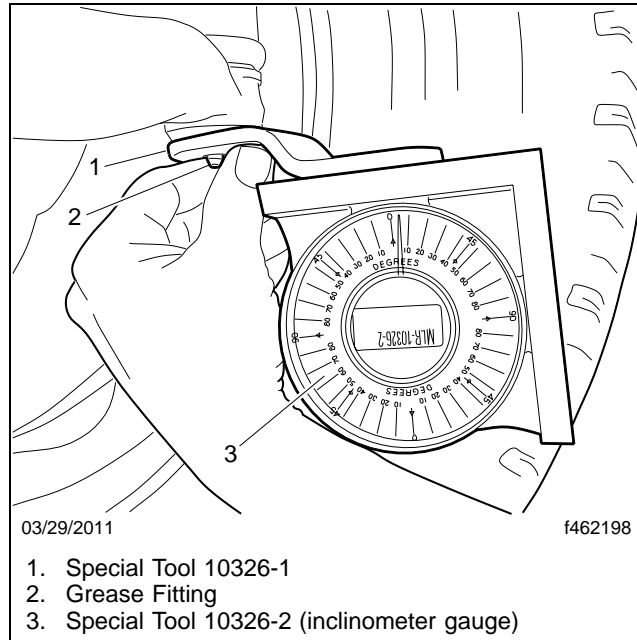
Fig. 3, Measuring Tie-Rod End Angle

Failure to set the same angles on both the left and right tie-rod ends will cause the condition this recall is addressing to still be present.

21. Set the toe and center the steering wheel following the alignment rack manufacturer's instructions.
22. Install special tools 10326-1 and 10326-2 (inclinometer gauge) on the bottom surface of the right tie-rod end. The grease fitting should be centered in the hole on special tool 10326-1. See **Fig. 3**.
23. Measure the angle of the right tie-rod end. Record the number displayed on the inclinometer gauge.
24. Install special tools 10326-1 and 10326-2 onto the bottom surface of the left tie-rod end.

25. Adjust the left tie-rod end so that the same angle appears on the inclinometer gauge as was measured on the right tie-rod end.
26. Tighten the tie rod adjuster clamp 40 lbf·ft (54 N·m).
