Customer Service Notice

Units Affected: All DC912A Chipper Units having chassis serial numbers ending with 9S200342 through AS200450 (see attached list)

Wheel Lug Nut Inspection

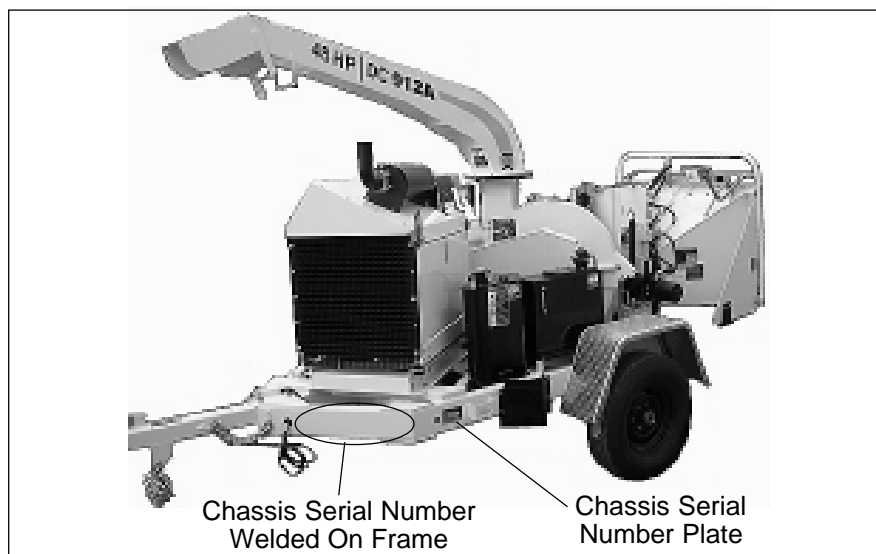
Figure 1 — Serial Number Location

Altec has received a small number of reports of lug nuts becoming loose and causing damage to the wheel or hub of the above chipper. The serial number for the units involved in this action is located on a plate on the chipper chassis and is also welded on the frame (refer to Figure 1). The serial number is the last eight digits of the chassis VIN.
