Customer Service Notice

Date: May 23, 2011

Units Affected: All AT40M/P units built from serial numbers 0607CZ0000 (June, 2007) through 1009CZ0118 (October, 2009)

Link Replacement

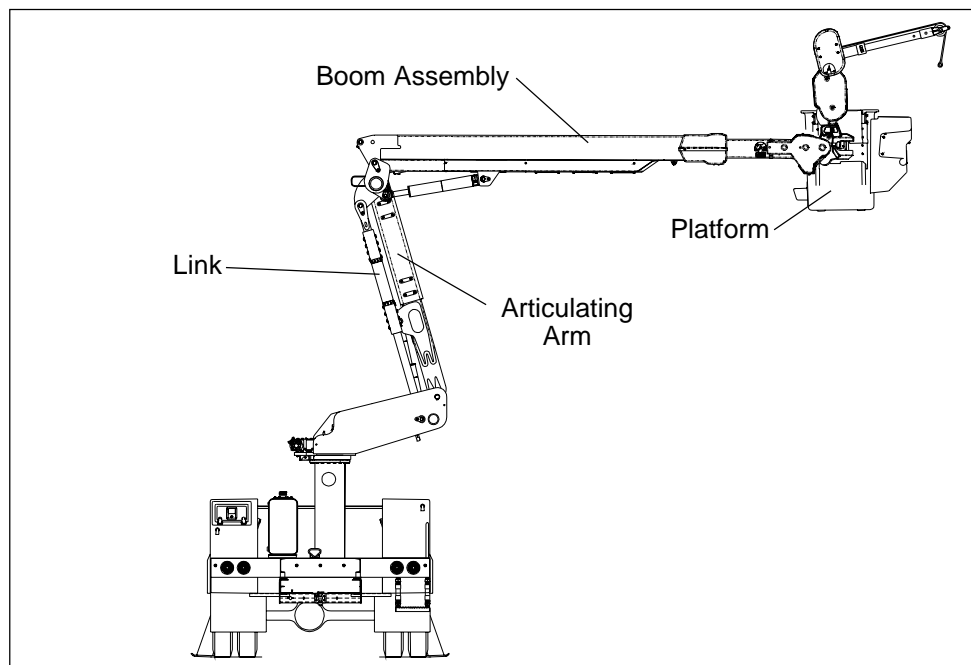
Figure 1 — Link Location

The link on the AT40M/P units is part of the articulating arm assembly (refer to Figure 1). The link is also part of the chassis insulating system on the aerial device. Altec has found rust inside the steel weldment may run over the inner surface of the insulating link and over time compromise the dielectric integrity of the link. The source of the rust within the links was found to be metal particles generated during manufacturing. This condition only effects the quality of the insulating link of the chassis insulating system. The chassis insulating system is not required by industry standards, but was provided by Altec as standard equipment on these units. The insulating properties of the main boom are not effected.

Failure to maintain the dielectric characteristics of the provided chassis insulating system can allow the chassis to become energized in the event of accidental contact between the upper boom assembly and an unguarded energized conductor. Death or serious injury will result should a person standing on the ground come in contact with or close proximity to an energized chassis.

Altec requires that the links on the above listed units be replaced to ensure continued dielectric integrity. The links must be replaced within 60 days of receipt of this CSN. If the chassis insulating system has been dielectrically tested within the last year, the unit may continue to be operated as normal while awaiting link replacement. If the unit has not had the chassis insulating system tested in the last year, such a test should be conducted or crews must treat the link sections as non-insulating. The manufacturing process has been changed and replacement link has been redesigned to address the initial condition.

Call 1-877-GO-ALTEC to order the Link Replacement Kit, part number 970299534, or to schedule the work to be done by an Altec service technician. This repair is covered under the Altec Warranty System. Installation of the Link Replacement Kit can be done by the customer. The parts for this repair are covered under the Altec Warranty System. Additionally, Altec will reimburse up to \$240 for the labor to perform this repair. A warranty claim must be submitted for reimbursement for the cost of the parts and labor. Customers are responsible for the travel costs of an Altec Mobile Service technician if the technician performs the repair at the owner's location.
