Lexus Division  
Toyota Motor Sales, U.S.A., Inc.  
19001 South Western Avenue  
P.O. Box 2991  
Torrance, CA 90509-2991

**Certain 2006 and 2007 Model Year Lexus RX 400h Vehicles  
Hybrid System Inverter, Intelligent Power Module  
SAFETY RECALL NOTICE (*Interim Notice*)**

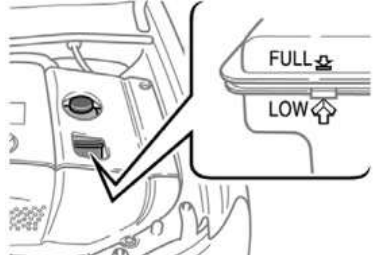
<p>Inverter Coolant Reservoir</p>	<p>(1) Regularly confirm that the coolant level in the inverter coolant reservoir is between FULL and LOW. If the coolant level is below the LOW line, please add coolant up to the FULL line. If you wish, you may contact any Lexus dealer for assistance at no charge.</p>

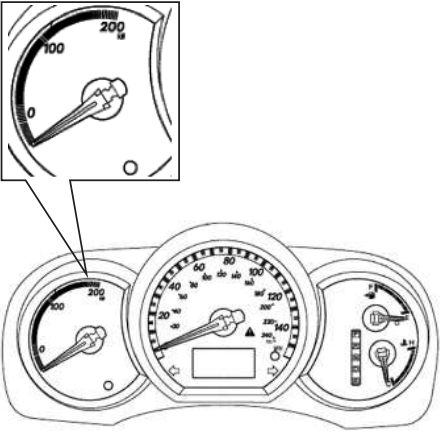
<p>Power Meter</p>	<p>(2) Avoid placing a high load on the Hybrid System. We suggest that you refrain from towing anything with the vehicle until the remedy is performed.</p> <p>(3) Monitor your Power Meter. The Power Meter indicates the immediate output from the Hybrid System in approximate kilowatts. Keep power usage below 100kW as much as possible. Situations where the Power Meter shows output slightly over 100kW for a brief moment should not raise any concerns.</p>
