## SAFETY RECALL G-11510

OCTOBER 2011

IC Bus has decided that a defect which relates to motor vehicle safety exists in certain RE model school buses built 2/4/10 thru 6/16/11 with a 2010 exhaust emissions engine feature code 510974.

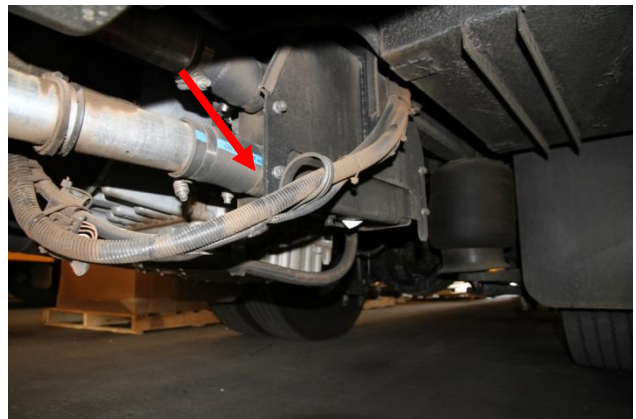
The positive battery cable may rub on the hydraulic cooler reservoir mounting bracket possibly resulting in an electrical short.

1. Inspect the battery cables where they route around the hydraulic cooler reservoir bracket.

4. Wrap the damaged insulation area with electrical tape and attach a piece of plastic conduit or rubber hose over the damaged area with electrical tape to prevent further damage.
