## SAFETY RECALL G-11511

OCTOBER 2011

IC Bus has decided that a defect which relates to motor vehicle safety exists in certain RE model commercial buses built 2/4/10 thru 6/16/11 with a 2010 exhaust emissions engine feature code 510974.

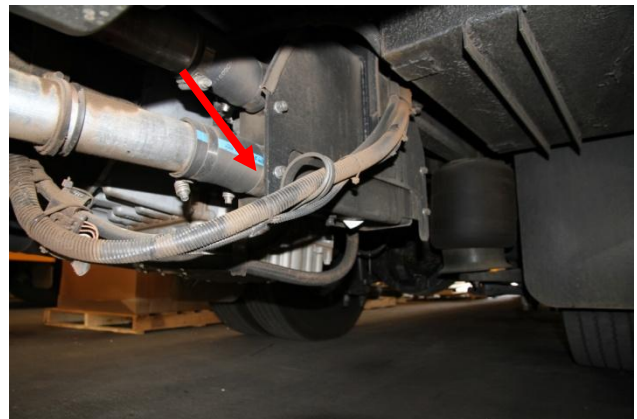
The positive battery cable may rub on the hydraulic cooler reservoir mounting bracket possibly resulting in an electrical short.

1. Inspect the battery cables where they route around the hydraulic cooler reservoir bracket.

4. Wrap the damaged insulation area with electrical tape and attach a piece of plastic conduit or rubber hose over the damaged area with electrical tape to prevent further damage.
