MOTOR COACH
INDUSTRIES

SUBJECT: SAFETY RECALL OF 2011 MCI J & E MODEL COACHES WITH DOGA WINDSHIELD WIPER MOTORS

Ref.: **NHTSA # 11V-379**
TRANSPORT CANADA #TC 2011-275
MCI Service Bulletin 362

MODEL E / J Series Coaches	TYPE Field Change Program	SECTION/GROUP 7-- Electrical	DATE Aug. 02, 2011
SUBJECT DOGA WINDSHIELD WIPER MOTOR FUSE			
CONDITIONS

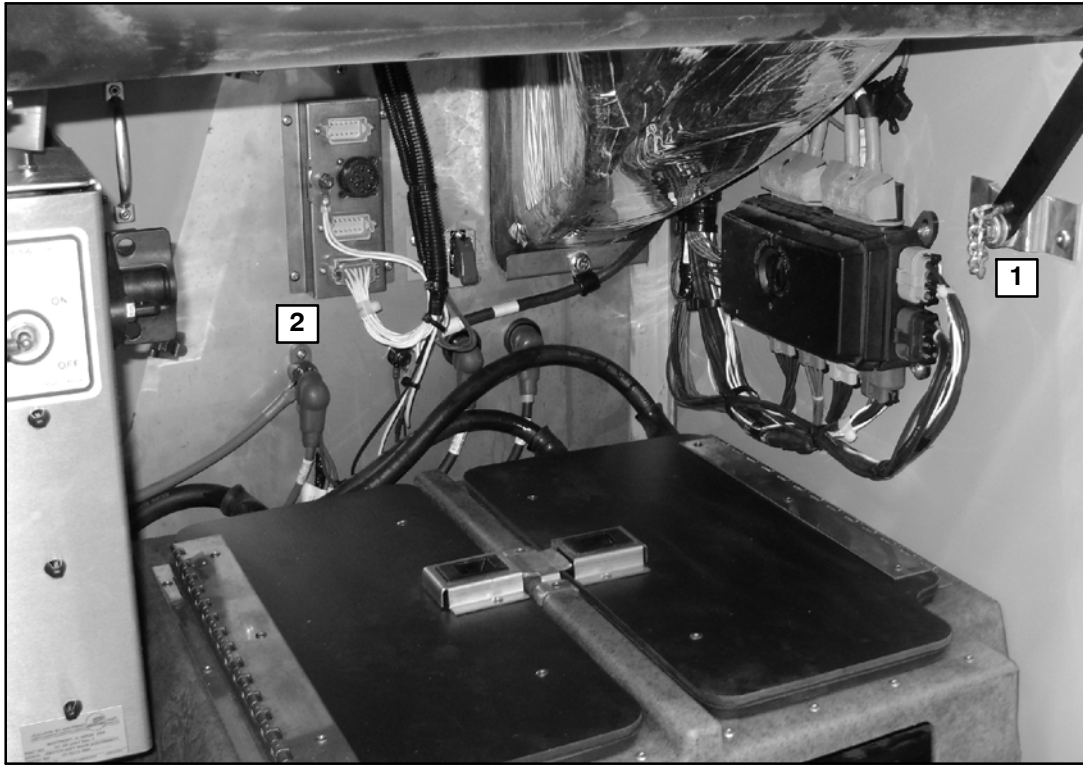
Figure 1.

1. Open the battery compartment door. Install the positive lock pin in the hole of the hinge to secure the door in the open position (refer to Figure 1).
2. Activate the disconnect feature of the main battery disconnect (MDS) system by pressing (for one second only) the momentary toggle switch on the MDS module to OFF. An audible click can be heard from the main solenoids in the MDS module. Position the rotary switch to the DOWN (OFF) position.
3. Chock both sides of the tires.

4. Locate the 24V HOT power stud block on the back compartment wall (refer to Figure 1).

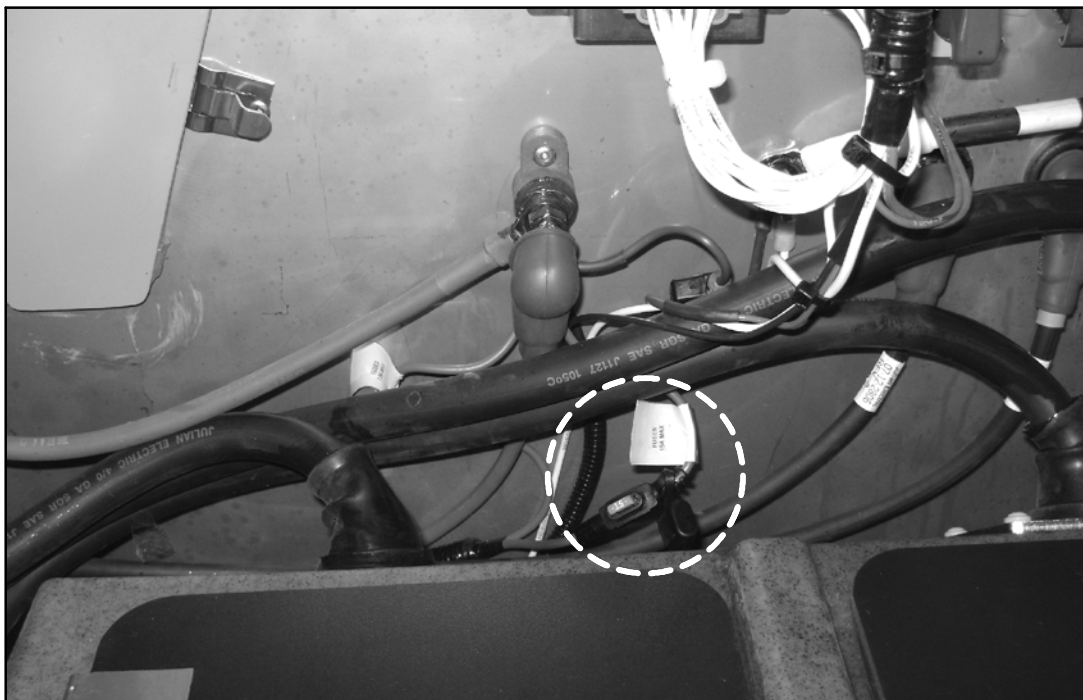
Figure 2.

5. Locate the inline fuse routed from the 24V HOT power stud block with the decal labelled either FUSE5 15A MAX, or 30A MAX. BATT HOT (refer to Figure 2).

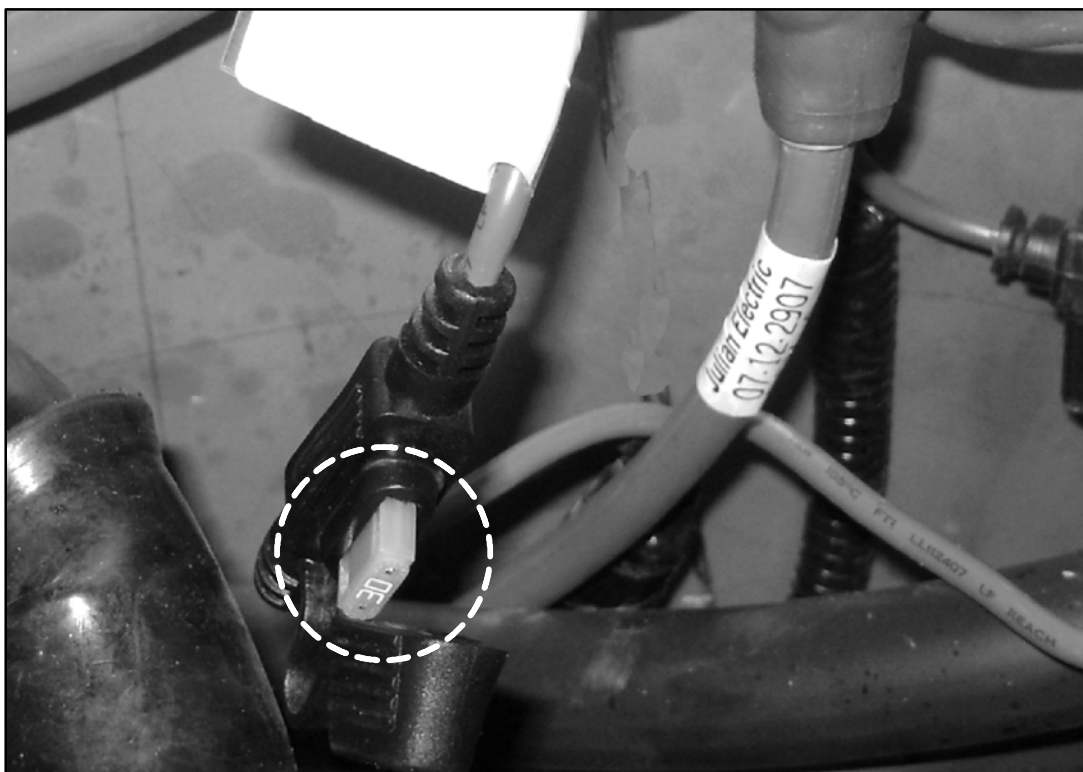
Figure 3.

The fuse in the battery compartment for the circuit powering the wiper system may be incorrect.

6. Remove the protective flip–cap. Visually inspect to verify that a 30 AMP fuse is installed (refer to Figure 3).

If a 30 AMP fuse is installed, press to secure the flip–cap over the fuse. Visually inspect to verify that the decal text is 30A MAX BATT HOT. If not, install a new 30A decal, p/n 07-08-4061. Close the battery compartment door. Procedure complete.

If a 15 AMP fuse is installed, carefully remove the 15 AMP fuse and install a 30 AMP fuse, p/n 07-08-2176. Press to secure the flip–cap over the 30 AMP fuse. Remove the existing 15A decal and install a new 30A decal, p/n 07-08-4061. Close the battery compartment door. Procedure complete.
