MAB 547

MANDATORY ACTION BULLETIN

Units Affected: DC912A Chippers (chassis s/n ending with 9S200342 through BS200265)
WC126A/166A Chippers (chassis s/n ending with AS200311 through BS200479)

Axle Spindle Inspection and Replacement

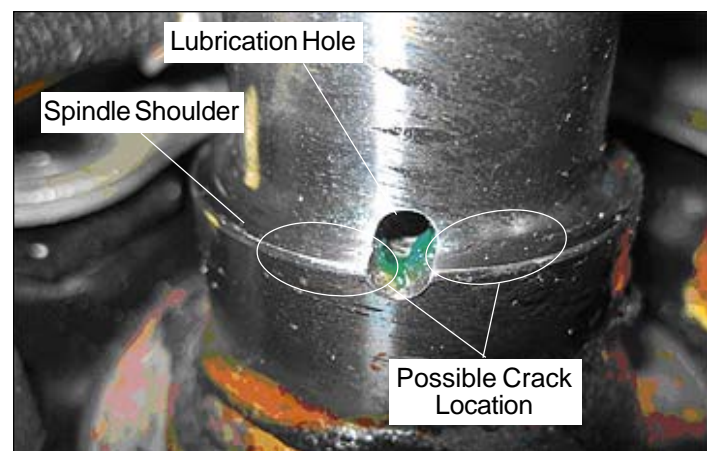
Figure 4 — Identifying Cracks

This Mandatory Action Bulletin requires immediate inspection of the chipper transport axle. Altec has received reports of spindle failures on these axles. A spindle failure can allow the transport wheel and brake hub to separate from the axle. **Death or serious injury can result from the failure of the axle spindle.**

Axles on all affected chippers must be replaced within 60 days of receipt of the MAB. Call 1-877-435-9258 to arrange for an axle replacement. Chipper owners must take the following action before the chipper is towed to the next job.

5. Securely grasp each side of the tire and rock it to loosen the wheel and brake drum from the spindle. Slide the wheel, drum, and bearings straight off the spindle. The inside grease seal and outside bearing should stay in the brake hub.
6. Wipe the remaining grease from shoulder of the spindle near the brake assembly.
7. Look for the lubrication cross drill hole on the shoulder of the spindle (refer to Figure 3).
8. Carefully look for any evidence of cracks along the base of the shoulder. Look at each side of the lubrication hole for cracks starting at the hole and radiating out along the shoulder (refer to Figure 4).
9. If any cracks are found, take the chipper out of service until the axle is replaced.
