SAFETY RECALL NOTICE

RE: New Safety Recall Notice- Arvin Meritor Recall Number 10E-057

Technical Bulletin

Procedures and Intervals to Inspect the Wheel Ends and Tighten the Spindle Nuts on Meritor TL Series Trailer Axles with Unitized Wheel Ends

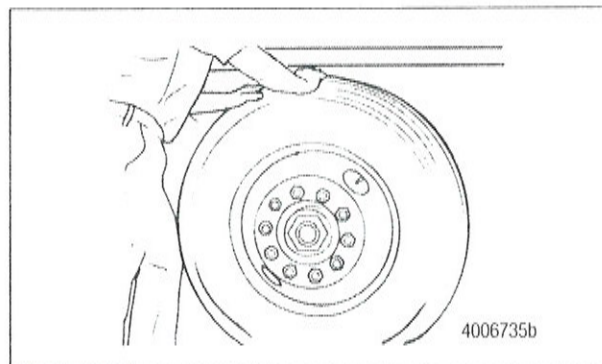
Figure 1

4. Grasp the tire and wheel-end assembly at the 12 and six o'clock positions. Check for vertical and horizontal movement. With your hands, apply approximately 50 lb (23 kg) of force to the assembly. You should not feel or see any looseness or movement. Figure 1.

- **If you feel or see movement at the tire circumference:** Proceed to the Detailed Hub Inspection procedure.
- **If no movement is detected:** Proceed to the Quick Clamp Load and Inspection procedure.

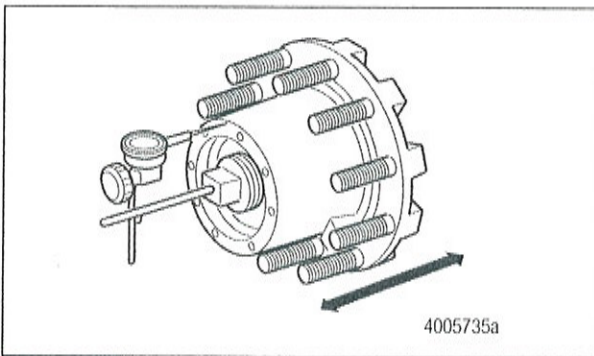
Figure 5

4. Set the dial indicator to ZERO. Do not rotate the wheel end. Place your hands at the nine and three o'clock positions.
5. Push the unitized wheel end straight IN. Note the reading. Then pull the wheel end straight OUT. Note the reading.
 - **If the total movement of the dial indicator is less than 0.003-inch (0.08 mm):** Follow instructions 2 through 11 in the Quick Clamp and Load Inspection procedure.
 - **If the total movement is 0.003-inch (0.08 mm) or greater:** Proceed to the Thread Inspection procedure.

1. Follow the wheel manufacturer's instructions to remove the tire, wheel assembly and brake drum.
2. If necessary, remove the hubcap.
 - **If this is not the first inspection:** Check the mark on the spindle nut and spindle to see if the nut has moved.
 - **If the mark has moved, then the nut was not previously tightened enough:** Clean the threads.
3. Attach the magnetic base of the dial indicator to the spindle. Touch the dial indicator stem to the hubcap mounting surface. Figure 5.

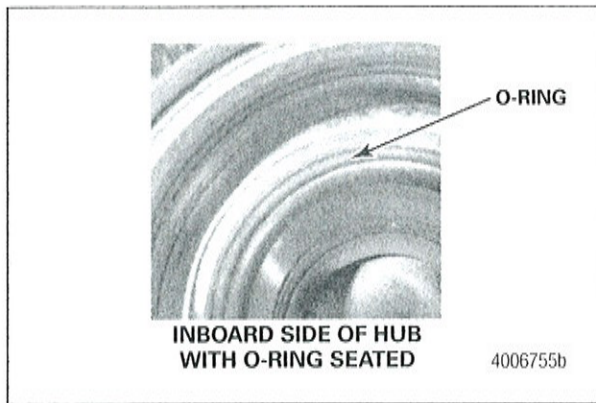
Figure 12

NOTE: Previous versions of TL hubs may or may not have an O-ring on the inboard side of the hub. All replacement hubs will include an O-ring. This O-ring must be installed with the replacement hub regardless of previous hub arrangement.

1. Ensure the O-ring (part number AM1205Q2747) between the bearing cartridge and the spindle shoulder is inserted into the groove and in place when the hub is installed. Figure 12.
