## **IMPORTANT SAFETY RECALL – 11V-542**

# Safety Notice

# 11-598-11

SUBJECT: *Weld inspection of XT55 Lower Boom*

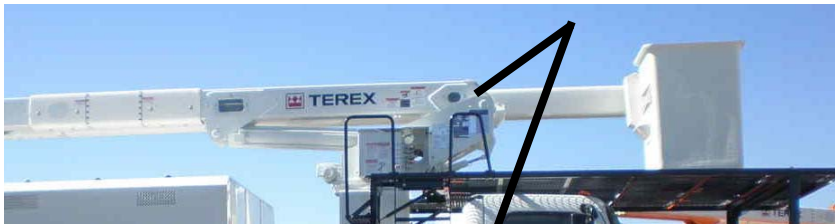
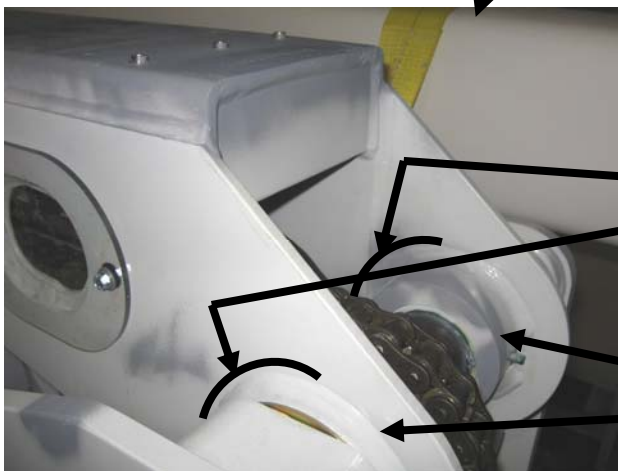
Terex Utilities has received reports of cracks in the welds that have progressed into failure of the side plate at the lower boom hinge pin on XT55 aerials. The failure originates at the joint between the boom tube and pivot boss in the side plates. **The failure of the plates will cause unexpected motion of the boom and possible falling of the platform.**

Inside on  
both sides

Outside on  
both sides

Inspect the areas all around the pivot boss on the inside and outside of boom on both side plates (4 places).

Pivot boss (2)

Immediately inspect for cracks in or near the welds of the lower boom side plates shown below before further use of the machine.

1. Raise the canvas cover over the lower boom pivot area and clean the area around the boss.
2. Perform a visual inspection for cracks in the areas shown below. Look especially around the pivot boss weld on the interior surface.

3. **After inspecting each unit, complete the inspection form attached with the owner letter. Return the completed form to Terex Utilities as instructed.**
4. **If any cracks are detected do not operate the unit, take it out of service immediately.** Contact TEREX Utilities at 605-884-3892 or email machine information to [utilities.warranty@terex.com](mailto:utilities.warranty@terex.com) to arrange repair before further use.
5. If no cracks are detected you may continue to use the unit provided that the maintenance and inspection requirements are performed as specified in the manuals. Complete the inspection form attached to the owner letter, (copy for each machine in your fleet). Return the completed form to TEREX Utilities as instructed on the form.
