SUBJECT: SAFETY RECALL OF CERTAIN 2010 & 2011 MCI D4505 MODEL COACHES WITH A PENNTEX ALTERNATOR

Ref.: **NHTSA # 11V-548**
MCI Service Bulletin 373

Service Bulletin No. 373

MODEL D Series Coaches	TYPE Field Change Program	SECTION/GROUP 7 – Electrical	DATE Nov. 29, 2011
SUBJECT PENNTEX BRUSHLESS ALTERNATOR BRACKET			
CONDITIONS

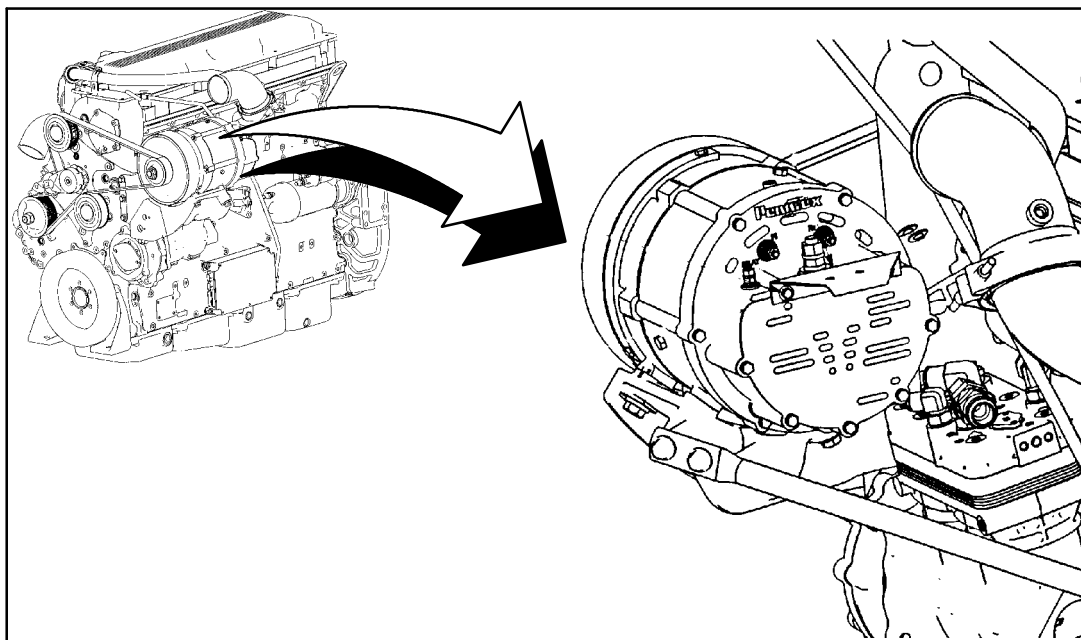
Figure 1.

4. Locate the alternator, mounted on the upper section of the engine (refer to Figure 1).

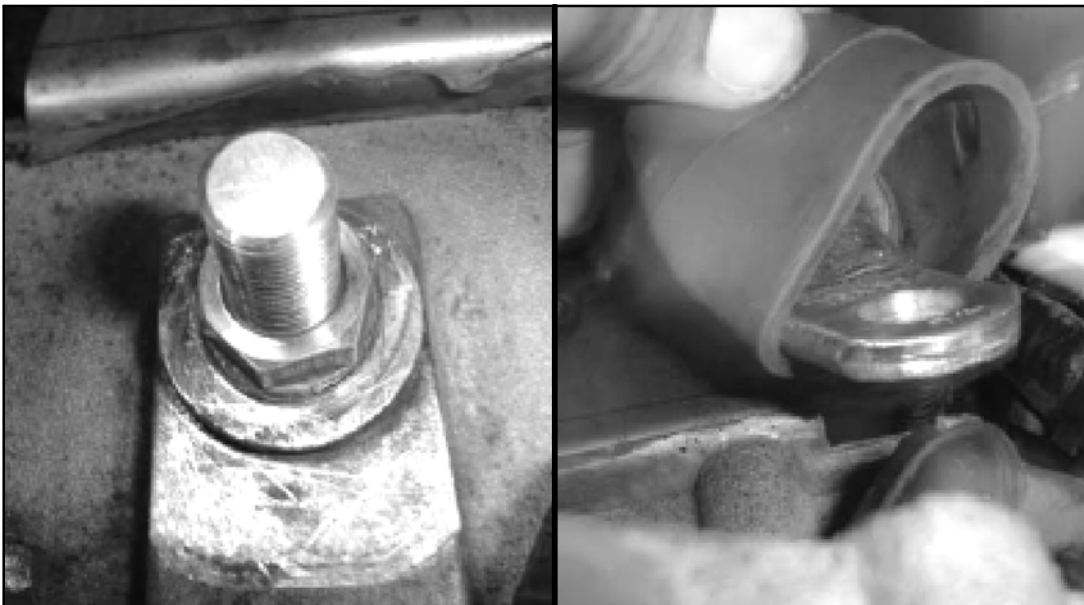
Figure 4. Reference photos of cleaned B+ stud, stud base and cable terminal.

9. Using a clean cloth, wipe away the dirt and grease from the cable terminal, the B+ stud and around the B+ stud base (refer to Figure 4).
