**Re: Defect Information Report – Supplemental Report No. 2
11V-558, FL-618, Meritor Axle Tower Bracket Welds**

Subject: Meritor Axle Tower Bracket Welds

Models Affected: Specific Western Star 4900 vehicles manufactured December 14, 2010, through January 26, 2011, with Meritor drive axles.

December 2011
FL618A
NHTSA #11V-558
Transport Canada #11-407

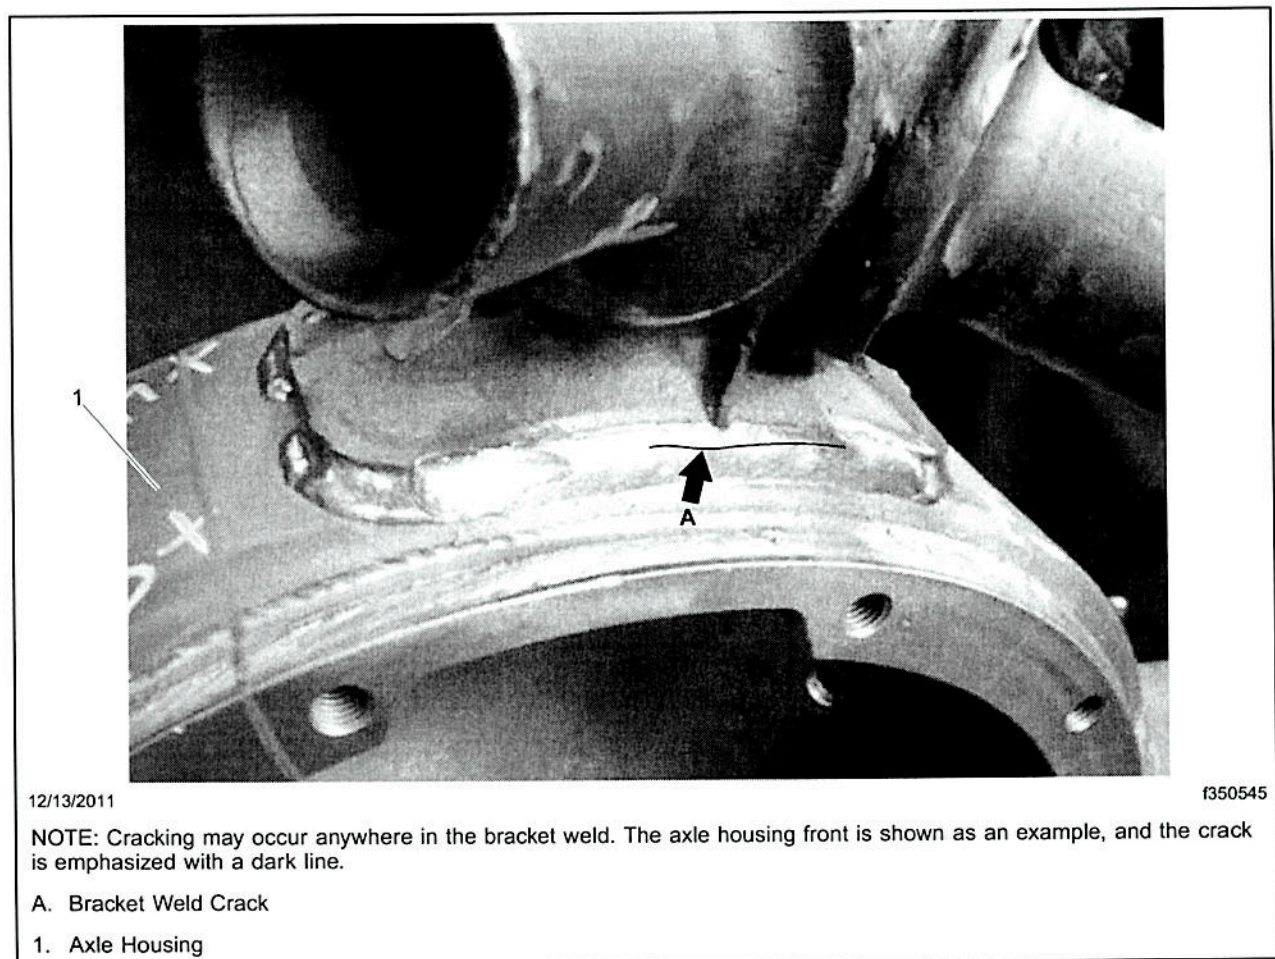
In certain drive axle assemblies, the weld that attaches a tower bracket to the housing may crack as a result of improper welding procedures. If a weld cracks, the bracket could detach, leading to a loss of vehicle control and possible vehicle crash.

3. Clean the affected region around the tower bracket, front and back. Use a cleaning solvent and wire brush to remove dirt and grease. Visually inspect for cracks around the Chalmers tower bracket weld. See Fig. 1.

4. Using a die penetrant, check the tower bracket weld for cracking. Refer to the product manufacturer's instructions for correct procedures.
5. Inspect the weld for a crack.

Fig. 1, Bracket Weld, Cracked

- If a crack is found, take a clear, detailed photo of the crack on the bracket, and email it along with the axle housing serial number, VIN, vehicle mileage, in-service date, to the OnTrac Customer Service Center at OnTrac@Meritor.com. In the email subject line, enter "DTNA Recall FL618 - Axle Welds." Then complete the "Weld Repair Procedure" in these work instructions.

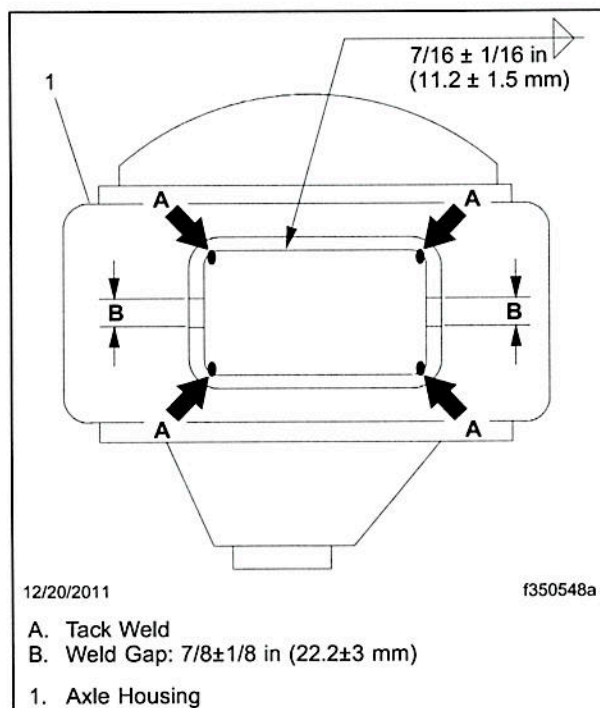
Fig. 3, New Bracket Weld, Locations and Dimensions

- Tack weld all four corners of the bracket to the housing as shown in **Fig. 3**.
- Repair weld the affected region following the dimensions in **Fig. 3**. It is important to smoothly tie in the weld with the ends. Make sure the weld covers the upper edge of tower bracket. See **Fig. 4**.

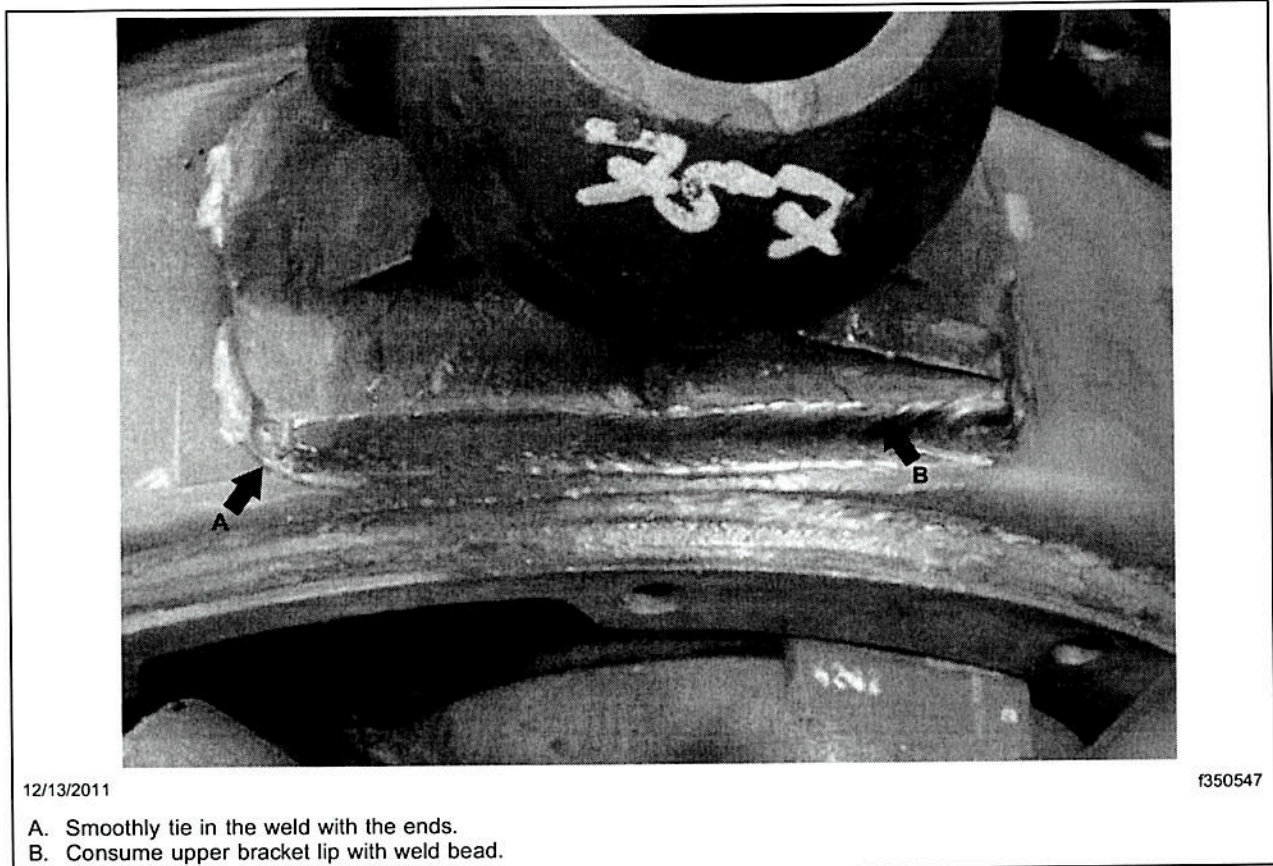
Fig. 4, New Bracket Weld, Completed
