**SAFETY RECALL – ARVINMERITOR TL SERIES TRAILER AXLES**

NOTICE: Revised Defect Information Notice – concerning Spindle Nuts and Stake Washer on certain ArvinMeritor TL Series trailer axles.

## Procedures and Intervals to Inspect the Wheel Ends and Tighten the Spindle Nuts on Meritor TL Series Trailer Axles with Unitized Wheel Ends

TP-0860  
Revised 02-11  
(16579)

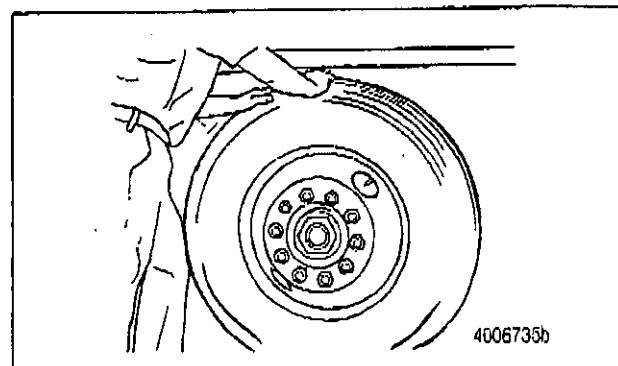
Figure 1

4. Grasp the tire and wheel-end assembly at the 12 and six o'clock positions. Check for vertical and horizontal movement. With your hands, apply approximately 50 lb (23 kg) of force to the assembly. You should not feel or see any looseness or movement. Figure 1.

- If you feel or see movement at the tire circumference: Proceed to the Detailed Hub Inspection procedure.
- If no movement is detected: Proceed to the Quick Clamp Load and Inspection procedure.

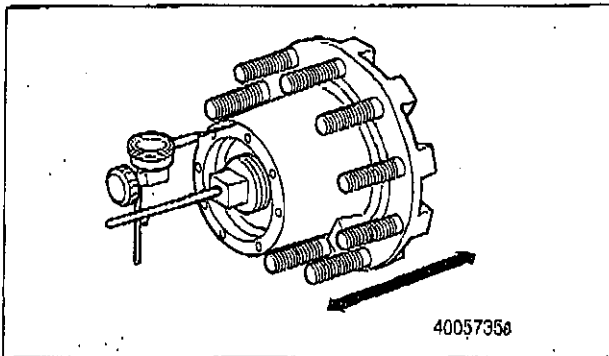
Figure 5

4. Set the dial indicator to ZERO. Do not rotate the wheel end. Place your hands at the nine and three o'clock positions.
5. Push the unitized wheel end straight IN. Note the reading. Then pull the wheel end straight OUT. Note the reading.
  - If the total movement of the dial indicator is less than 0.003-inch (0.08 mm): Follow instructions 2 through 11 in the Quick Clamp and Load Inspection procedure.
  - If the total movement is 0.003-inch (0.08 mm) or greater: Proceed to the Thread Inspection procedure.
