NOTICE: Defect Information Notice – concerning Spindle Nuts and Stake Washer on certain ArvinMeritor TL Series trailer axles.

ArvinMeritor File: C11AB

NHTSA File: 10E-058

Procedures and Intervals to Inspect the Wheel Ends and Tighten the Spindle Nuts on Meritor TL Series Trailer Axles with Unitized Wheel Ends

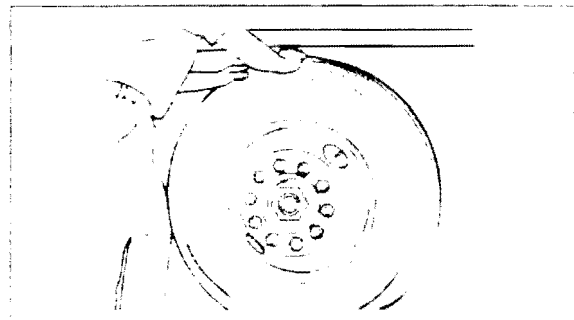
Figure 1

4. Grasp the tire and wheel end assembly at the 12 and six o'clock positions. Check for vertical and horizontal movement. With your hands, apply approximately 50 lb (23 kg) of force to the assembly. You should not feel or see any looseness or movement. Figure 1.

- **If you feel or see more than 0.04-inch (1 mm) of movement at the tire circumference:** Proceed to the Quick Clamp Load procedure, which avoids removing the wheel drum assembly, or the Detailed Hub Inspection procedure.
- **If no movement is detected:** Proceed to the Quick Clamp Load and Inspection procedure.

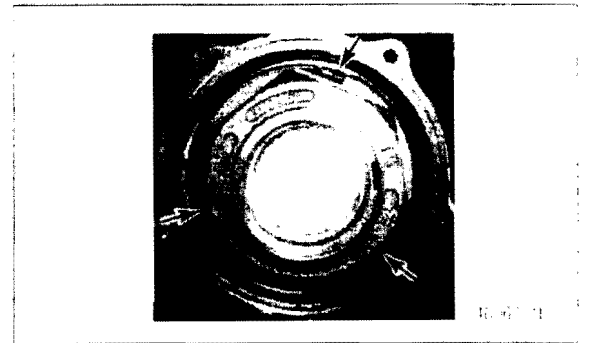
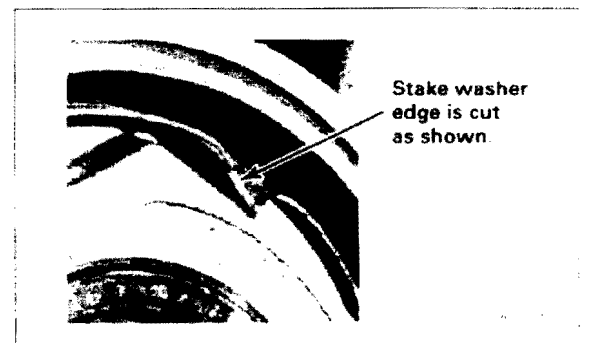
- **If unusual resistance or noise is detected:** Perform the Detailed Hub Inspection procedure contained in this bulletin.
5. Grasp the tire and wheel end assembly at the 12 and six o'clock positions. Check for vertical and horizontal movement. With your hands, apply approximately 50 lb (23 kg) of force to the assembly. You should not feel or see any looseness or movement. Figure 3.

NOTE: You must stake the stake washer to the spindle nut in **three** positions.

6. Use a hammer and staking tool (part number AM21225831) to stake the stake washer to the spindle nut in **three** positions. Bend the washer to the stake profile as shown. Figure 3 and Figure 4.

- **If the first stake does not align with the slot on the flange nut:** Stake a previously unused section of the retaining washer outer flange into **two** or **three** slots on the flange nut face. **NOTE:** Stake three slots if possible.

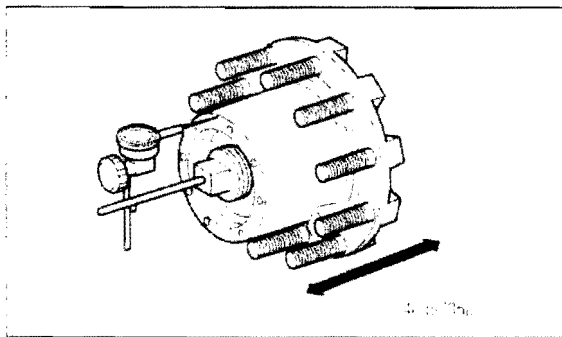
Figure 6

4. Set the dial indicator to ZERO. Do not rotate the wheel end. Place your hands at the nine and three o'clock positions.
5. Push the unitized wheel end straight IN. Note the reading. Then pull the wheel end straight OUT. Note the reading. If the total movement of the dial indicator is less than 0.003 inch (0.08 mm), perform the following steps.

2. If necessary, remove the hubcap.
 - **If this is not the first inspection:** Check the mark on the spindle nut and spindle to see if the nut has moved.
 - **If the mark has moved, then the nut was not previously tightened enough:** Clean the threads.
3. Attach the magnetic base of the dial indicator to the spindle. Touch the dial indicator stem to the hubcap mounting surface. Figure 6.

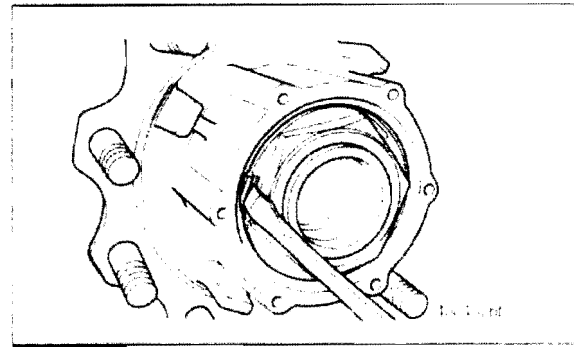
Figure 7

Perform the following procedure for each wheel end on the trailer with end play at the hub greater than 0.003-inch (0.08 mm) or wheel movement greater than 0.04-inch (1 mm).

1. Use a screwdriver to release the stakes from the stake washer flange. Figure 7.

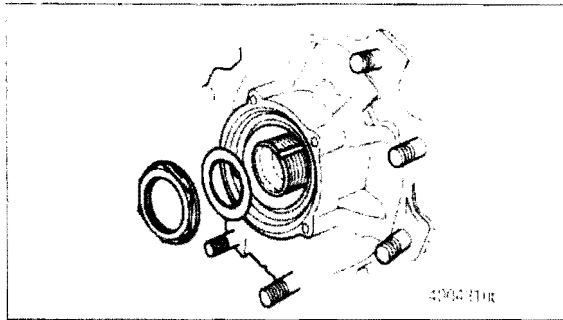
Figure 8

2. Remove the spindle nut from the spindle end. Figure 8. Check to ensure the spindle nut is free of resistance and the threads are not damaged. Fully thread the nut by hand down the entire length of the thread without the stake washer in place. Then remove the nut.
 - **If the threads are damaged:** Replace the spindle nut, part number AM21225405.

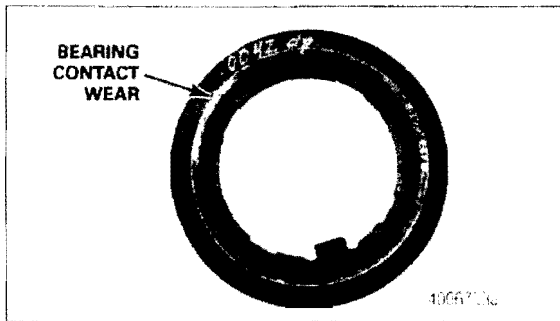
3. Inspect the inboard face of the stake washer for wear or an indent from the bearing contact face. Figure 9
 - **If wear exists:** Discard the washer unless the hub is being returned.
 - **If the hub is being returned:** Also return the washer and spindle nut.

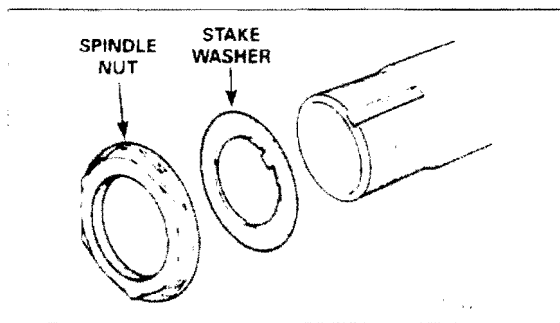
4. Check the spindle threads. Figure 10
 - **If the threads are not free running, and a limit of two threads are damaged:** Repair the threads with a thread file (Snap-On® tool, part number TTFM932, or equivalent).
 - **If there are more than two threads damaged:** Replace the axle beam. Refer to Maintenance Manual 14 for the procedures.

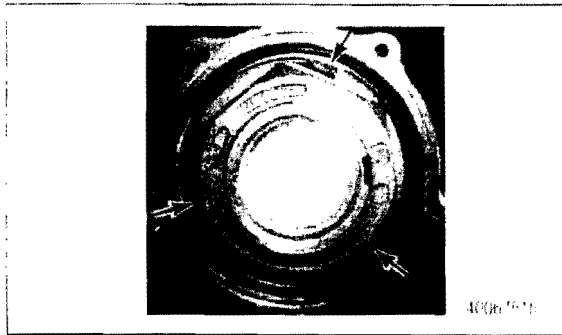
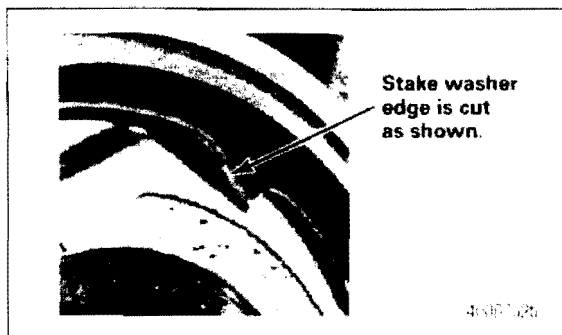
NOTE: You must stake the stake washer to the spindle in **three** positions.

10. Use a hammer to stake the stake washer (part number AM21225b14) to the spindle in **three** positions. Figure 12 and Figure 13.

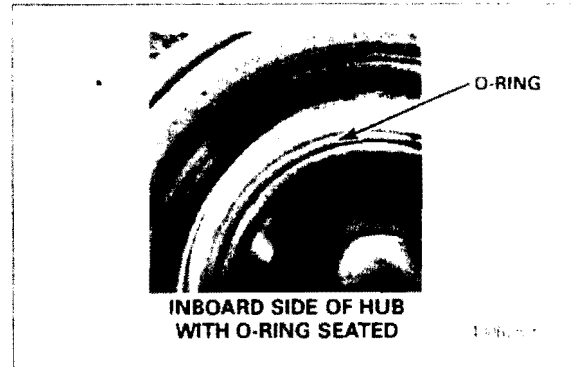
Figure 14

NOTE: Previous versions of TL hubs may or may not have an O-ring on the inboard side of the hub. All replacement hubs will include an O-ring. This O-ring must be installed with the replacement hub regardless of previous hub arrangement.

- 1 Ensure the O-ring (part number AM1205Q2747) between the bearing cartridge and the spindle shoulder is inserted into the groove and in place when the hub is installed. (Figure 14)
