SUBJECT: GUNITE AUTOMATIC SLACK ADJUSTER – NHTSA RECALL NOTICE NO. 11E-008

NO: GUN2.0014

Gunite® Automatic Slack Adjuster Inspection Instructions

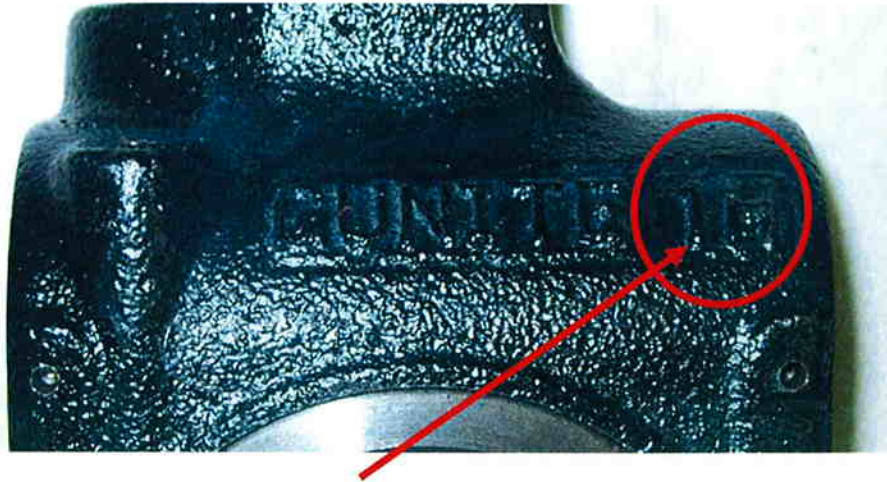
Figure A: Mold Line Nomenclature

1. Remove the automatic slack adjuster from the box and plastic shipping bag.
2. Inspect the automatic slack adjuster in two locations to determine the lot number.
 - a. On the side of the slack adjuster housing you will see the name Gunite and either an "H" or "1H". See Figure A. This is the mold line nomenclature.
 - b. On the bottom of the slack adjuster you will see the lot number information. See Figure B.
 - c. If the combination of slack adjuster mold line and lot number exactly match any of the combinations in the table below, see Figure C, the slack adjuster must be returned to Gunite. Please contact Customer Service at 1-800-677-3786 to obtain a Return Goods Authorization (RGA) document.

Side of Slack Adjuster Housing

All slack adjusters having the combined lot number and mold line number identified in the table in Figure C must be returned to Gunite. Please contact Customer Service at 1-800-677-3786 to obtain a Return Goods Authorization (RGA) document.

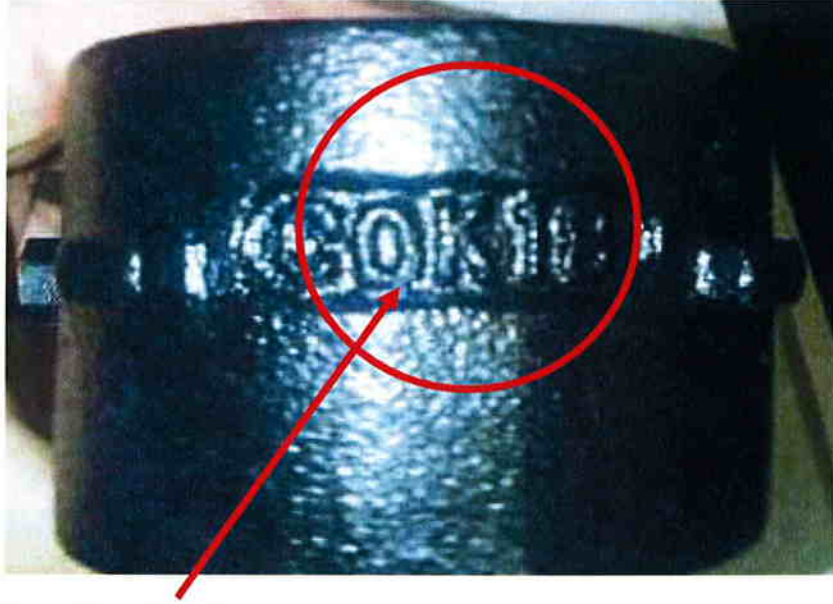
Figure B: Lot Number

Bottom of Slack Adjuster Housing
