# Safety Recall

**Code: 20Q8**

**Subject: 2011 – 2012 model year Audi R8 Spyder  
Fuel Supply Line**

August 23, 2011

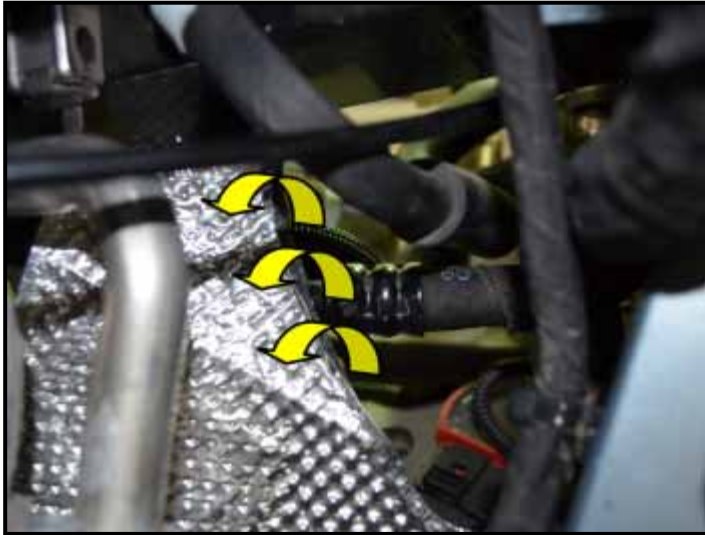
- ⇐ Using your hands, carefully roll the heat shield back approximately 120° as shown <arrows> in any areas that may come in contact with the fuel line

Note: Ensure that no sharp edges are formed along the rolled area of the heat shield

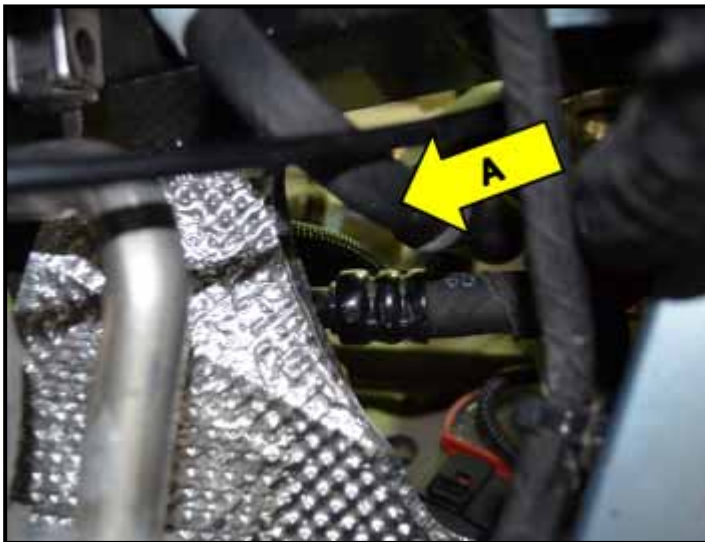
- ⇐ Inspect the fuel line <arrow A> for damage previously caused by rubbing against heat shield

- If fuel line **does not show any signs of wear or chafing**, continue to **Section B** to inspect fuel line clearance
- If fuel line **does show any signs of wear or chafing**, create an ATA ticket and contact Audi Technical Helpline to receive part. Once part is received, proceed to **Section C** to replace the fuel line

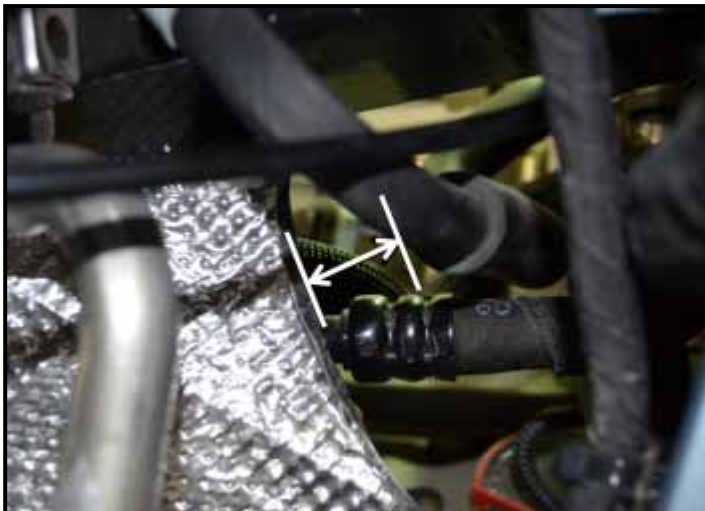
- ⇐ Inspect clearance between fuel line and modified heat shield <arrows>

Note: Clearance between fuel line and modified heat shield <arrows> should be approximately 20mm at minimum

- If **CLEARANCE IS ADEQUATE**, continue to **Section E**
- If **CLEARANCE IS NOT ADEQUATE**, continue to **Section C**
