Subject: **Part 573 Defect and Noncompliance Report: Gunite Automatic Slack Adjuster manufactured on October 15, 2010 through January 31, 2011**

PART 573 Defect and Noncompliance Report

Generic name of the item: Automatic Slack Adjuster

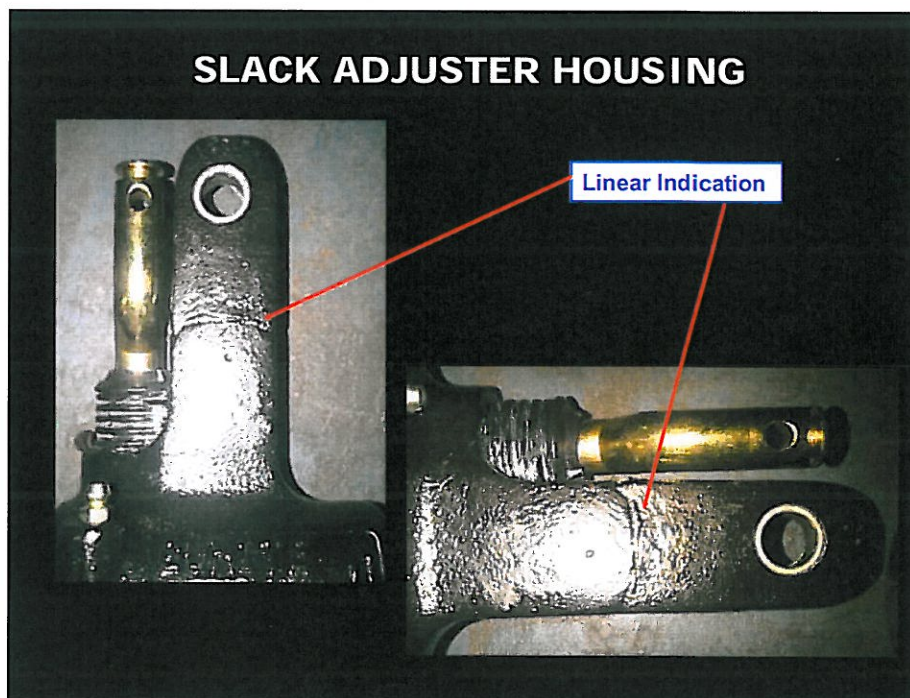
The nonconformance occurred in the “handle” portion of the slack adjuster housing during the casting operation. The dimensional characteristics of the area in question were not affected and contain adequate structural integrity, however, in certain cases the casting process resulted in a flow notch in the “handle” portion that reduced the effective cross section structural (“knitted”) area. This condition occurred at a high load or stressed area of the housing. See following pictures.

The nonconformance is caused due to incomplete “knitting” of the iron at the time of casting, which is commonly referred to as a “misrun” by the foundry industry. While the dimensional characteristics of the area in question are within specification, in certain cases the casting process resulted in a “flow notch” in the “handle” portion. Causes of the nonconformance could be an interruption in the pour of the mold, low iron temperature, slow pouring practice or temporary blockage in the gating system.

In some instances, the nonconformance can cause inadequate structural integrity of the slack adjuster housing, which could cause the housing to break at the handle under normal operating loads. To date, all such failures of which Gunitite is aware have occurred upon initial application of brake pressure in the vehicle assembly plant after installation during final validation testing of the vehicle at the Original Equipment Manufacturer's facilities. There have been no field failures attributable to a broken slack adjuster housing reported. If the slack adjuster housing were to break, the wheel brake to which the slack adjuster is attached would no longer function, causing the vehicle to have reduced braking capacity and if mounted on the steer axle a possible pull to one side and the vehicle could be involved in an accident resulting in property damage, personal injury or death.

The remedy is to request customers to inspect Gunite slack adjusters manufactured between October 15, 2010 and January 30, 2011, and return slack adjusters with housings containing any one of the combinations of lot numbers and mold line identifications noted above, unless such slack adjuster has a green painted dot on the housing, which indicates that the housing has already been inspected by Gunite and does not contain the potential nonconformance. Gunite will provide a free replacement of the slack adjusters with the matching housing codes that are returned to Gunite.

Gunite has ceased purchase of slack adjuster housings from the non-approved source. Gunite has received assurance from the approved supplier that (a) all slack adjuster castings will be produced in its approved foundry using the revised and approved process, (b) all slack adjuster housings will be manufactured using iron at the proper casting temperature between 1390° and 1430°C, (c) the pouring time will be continuous and within the phase time and (d) it will no longer outsource slack adjuster housing production to third parties without Gunite's prior written consent and approval. Further, Gunite has implemented 100% ultrasonic inspection of slack adjuster housings to confirm proper casting beginning February 1, 2011.
