Safety Recall

Code: 26G9

Subject: **2011-2012 Jetta Sedan (6th Generation)**
Accessory Exhaust Tips

November 29, 2011

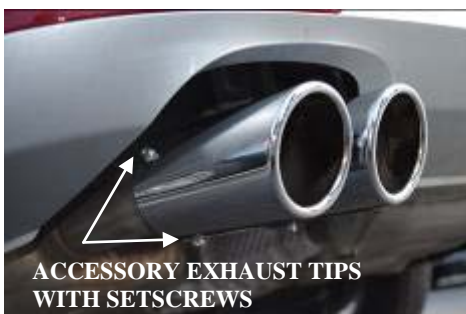
If your vehicle has accessory exhaust tips attached to the exhaust pipes with setscrews (as shown in this picture), please contact your authorized Volkswagen dealer to schedule a recall repair appointment without delay.

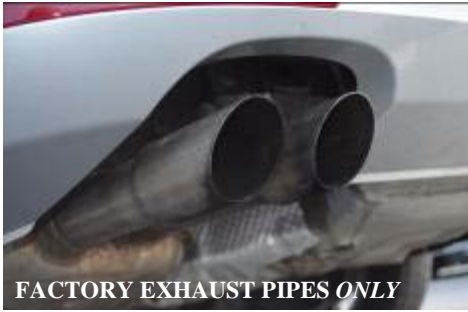
If your vehicle has *only* factory exhaust pipes (as shown in this picture), no recall repair is needed.

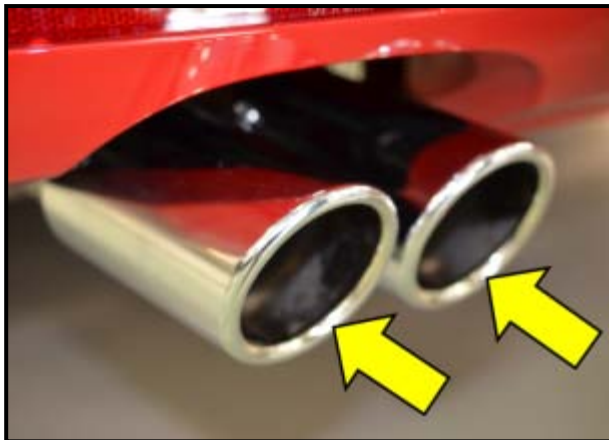
- ← Inspect for presence of VW accessory exhaust tips <arrows>
- If VW accessory exhaust tips <arrows> are present, **continue to Section C to remove exhaust tips**
- If VW accessory exhaust tips <arrows> are NOT present, **continue to Section E to install campaign label**
