Applies To: **See VEHICLES AFFECTED**

January 15, 2011

Safety Recall: Loose Wire Terminal May Cause Engine Stalling or No Start

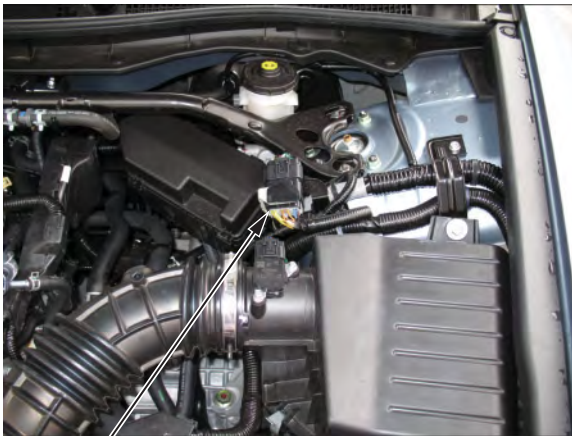
ACCORD

1. Do the battery terminal disconnection procedure.
2. *CR-V only*: Remove the air cleaner.
3. Locate the C101 junction connector; it's under the hood, near the left damper tower.
