Recall Bulletin

PRODUCT SAFETY RECALL

SUBJECT: Rear Axle Cross Pin Fracture

MODELS: 2011 Cadillac Escalade, Escalade ESV, Escalade EXT
2011 Chevrolet Avalanche, Colorado, Silverado, Suburban, Tahoe
2011 GMC Canyon, Sierra, Yukon, Yukon XL

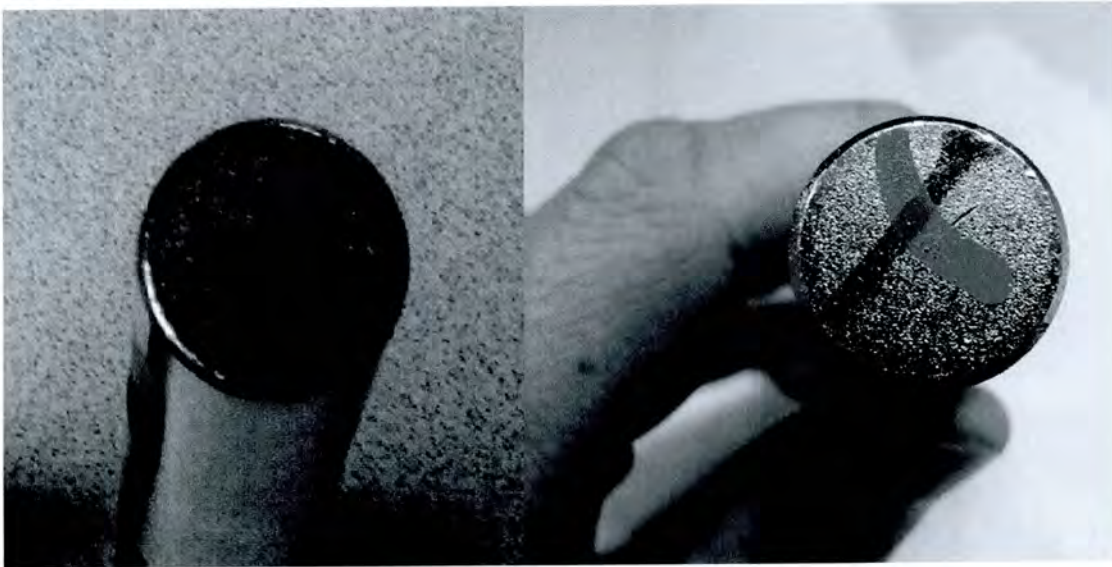
8. While holding one wheel, turn the other wheel until the lock screw is visible.
9. Determine if the rear axle cross pin must be replaced.

Note: If **BOTH** lines are not clearly visible on the cross pin, the cross pin **MUST** be replaced.

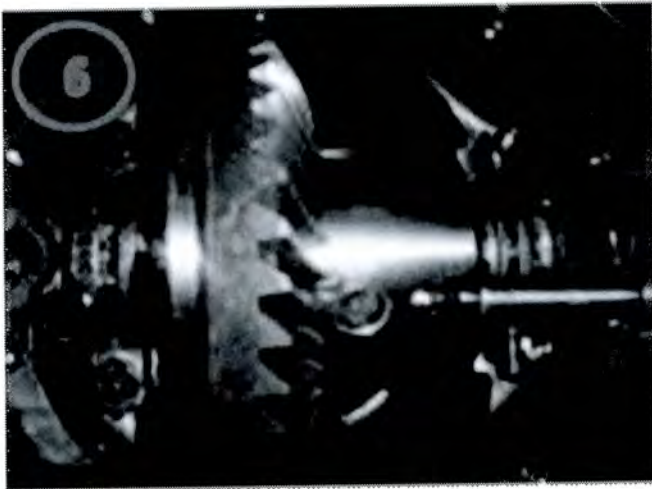
- If the head of the rear axle cross pin has orange and black paint marks or blue and black paint marks, do **NOT** replace the cross pin. Refer to illustration. Proceed to Step 14.
- If the head of the rear axle cross pin does **NOT** have a clearly visible orange and black paint mark, or a blue and black paint mark, (**BOTH** lines **MUST** be clearly visible), **REPLACE** the rear axle cross pin. Refer to illustration. Proceed to Step 10.
