Recall Bulletin

PRODUCT SAFETY RECALL

SUBJECT: Rear Axle Cross Pin Fracture

MODELS: 2011 Cadillac Escalade, Escalade ESV, Escalade EXT
2011 Chevrolet Avalanche, Colorado, Express, Silverado, Suburban, Tahoe
2011 GMC Canyon, Savana, Sierra, Yukon, Yukon XL

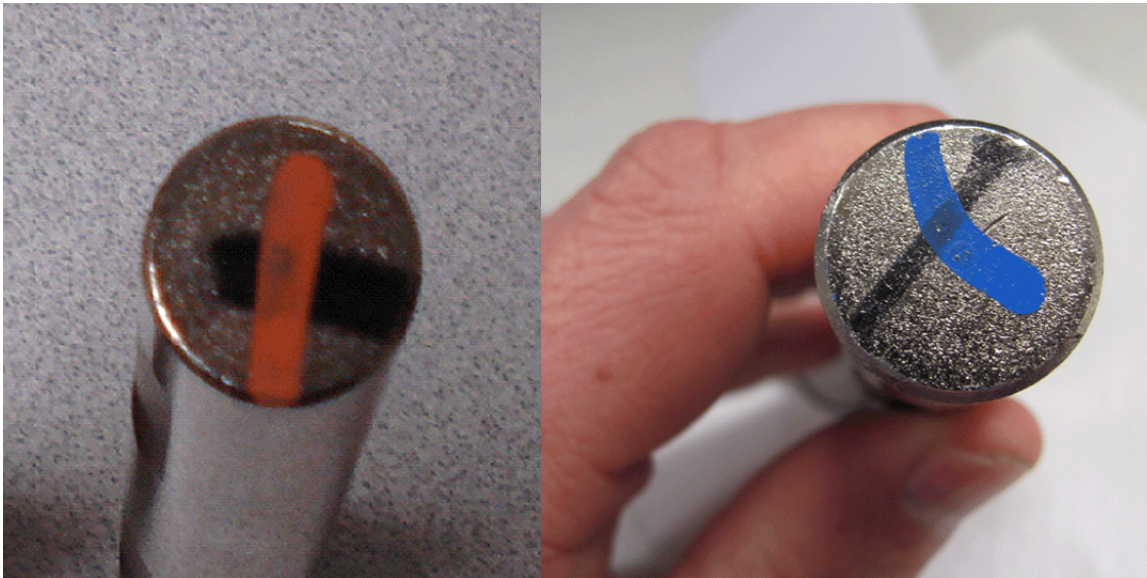
2554944

Note: If **BOTH** lines are not clearly visible on the cross pin, the cross pin **MUST** be replaced.

- If the head of the rear axle cross pin has orange and black paint marks or blue and black paint marks, do NOT replace the cross pin. Refer to illustration. Proceed to Step 14.
- If the head of the rear axle cross pin does NOT have a clearly visible orange and black paint mark, or a blue and black paint mark, (**BOTH** lines **MUST** be clearly visible), **REPLACE** the rear axle cross pin. Refer to illustration. Proceed to Step 10.
