Recall Bulletin

PRODUCT SAFETY RECALL

SUBJECT: Rear Axle Cross Pin Fracture

MODELS: 2011 Cadillac Escalade, Escalade ESV, Escalade EXT
2011 Chevrolet Avalanche, Colorado, Silverado, Suburban, Tahoe
2011 GMC Canyon, Sierra, Yukon, Yukon XL

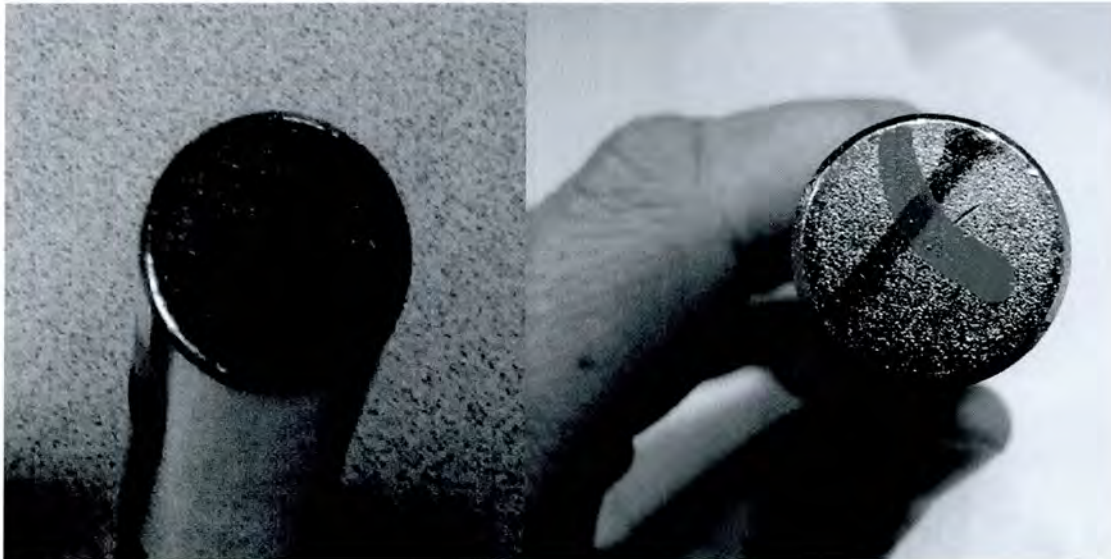
8. While holding one wheel, turn the other wheel until the lock screw is visible.
9. Determine if the rear axle cross pin must be replaced.

Note: If **BOTH** lines are not clearly visible on the cross pin, the cross pin **MUST** be replaced.

- If the head of the rear axle cross pin has orange and black paint marks or blue and black paint marks, do **NOT** replace the cross pin. Refer to illustration. Proceed to Step 14.
- If the head of the rear axle cross pin does **NOT** have a clearly visible orange and black paint mark, or a blue and black paint mark, (**BOTH** lines **MUST** be clearly visible), **REPLACE** the rear axle cross pin. Refer to illustration. Proceed to Step 10.
