Service Bulletin No. 351

<i>MODEL</i>	D Series Coaches	<i>TYPE</i>	Field Change Program	<i>SECTION/GROUP</i>	6 – Cooling	<i>DATE</i>	
<i>SUBJECT</i>	MISSING WELDS ON FAN BELT IDLER PULLEY COVER						
<i>CONDITIONS</i>

Ref. NHTSA Recall No.: 11V–TBD

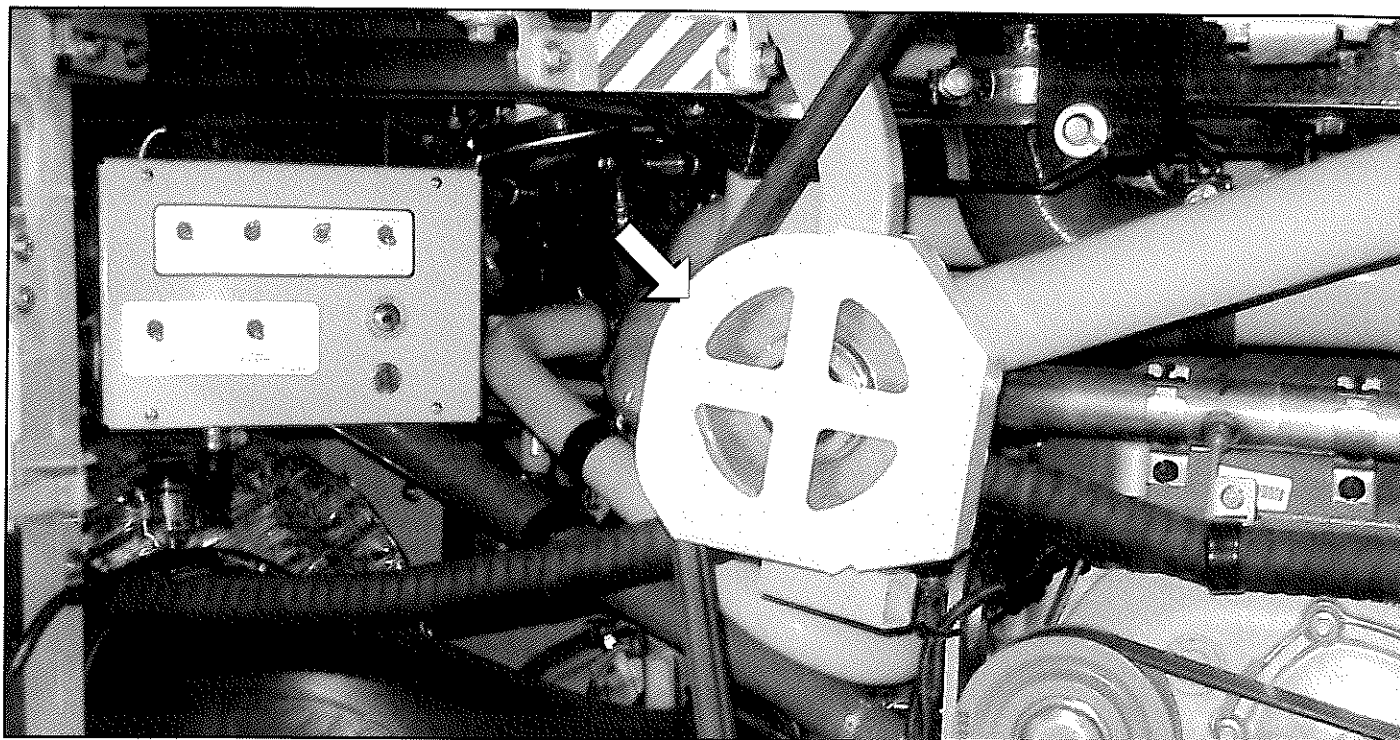
Figure 1.

3. Open the engine door. Locate the fan belt idler pulley cover (refer to Figure 1).

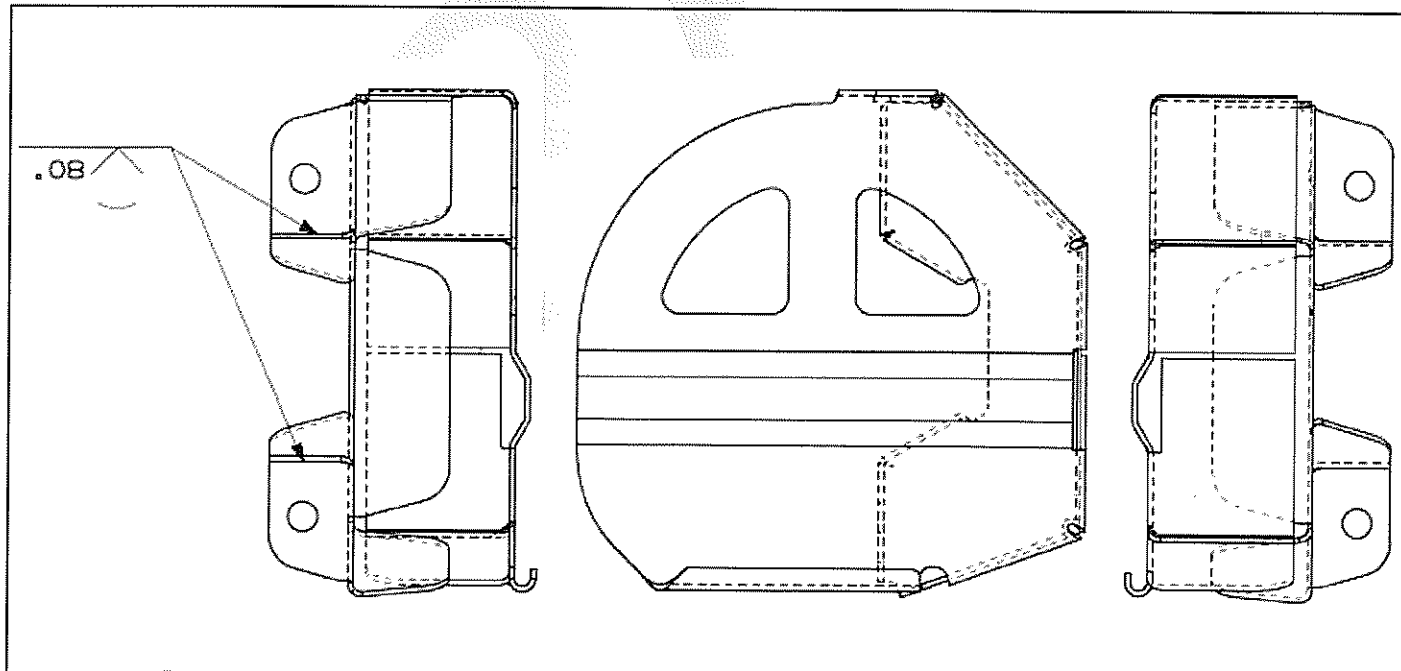
Figure 2.

MCI has determined that the fan belt idler pulley cover may lack two welds that provide stiffness and rigidity to the part. Without these welds MCI believes that the part will eventually fail as a result of fatigue near the area where the cover is assembled to the coach structure. If a failure of both attachment areas occurs, the part may become detached from the coach and potential injury to persons and/or damage to other vehicles or property could occur.

4. Visually inspect the fan belt idler pulley cover for the two (2) welds shown in Figure 2

If the two (2) welds shown in Figure 2 are on the fan belt idler pulley cover, no further action is required. Close the engine door. Fill out the attached verification form and submit to MCI's warranty department.

If the two (2) welds shown in Figure 2 are not on the fan belt idler pulley cover, proceed to Step 5.
