CERTAIN 1999-2003 MODEL YEAR WINDSTAR VEHICLES OPERATED IN CORROSION STATES — SUBFRAME FRONT LOWER CONTROL ARM REAR ATTACHING FLANGES AND REAR BODY MOUNT ATTACHMENTS INSPECTION AND REPAIR

Interim Service Procedure

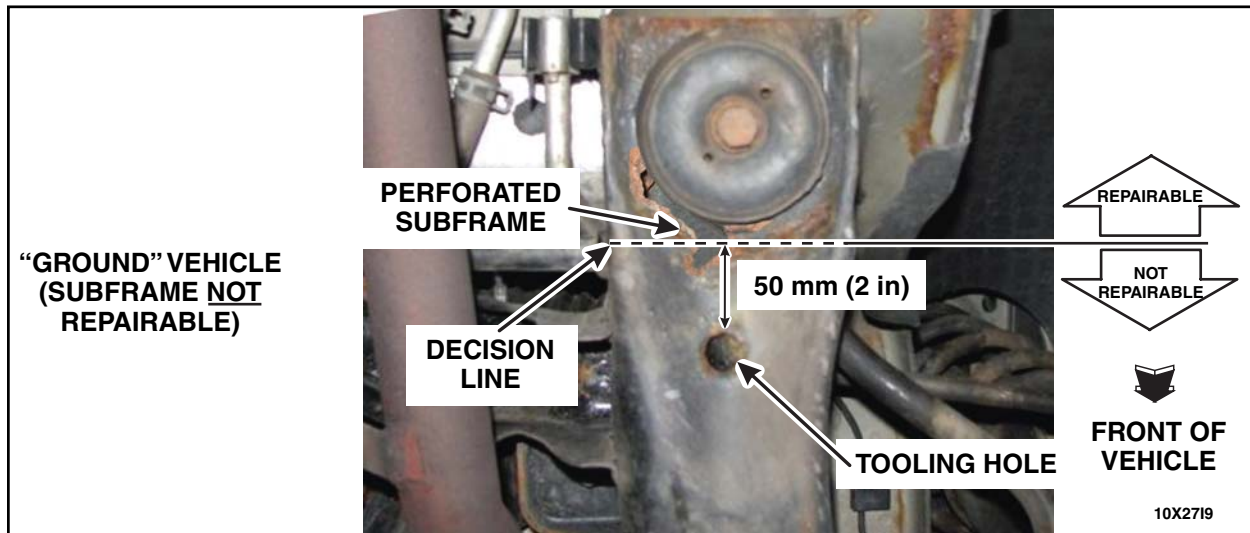
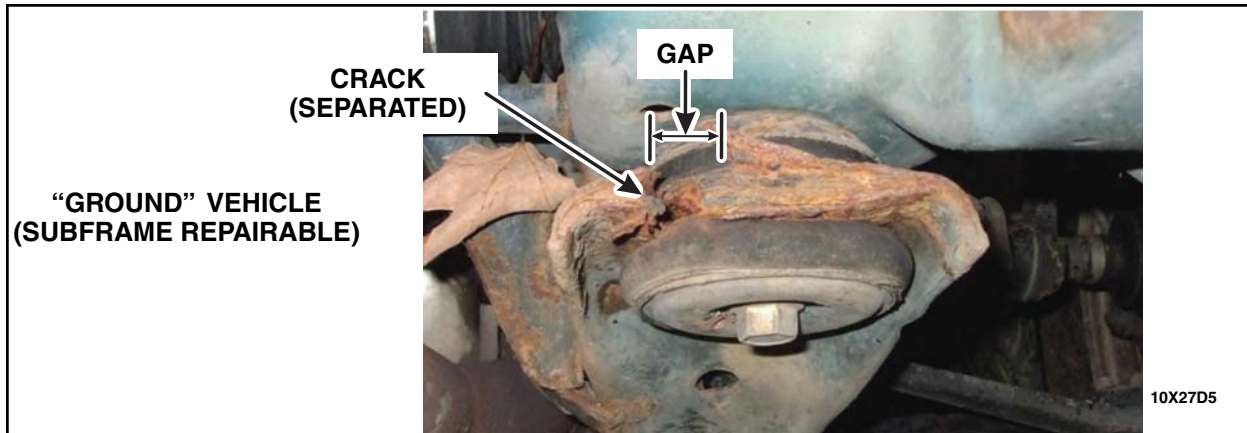
1. With the gear selector in NEUTRAL, position the vehicle on a hoist and lift the vehicle. For additional information, refer to the WSM, Section 100-02.
2. Inspect the driver and passenger side of the rear body mount area of the subframe for cracks, perforations, gaps and any non-factory welds or reinforcements. See Figures 1, 2, 3 and 4.

- If non-factory welds or reinforcements are found, the subframe is beyond repair and pictures must be sent to Digital Imaging (DI) for vehicle refund consideration. Proceed to Digital Imaging Instructions on page 8.

- If a perforation or crack is forward of the decision line, the subframe is beyond repair and pictures must be sent to Digital Imaging (DI) for vehicle refund consideration. Proceed to Digital Imaging Instructions on page 8.

- If perforation is located behind the decision line, the vehicle must be "grounded". Proceed to the LCA Rear Attachment Flange Inspection on page 5 to see if the subframe is beyond repair.

- If there is a crack rearward of the body mount that has become a gap greater than 3 mm (0.12 in), the vehicle must be "grounded". Proceed to the LCA Rear Attachment Flange Inspection on page 5 to see if the subframe is beyond repair.

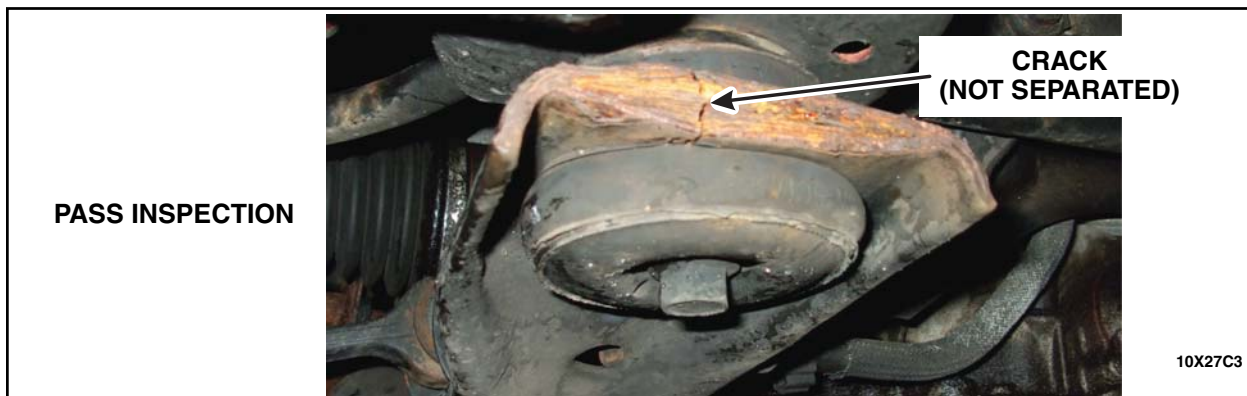
FIGURE 4

NOTE: A narrow crack at the end of the subframe that **is not** separating does not justify grounding the vehicle. See Figure 4.

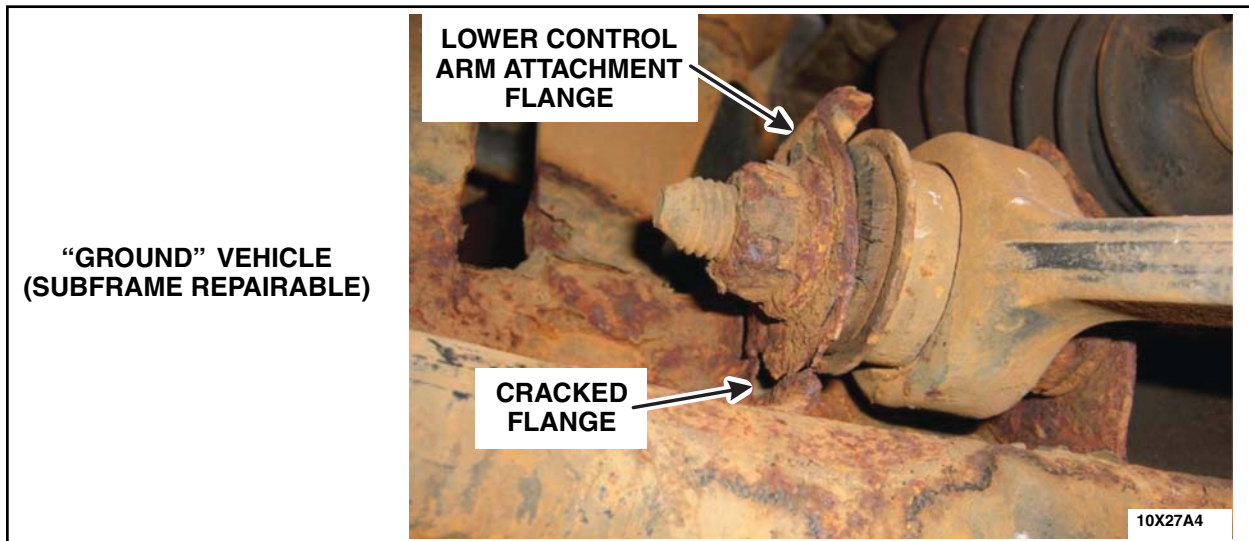
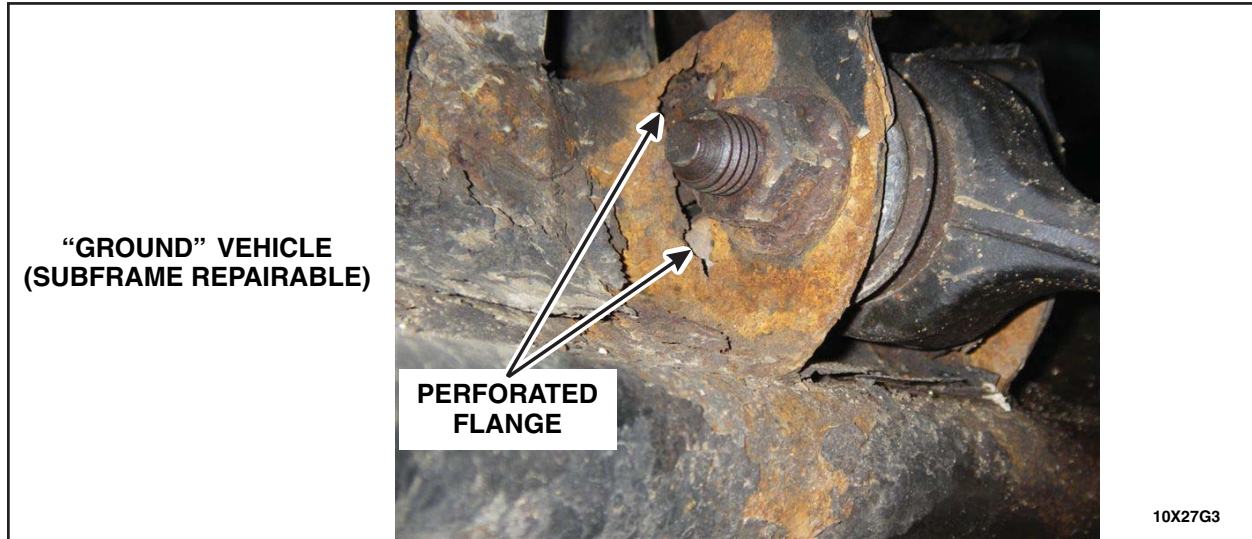
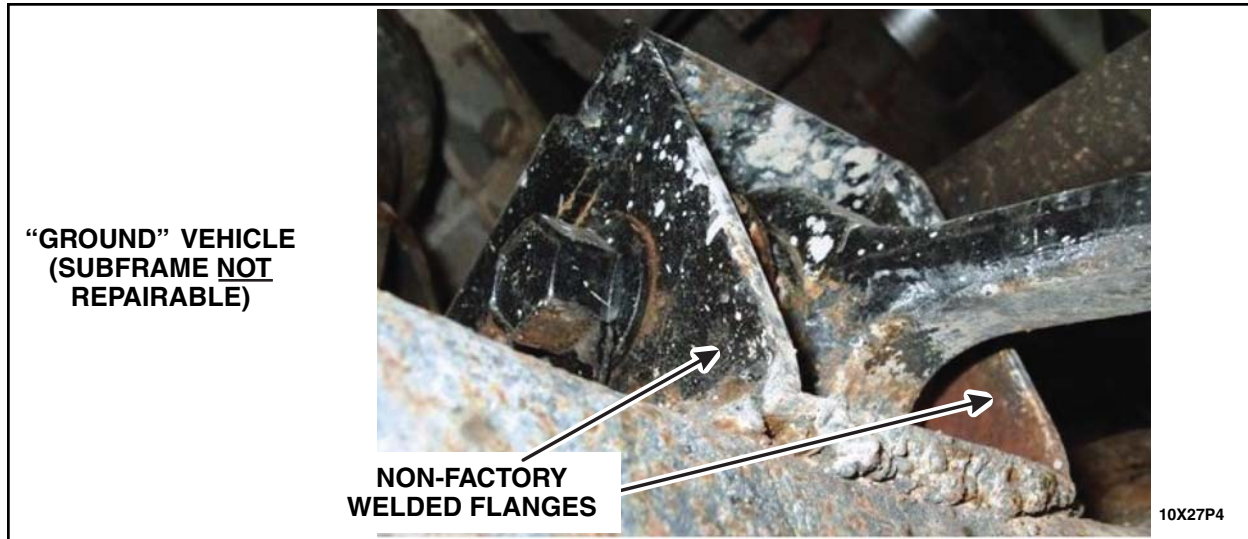
3. Inspect both surfaces of the LCA rear attachment flanges on the driver and passenger side of the subframe for cracks, perforations, excessive loss of metal, non-factory welded flanges or reinforcements. See Figures 2, 3, 4 and 5.

- If non-factory welds or reinforcements are found, the subframe is beyond repair and pictures must be sent to Digital Imaging (DI) for vehicle refund consideration. Proceed to Digital Imaging Instructions on page 8.
- If both LCA rear attachment point flanges are missing, the subframe is beyond repair and pictures must be sent to Digital Imaging (DI) for vehicle refund consideration. Proceed to Digital Imaging Instructions on page 8.
- If a crack, perforation or excessive metal loss is found, "ground" the vehicle until reinforcement brackets are available. Offer the customer rental transportation and provide them with a copy of the Did Not Pass Subframe Inspection Customer Information Sheet.
- If subframe passed the inspection, return the vehicle to the owner and provide them with a copy of the Passed Subframe Inspection Customer Information Sheet.
