## CERTAIN 1999-2003 MODEL YEAR WINDSTAR VEHICLES OPERATED IN CORROSION STATES — SUBFRAME FRONT LOWER CONTROL ARM REAR ATTACHING FLANGES AND REAR BODY MOUNT ATTACHMENTS INSPECTION AND REPAIR

#### Interim Service Procedure

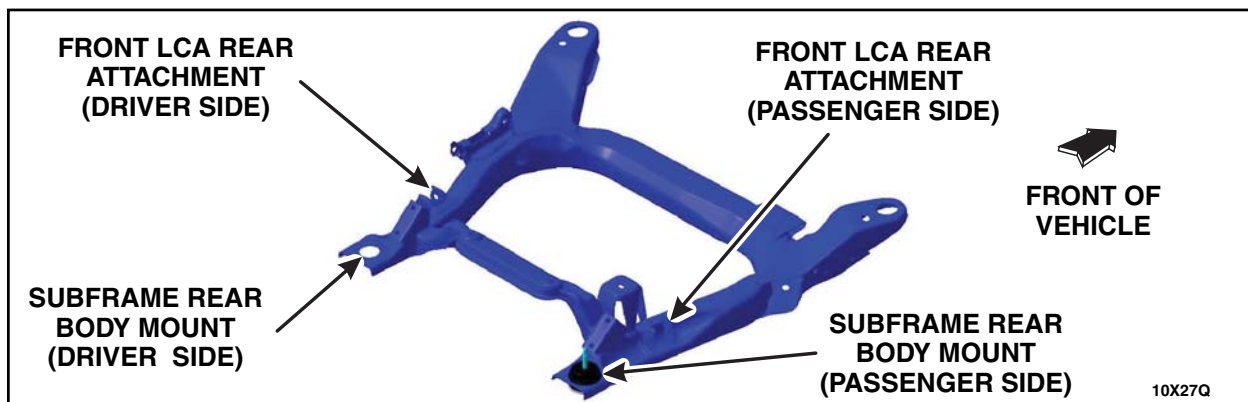
FIGURE 1

The interim service procedure involves inspecting four locations of the subframe. See Figure 1. These locations are the driver and passenger rear body mount sections of the subframe and the Lower Control Arm (LCA) rear attachment flanges that are welded to the subframe.

The permanent repair involves installing four reinforcement brackets on the subframe. These reinforcement brackets will be installed:

- under the rear body mount section of the subframe.
- over the LCA rear attachment flanges.

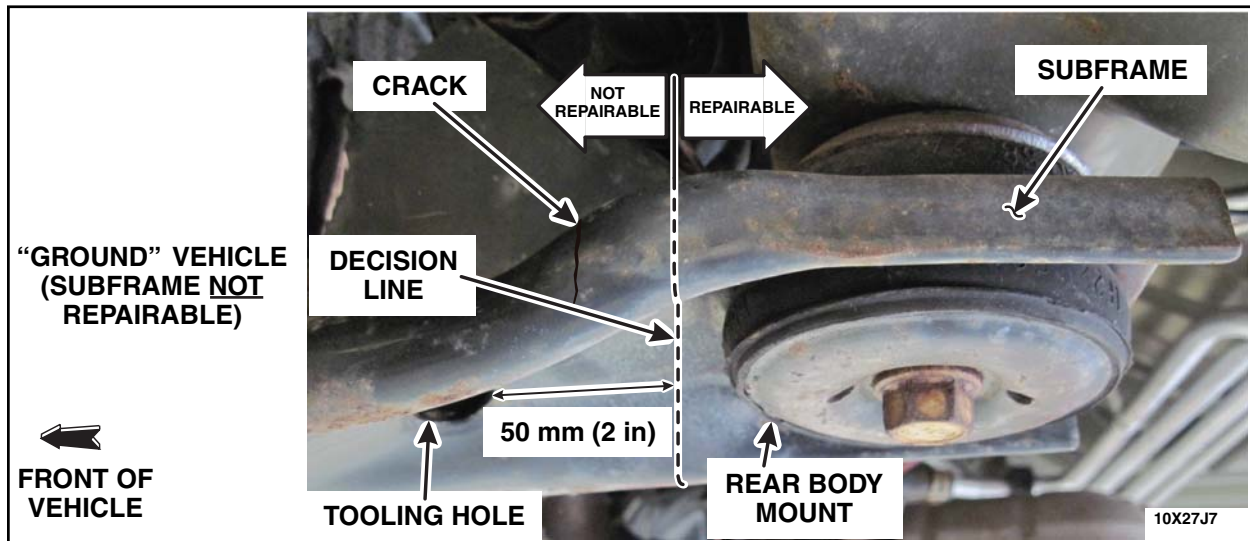
FIGURE 1

1. With the gear selector in NEUTRAL, position the vehicle on a hoist and lift the vehicle. For additional information, refer to the WSM, Section 100-02.
2. Inspect the driver and passenger side of the rear body mount area of the subframe for cracks, perforations, gaps and any non-factory welds or reinforcements. See Figures 1, 2, 3 and 4.

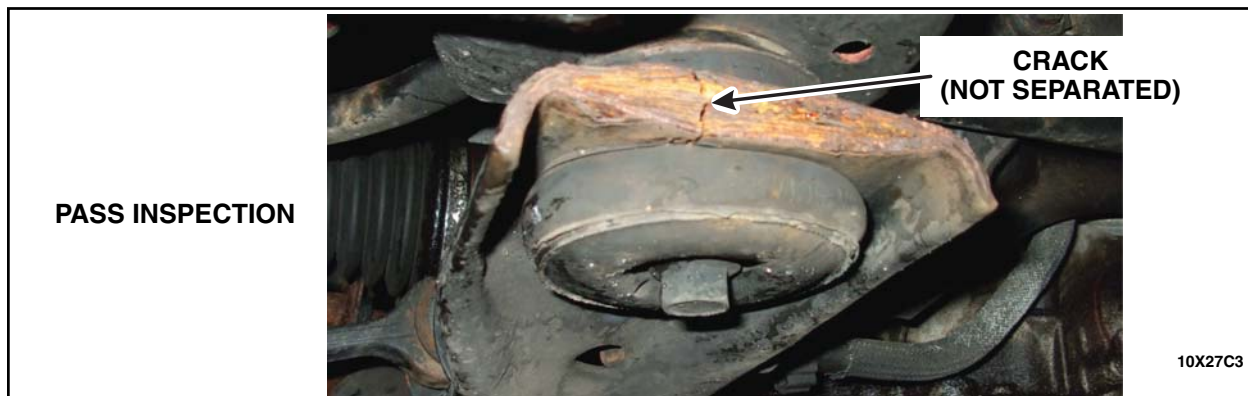
FIGURE 4

**NOTE:** A narrow crack at the end of the subframe that **is not** separating does not justify grounding the vehicle. See Figure 4.

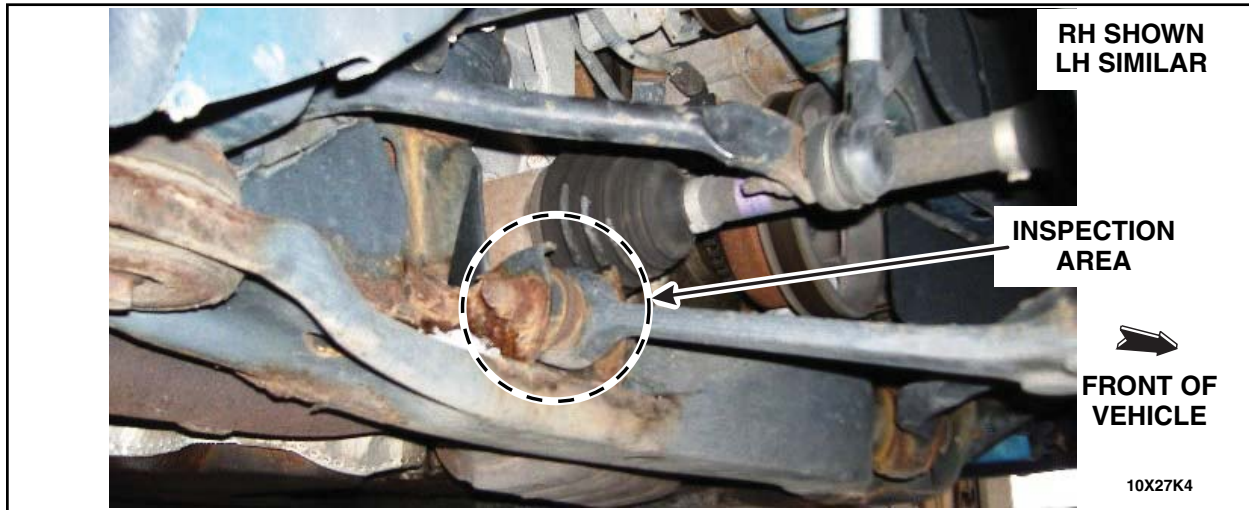
FIGURE 1

1. Remove both front wheels. For additional information, refer to the WSM, Section 204-04.
2. Using a hand-held wire brush, clean all loose rust, scale, and debris from both surfaces of the driver and passenger side of the subframe lower control arm (LCA) rear attachment flanges. See Figure 1.

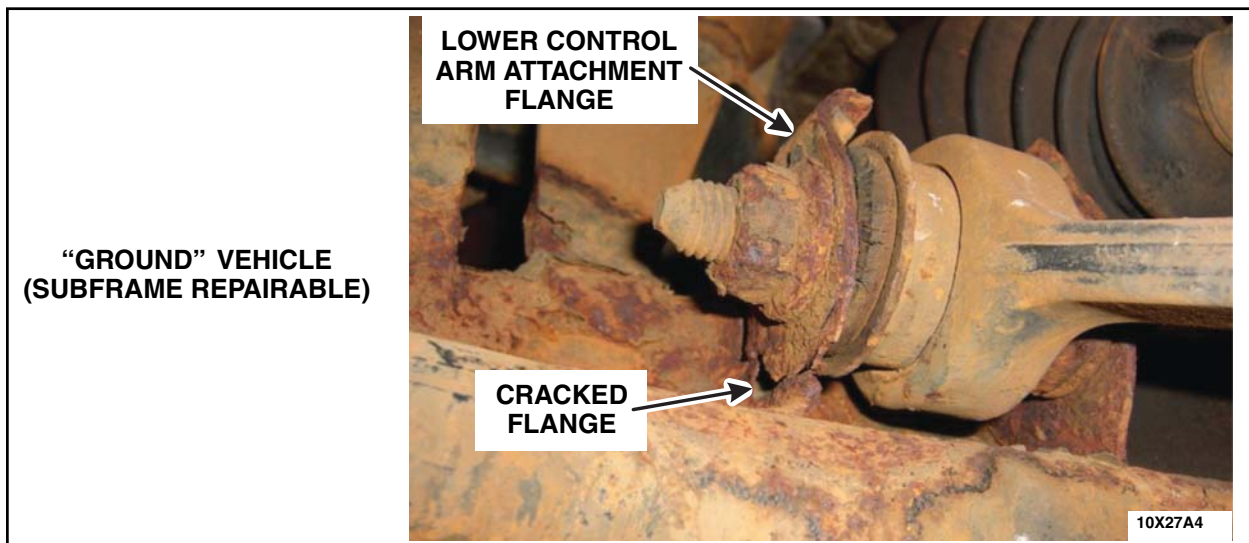
FIGURE 2

3. Inspect both surfaces of the LCA rear attachment flanges on the driver and passenger side of the subframe for cracks, perforations, excessive loss of metal, non-factory welded flanges or reinforcements. See Figures 2, 3, 4 and 5.

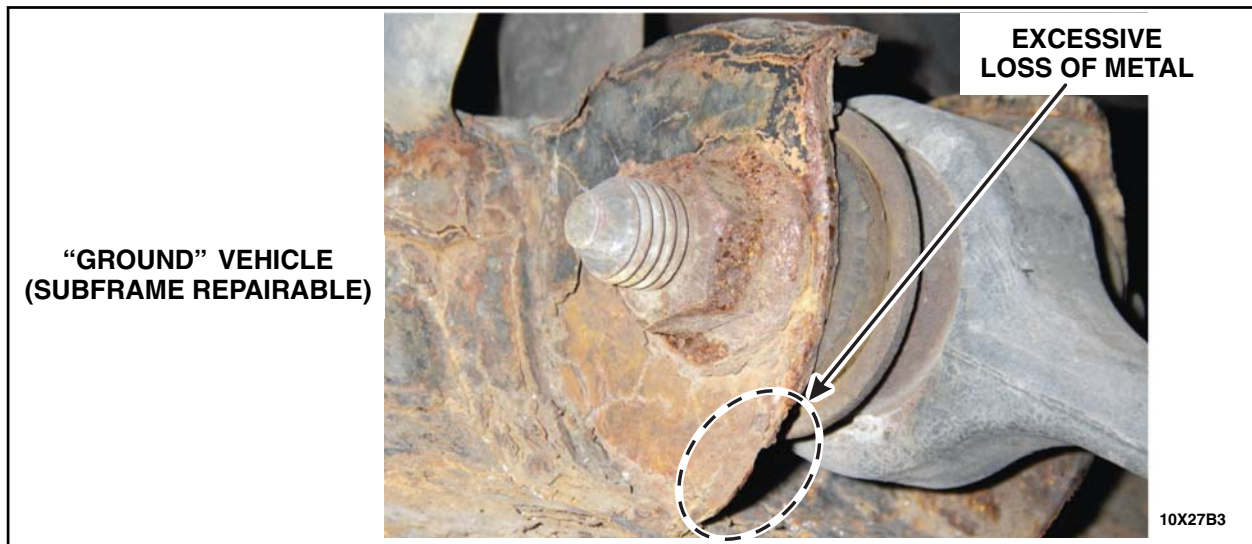
**FIGURE 4**

**NOTE:** A flange that is as thin or thinner than the one shown in Figure 4 should be "grounded".

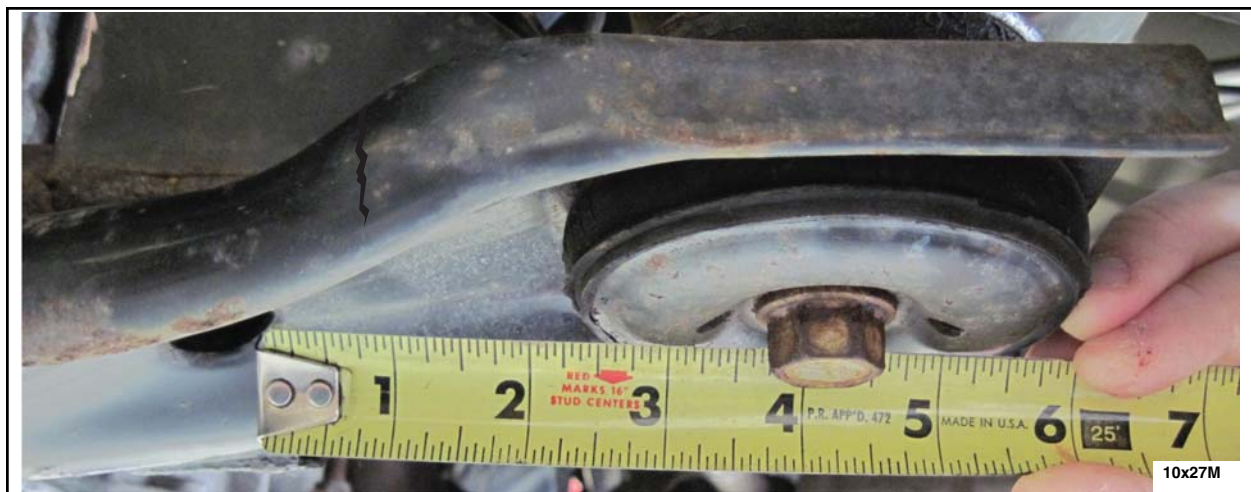
Take three close up pictures from the side of the subframe showing the crack and the tooling hole. In order to make a determination, the evaluator will need to be able to see the crack in relationship to the tooling hole. See Figure 3.

FIGURE 3 - Proper angle for a cracked subframe

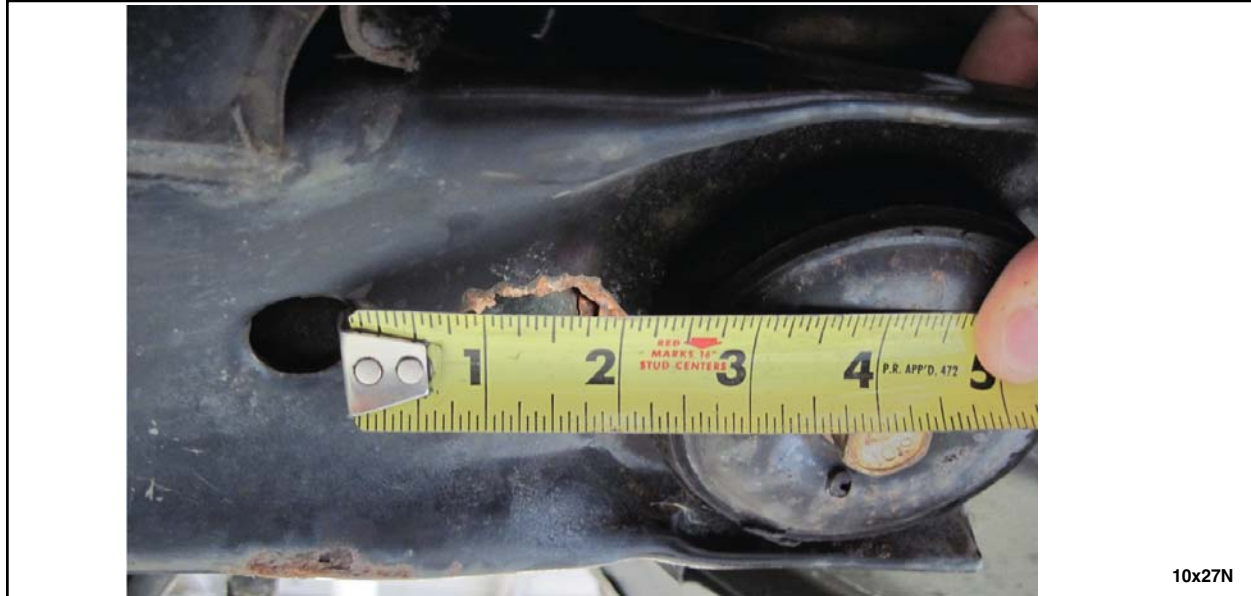
Take three close up pictures from the bottom of the subframe showing the perforation and the tooling hole. In order to make a determination, the evaluator will need to be able to see the perforation in relationship to the tooling hole. See Figure 4.

**FIGURE 4 - Proper angle for a perforated subframe**

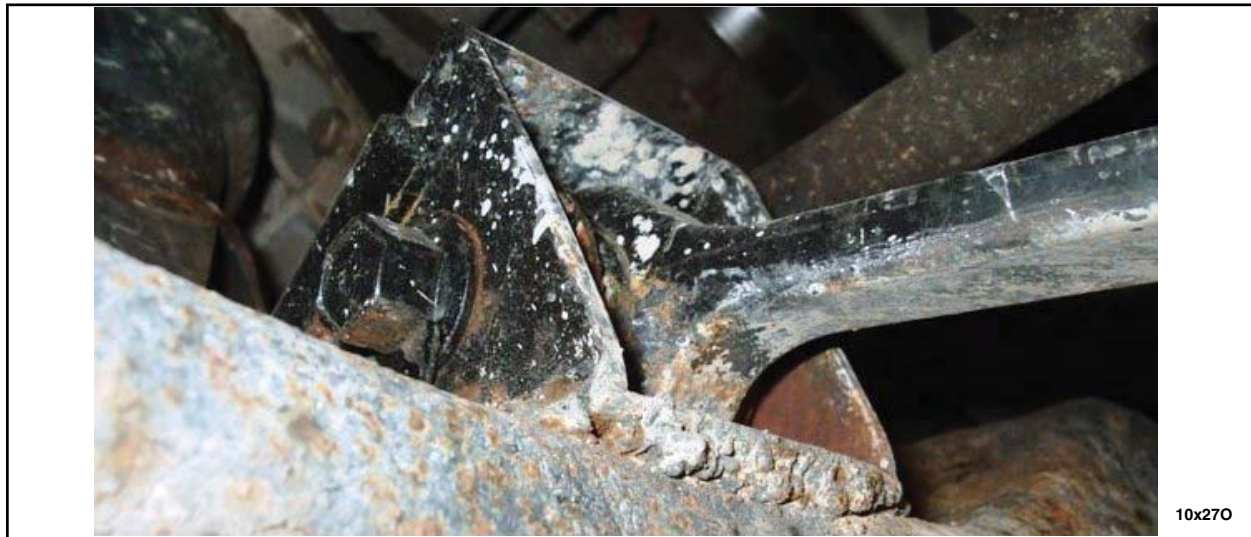
**FIGURE 5**

Take three close up pictures that clearly show the location and extent of the non-factory welds and/or reinforcements. See Figure 5.
