Date	Number	Page
04.11	RVXX1101	1(7)

Engine Harness Ground Feedback

SAFETY RECALL INFORMATION:

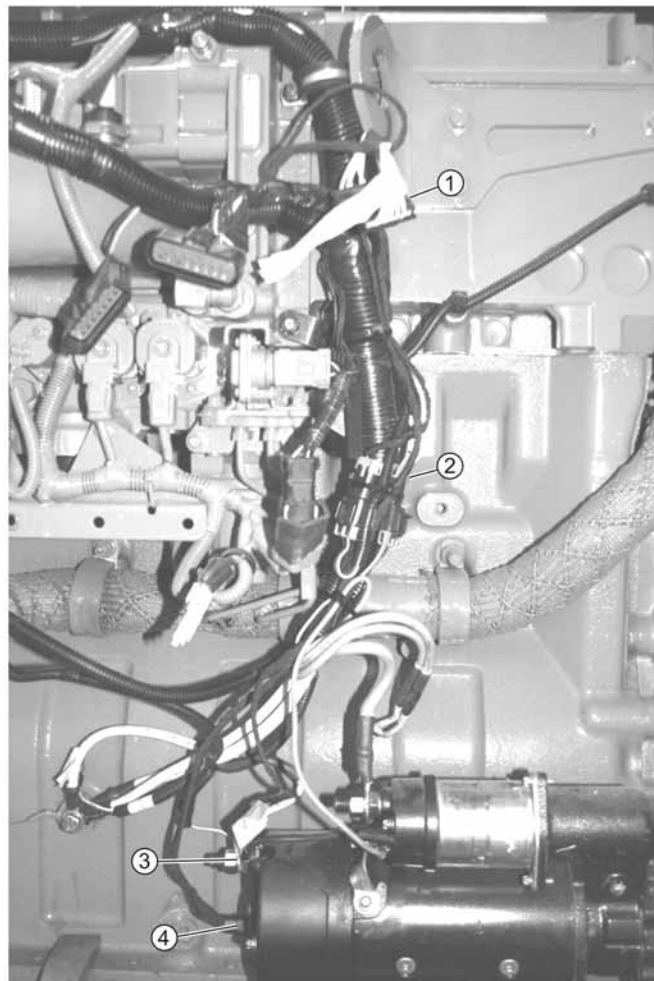
NOTE: The photo is for reference only, the location of the connector may vary through the build dates.

| 1) FCEN Connector | 2) ENOCP Connector |
| 3) Starter Ground stud | 4) Start OCP Connector |

1. Secure the vehicle for service by parking it on a flat level surface, applying the parking brake, chocking the rear wheel, and placing the transmission in neutral.
2. Disconnect both the battery cables.
IMPORTANT NOTE! The POSITIVE BATTERY CABLE MUST BE DISCONNECTED FIRST! Removing the negative cable first will result in unintended engine cranking.
3. Locate and disconnect the front chassis engine interface (FCEN) connector on the left hand side of the engine. Insert the six way connectors of jumper harness PN 21669355 into the FCEN connectors. See photo position 1.

4. Locate the engine over crank protection (ENOCP) connector on the left hand side of the engine and remove the existing female connector fold back and tie. Insert the ENOCP female connector of the new jumper harness.
5. Locate the over crank protection (OCP) connector at the rear of the starter. Remove the existing male connector fold back and tie. Insert the OCP male connector of the new jumper harness on the rear of the starter.
6. Remove the nut securing the ground connections on the rear of the starter and install the ring terminal of the jumper harness. Torque ground stud nut to 30.5 ± 3.5 Nm (22.5 ± 2.6 ft-lb).
7. Secure harness with cable ties as needed.
8. Reconnect all previously removed cables to the battery terminals, then switch the main disconnect switch to the ON position.
9. Check starter operation

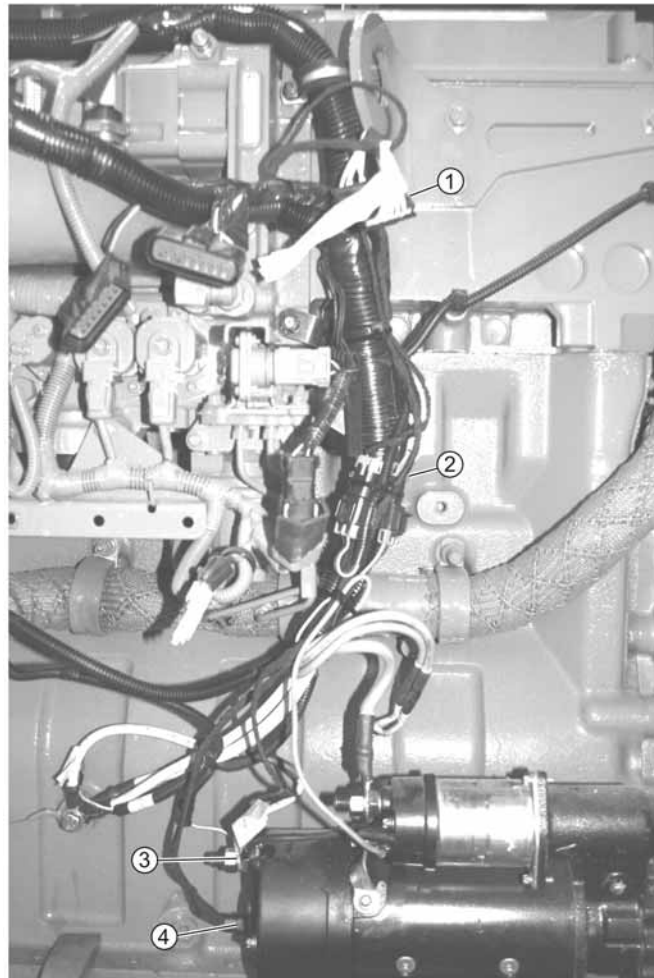
NOTE: The photo is for reference only, the location of the connector may vary through the build dates.

| 1) FCEN Connector | 2) ENOCP Connector |
| 3) Starter Ground stud | 4) Start OCP Connector |

1. Secure the vehicle for service by parking it on a flat level surface, applying the parking brake, chocking the rear wheel, and placing the transmission in neutral.
2. Disconnect both the battery cables.
IMPORTANT NOTE! The POSITIVE BATTERY CABLE MUST BE DISCONNECTED FIRST! Removing the negative cable first will result in unintended engine cranking.
3. Locate and disconnect the front chassis engine interface (FCEN) connector on the left hand side of the engine. Insert the four way connectors of jumper harness PN 21676190 into the FCEN connectors. See photo position 1.

4. Locate the engine over crank protection (ENOCP) connector on the left hand side of the engine and remove the existing female connector fold back and tie. Insert the ENOCP female connector of the new jumper harness.
5. Locate the over crank protection (OCP) connector at the rear of the starter. Remove the existing male connector fold back and tie. Insert the OCP male connector of the new jumper harness on the rear of the starter.
6. Remove the nut securing the ground connections on the rear of the starter and install the ring terminal of the jumper harness. Torque ground stud nut to 30.5 ± 3.5 Nm (22.5 ± 2.6 ft-lb).
7. Secure harness with cable ties as needed.
8. Reconnect all previously removed cables to the battery terminals, then switch the main disconnect switch to the ON position.
9. Check starter operation

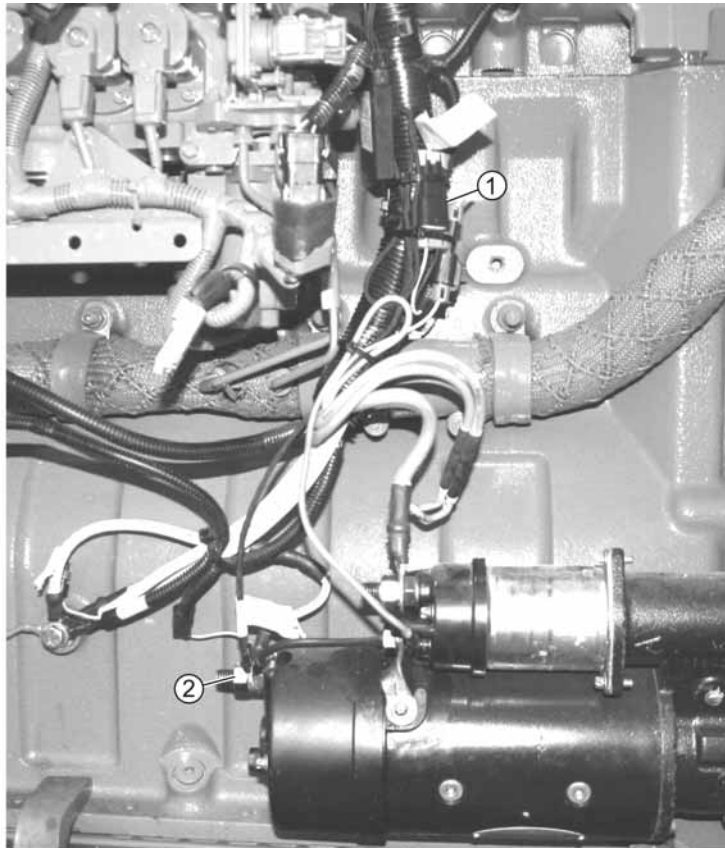
NOTE: The photo is for reference only, the location of the connector may vary through the build dates.

1) OCP Connector

2) Starter Ground stud

1. Secure the vehicle for service by parking it on a flat level surface, applying the parking brake, chocking the rear wheel, and placing the transmission in neutral.
2. Disconnect both the battery cables.
IMPORTANT NOTE! The POSITIVE BATTERY CABLE MUST BE DISCONNECTED FIRST! Removing the negative cable first will result in unintended engine cranking.
3. Locate the engine over crank protection (ENOC) connector on the left hand side of the engine and remove the plug from the connector and insert the ENOC connector of the new jumper harness PN 21676192. See photo position 1.

4. Remove the nut securing the ground connections on the rear of the starter and install the ring terminal of the jumper harness. Torque ground stud nut to 30.5 ±3.5 Nm (22.5 ±2.6 ft-lb).
