Technical Bulletin

Section Title: Engine
 TSB No. TS 30 02011

SUBJECT: SAFETY RECALL CAMPAIGN: SM, ALTERNATOR BELT TENSIONER DAMAGE.
MODEL(S): GRAND VITARA (JB424)
YEAR: 2009~2011
PRODUCTION RANGE: JUNE 2, 2008~OCTOBER 20, 2010

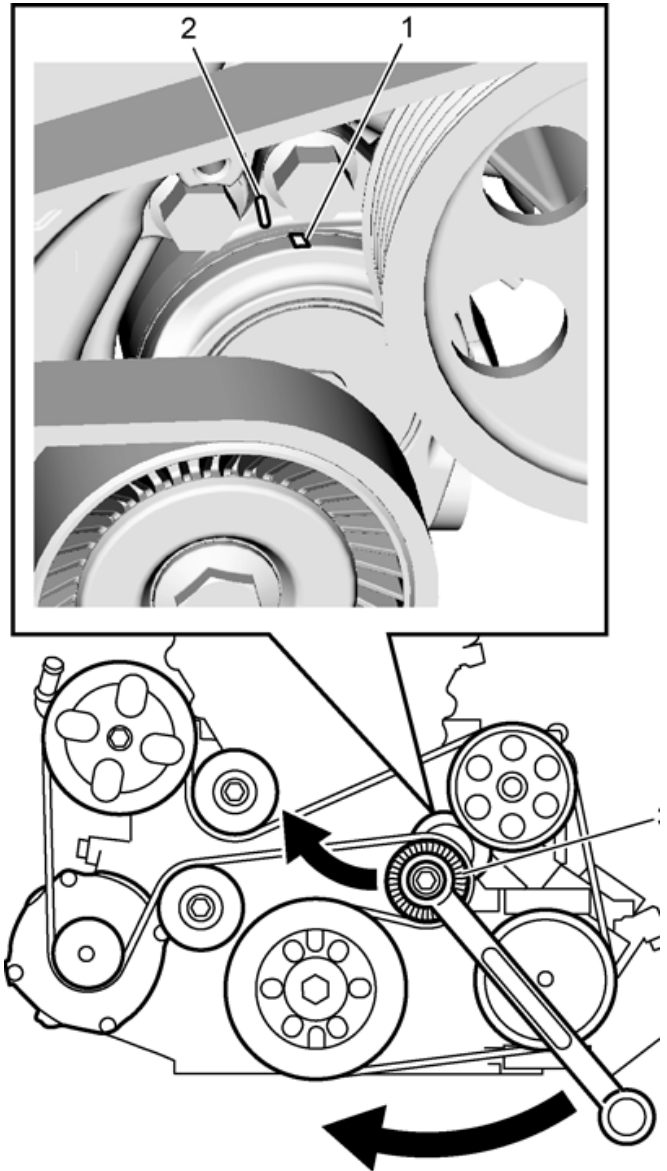
Drive Belt Inspection

Before beginning the removal process, please inspect the position of the tension indicators on the tensioner pulley, as well as the condition of the drive belt.

In cases of normal belt condition, the front tension indicator (1) (nearest the pulley) is on the right of the rear tension indicator (2), as shown in the illustration to the right.

If indicator (1) is on the left of Indicator (2), the belt should be replaced as a general service in addition to the tensioner replacement.

If it is recommended that the belt should be replaced due to the tension indicators or the visual appearance during inspection, please contact the vehicle owner to advise them of these needs. It is the customer's responsibility to pay for the cost of the replacement belt as this is not included as part of the service recall campaign.
