Recall Bulletin

PRODUCT SAFETY RECALL

SUBJECT: Rear Suspension Toe Link Separation

MODELS: 2009-2010 Cadillac CTS

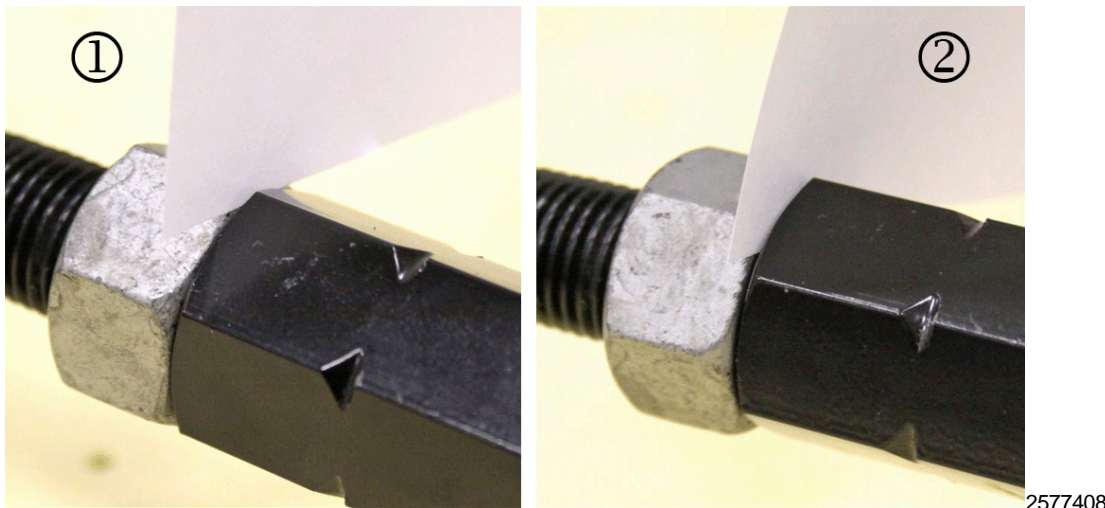
(1) Paper does NOT fit between jam nut and rear suspension adjustment link. (2) Paper fits between jam nut and rear suspension adjustment link.

4. Inspect for the toe link assembly for loosened jam nuts. In addition, inspect for looseness in the toe link assembly by grasping the adjuster link using a pull up and pull down method. Perform these procedures on both the rear driver's and passenger's side toe link assembly.
 - If a piece of paper fits between either of the two jam nuts and rear suspension adjustment link (2), replace toe link assembly. Refer to *Adjust Link Replacement* in SI.
 - If the toe link assembly has any kind of looseness, replace toe link assembly. Refer to *Adjust Link Replacement* in SI.
 - If the jam nuts are not loose and the toe link assembly is not loose, proceed to Step 5.

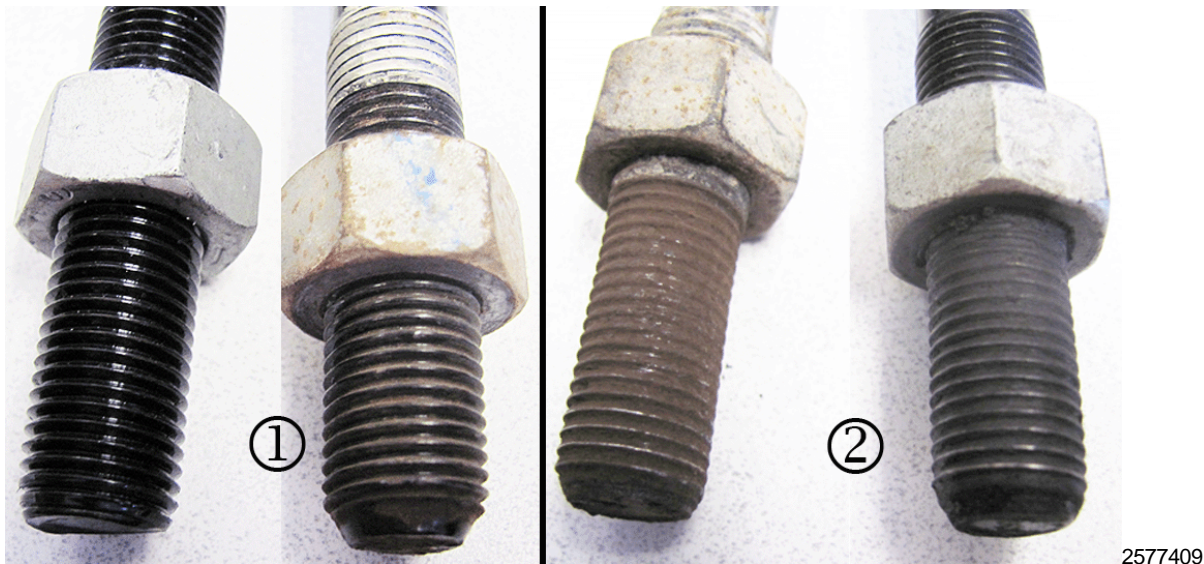
- 5.15 Inspect the threads inside the rear suspension adjustment link for thread wear, damage or corrosion.
 - If the threads on both the inside and outside rod and adjustment link are NOT damaged or worn and do NOT have excessive corrosion (1), proceed to *Clean and Reassemble Toe Link Assembly* in this bulletin.
 - If the threads on one or both rods are worn, damaged or corroded (2), or the adjustment link threads are damaged, replace the toe link assembly. Refer to *Adjust Link Replacement* in SI.
