## Gordon Foods – Ramp Clip Repair

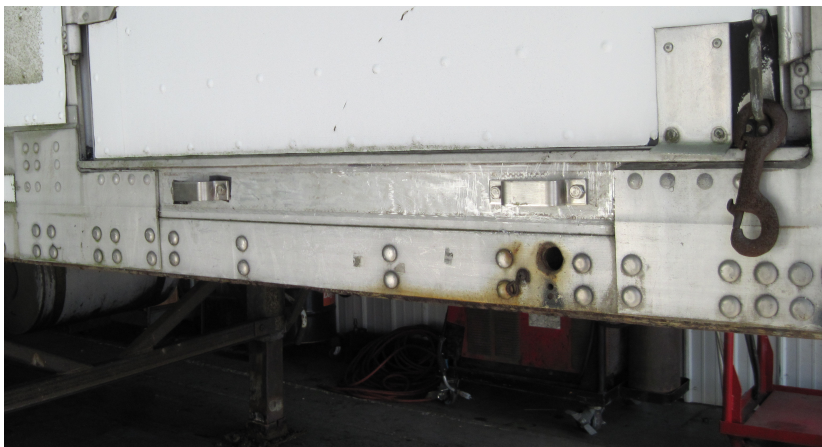
10. Completed installation
